San Jose Creek Flood Control Revegetation Sites **And Los Carneros Mitigation Bank** **Review and Recommendations**

ENVIRONMENTAL DEFENSE CENTER
October 24, 2022

Natalie Blackwelder, EDC Watershed Program Intern
Brian Trautwein, Senior Analyst / Watershed Program Director

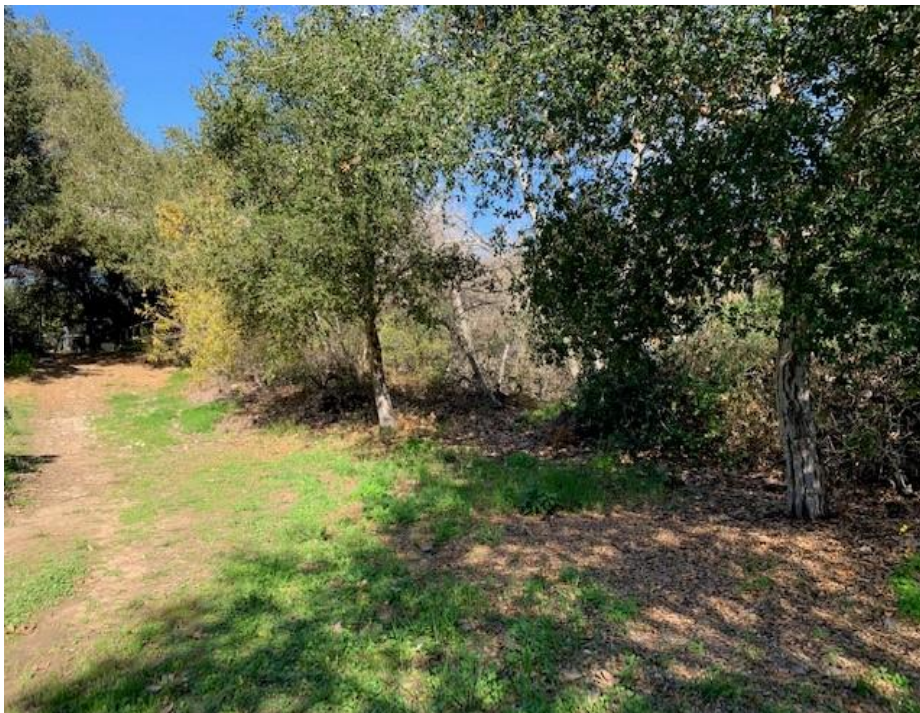
Figure 3. North end of Vineyard Site looking north from trail. Note the failure to establish native vegetation cover between the trail and the Creek. Successful establishment of oaks (presumably two of seven planted at Vineyard site). Trautwein. January 25, 2022.

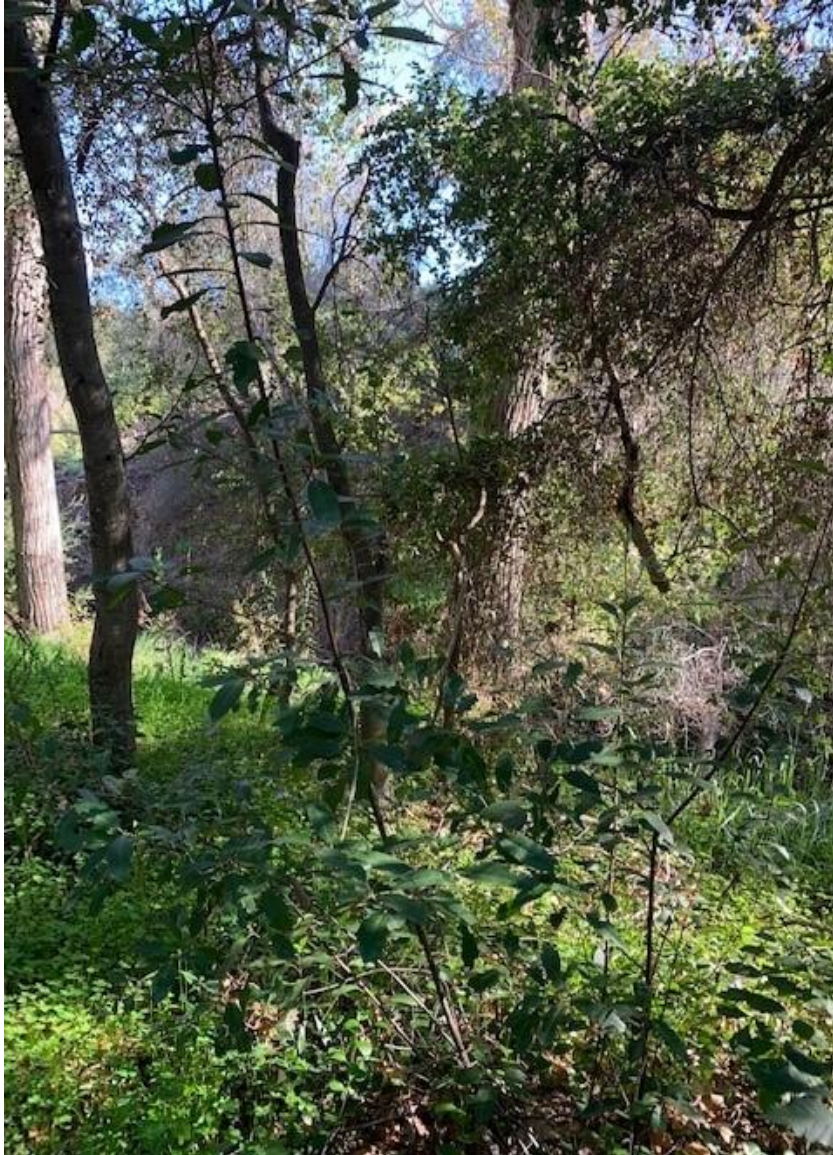
Figure 24. Toyon in shade of oak canopy. South End West Bank Section of Vineyard Site adjacent to trail near Patterson Avenue Bridge. Understory dominated by nonnative oxalis and vinca. Trautwein. January 25, 2022.

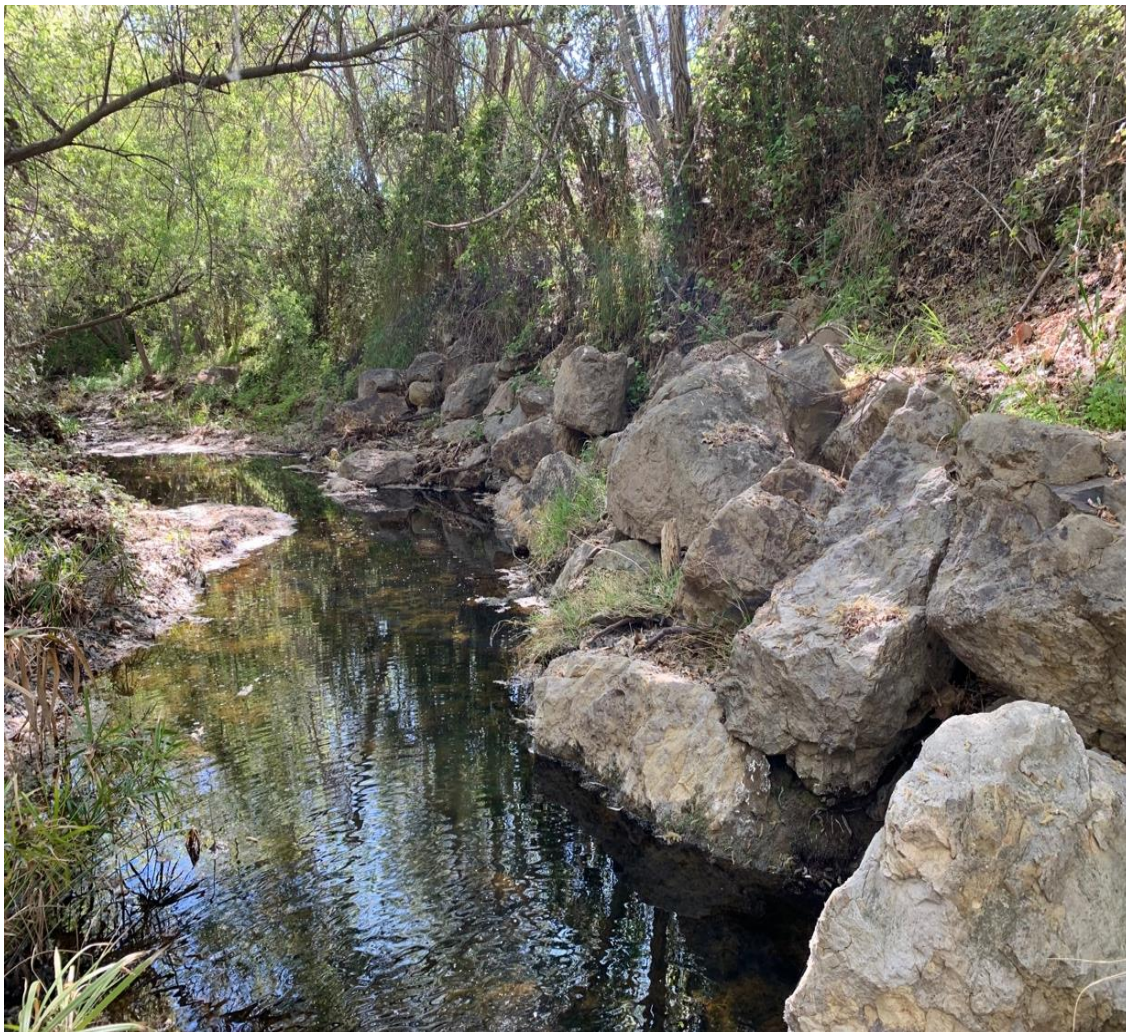
Figure 25. Looking downstream San Jose creek at the Norma Site (Site 1). Successful establishing of willow woodland. Note the riprap installed on the west bank. This site was visited in late February/early March and water was still flowing. All of the surviving revegetation is located above the installed rip rap. Trautwein. March 7, 2022.

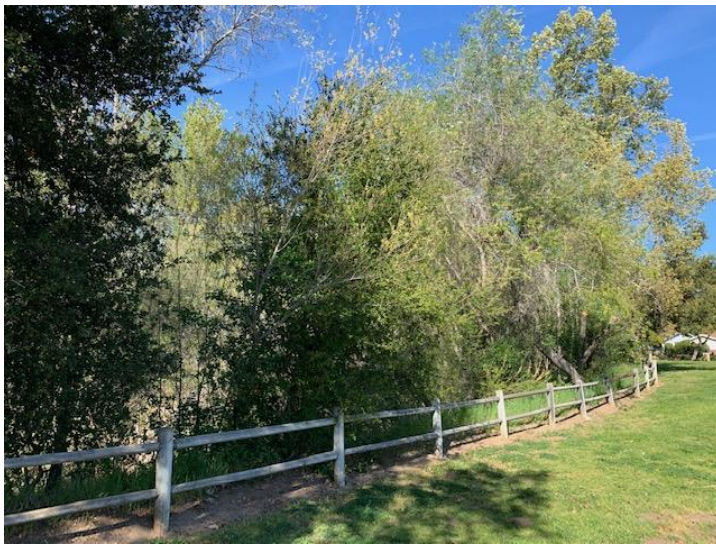
Figure 32. Paseo Cameo Site. Wood rail fence installed after 1998 storm eroded bank approximately twenty-five feet into street. One hundred willows were planted on the east creek bank inside the fence. Site experiencing natural recruitment of coast live oak and bay laurel saplings. Trautwein. March 7, 2022.

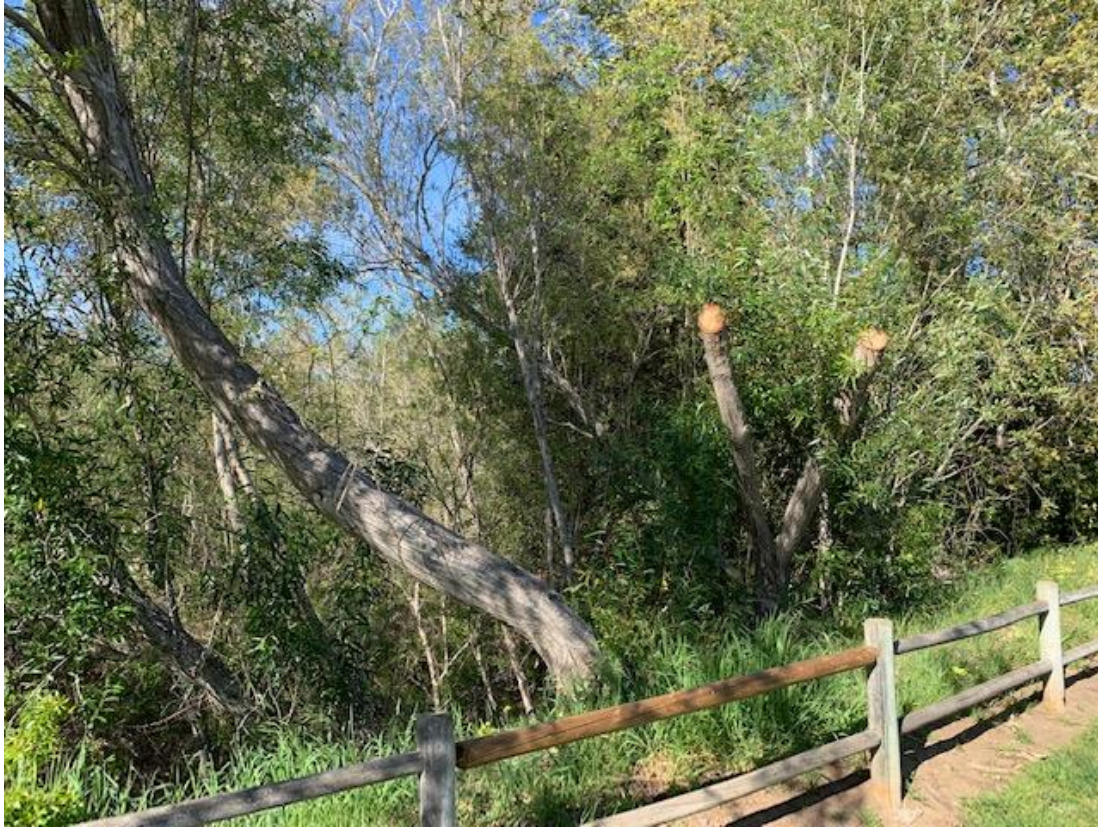
Figure 34. Paseo Cameo site with wood rail fence in foreground. Note the amputated branches of the willow tree above the fence. Most trees along this stretch seem to be in fair to good condition. Trautwein. March 7, 2022.

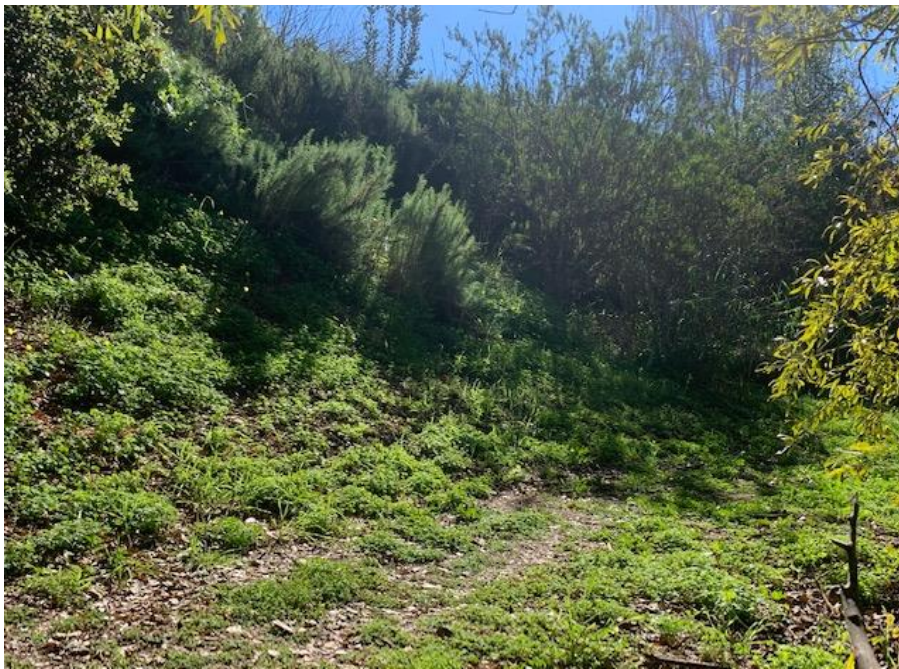
Figure 46. COVA Site #2 showing California sage, mulefat, and toyon surviving with portion of site in lower left quadrant covered by invasive herbaceous species. Trautwein. January 23, 2022.

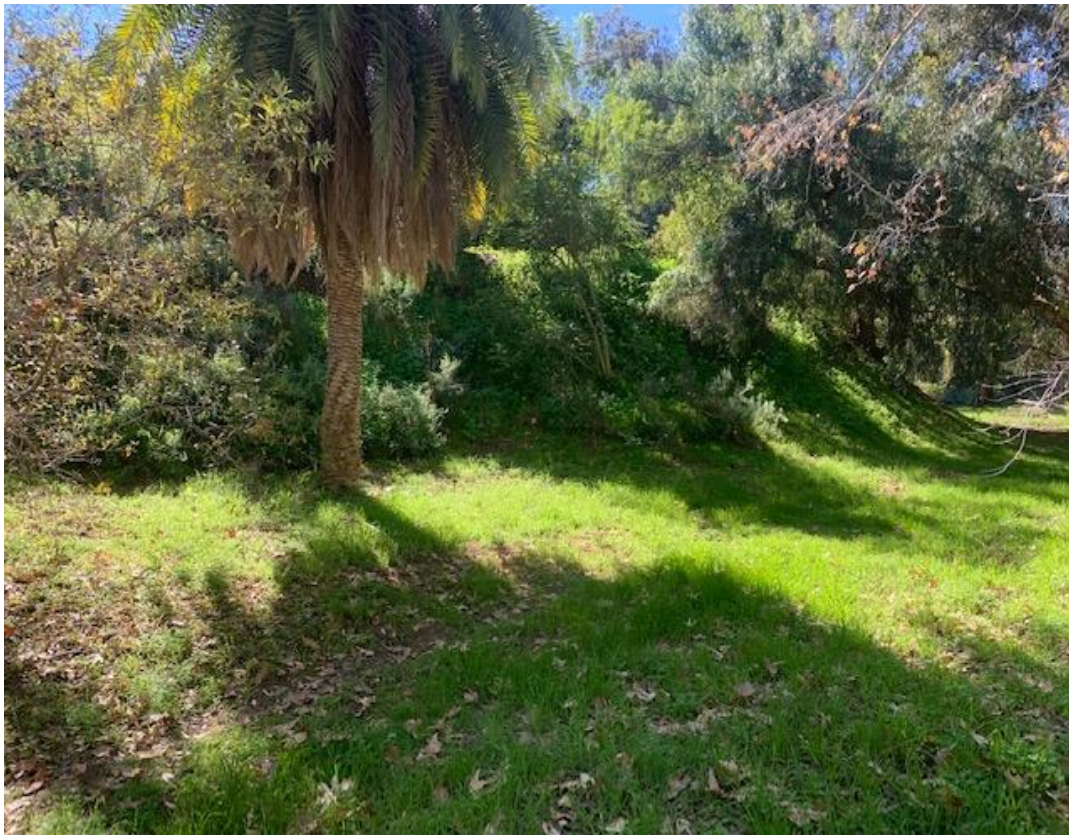
Figure 48. COVA Site #3. Large palm tree retained on edge of site when riparian habitat was cleared. Planted species on slope are primarily non-riparian upland species including California sage, black sage, coyote brush and ceanothus. A large area of dense riparian habitat had been removed (lower half of image). Trautwein. January 30, 2022.

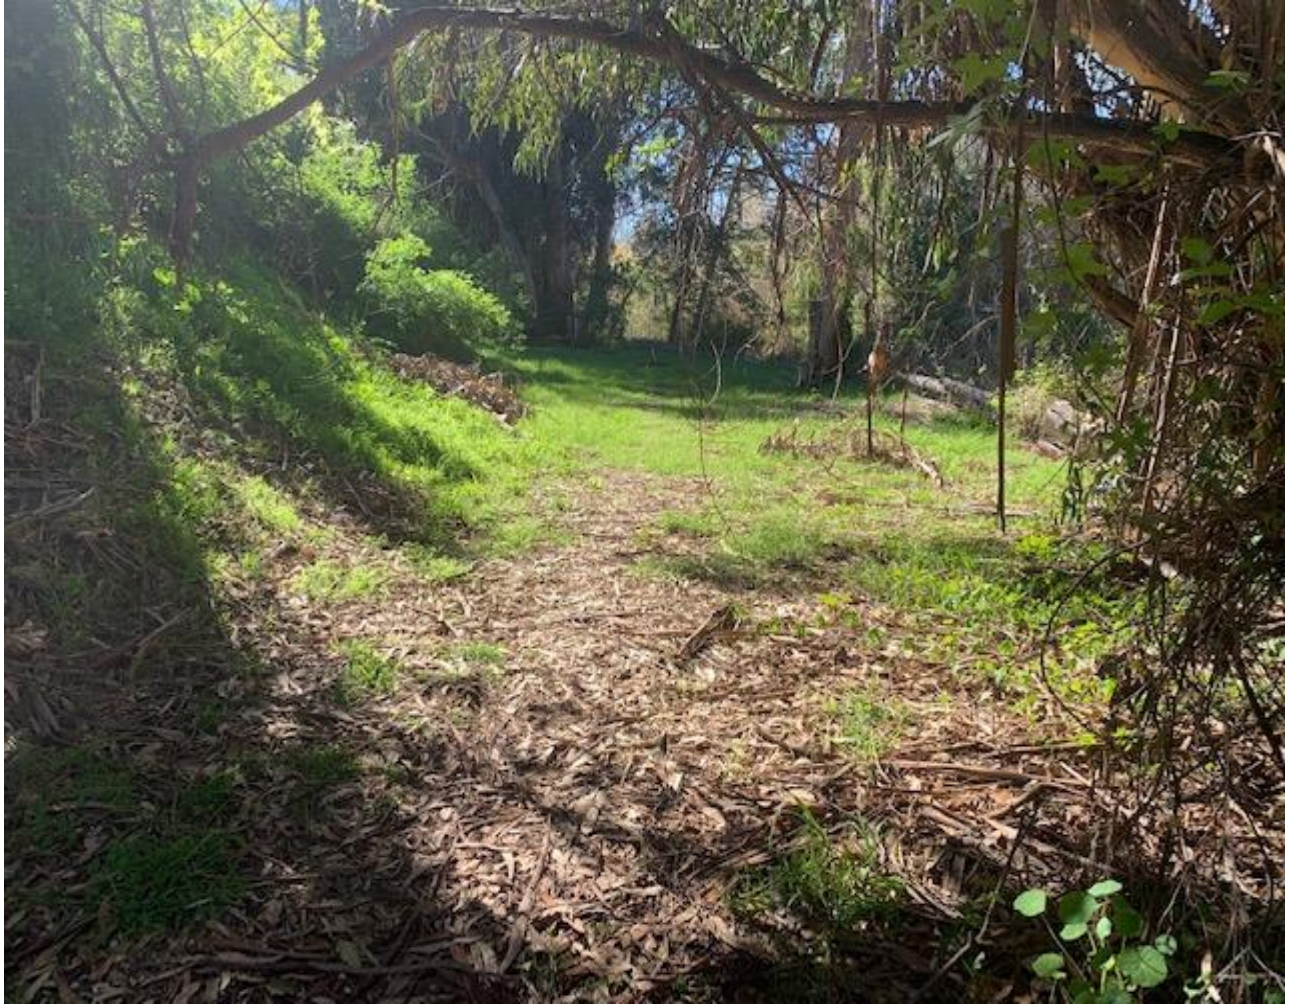
Figure 54. COVA Site #4 (upper left quadrant of image). Note large area (approximately 90' by 30') of once dense willow riparian woodland cleared by COVA circa 2015 now covered by 100% invasive nonnative grasses. See Figure 66. Trautwein. January 30, 2022.

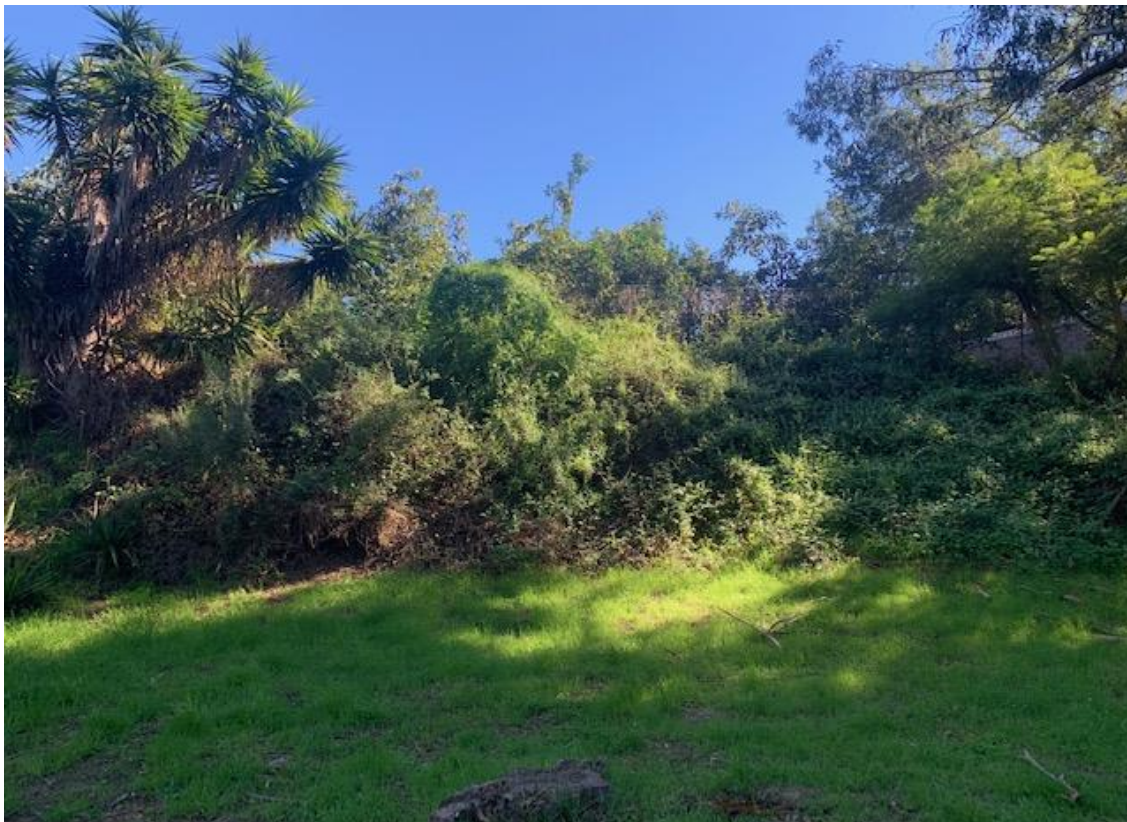
Figure 58.
COVA Site #4.
South end of
Site supports
large stand of
wild blackberry
mixed with
native wild
cucumber and
aggressive,
exotic
nasturtium. Note
the grassy area
in the lower
portion of Figure
58 is where
COVA cleared
extensive
riparian habitat.
Trautwein.
January 30,
2022.

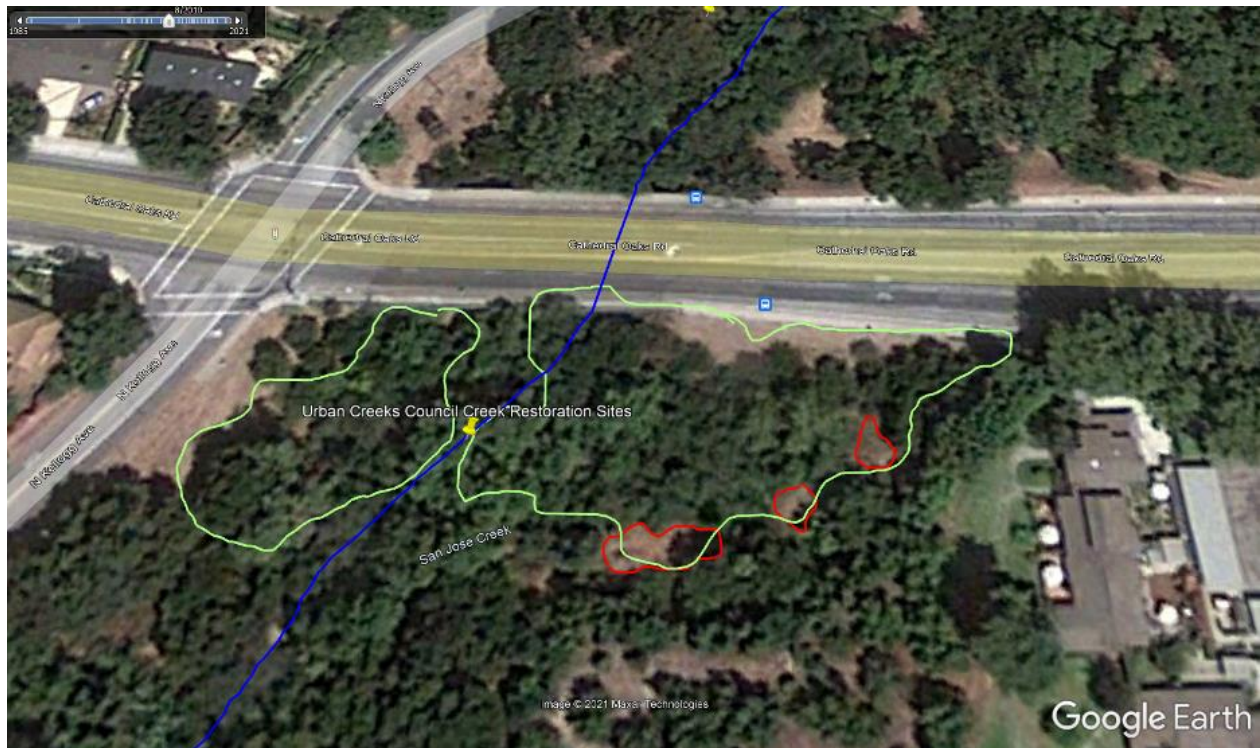
Figure 60. Riparian habitat in UCC's Site #1 cleared by COVA (red polygons) in 2007-2010. Google Earth. 2010.

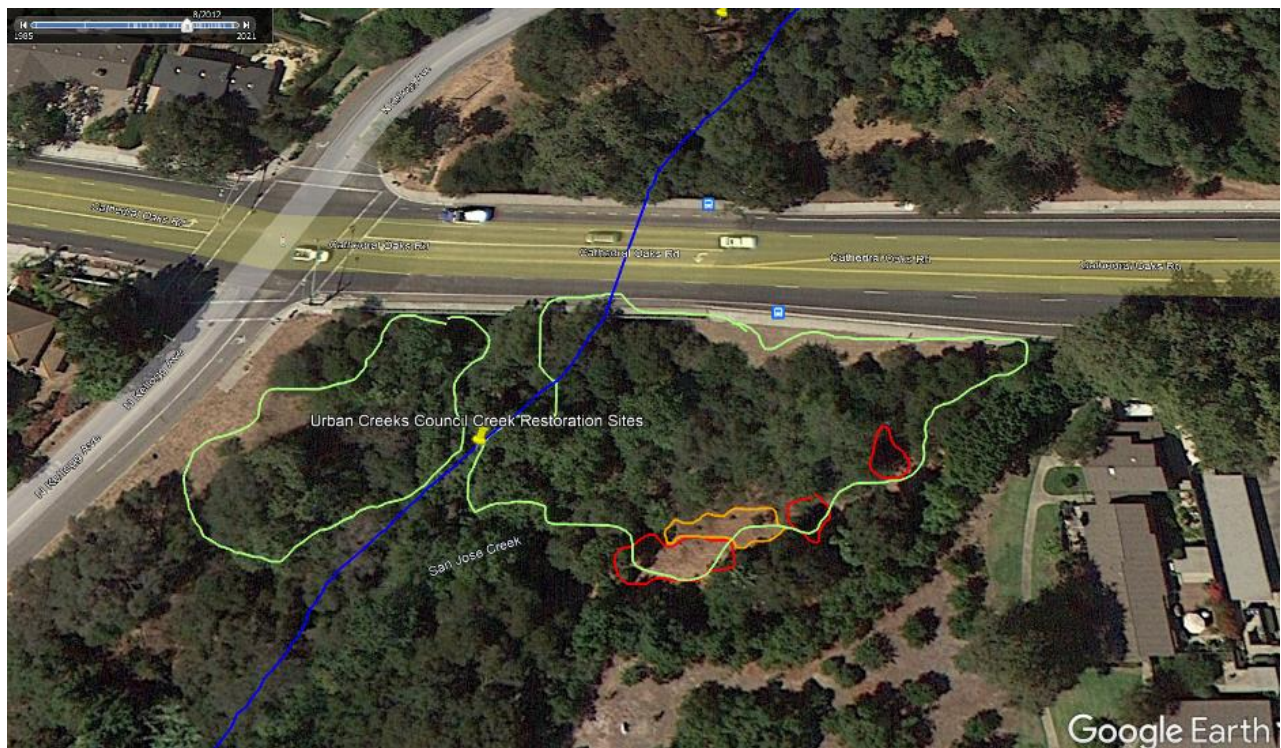
Figure 61. Additionally riparian habitat cleared by COVA (orange polygon) in 2010-2012. Google Earth. 2012.

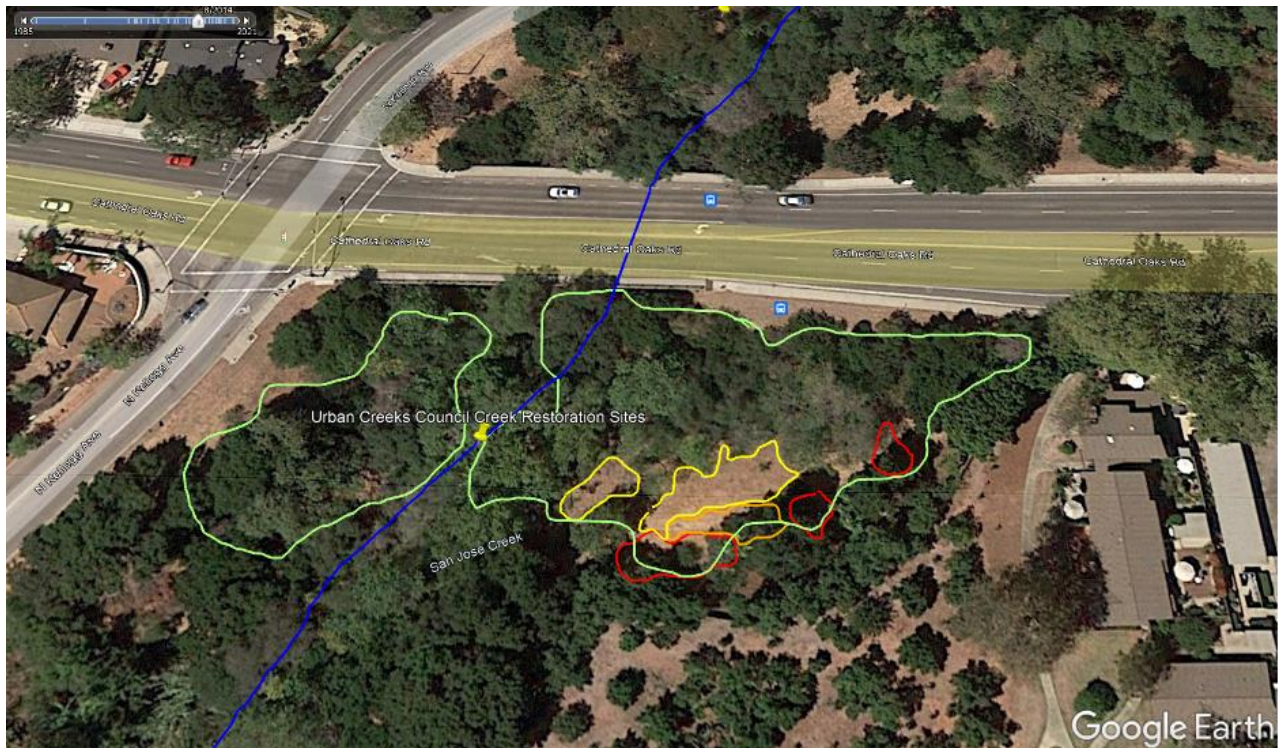
Figure 62. More riparian habitat cleared by COVA (yellow polygons) in 2013-2014. Google Earth. 2014.

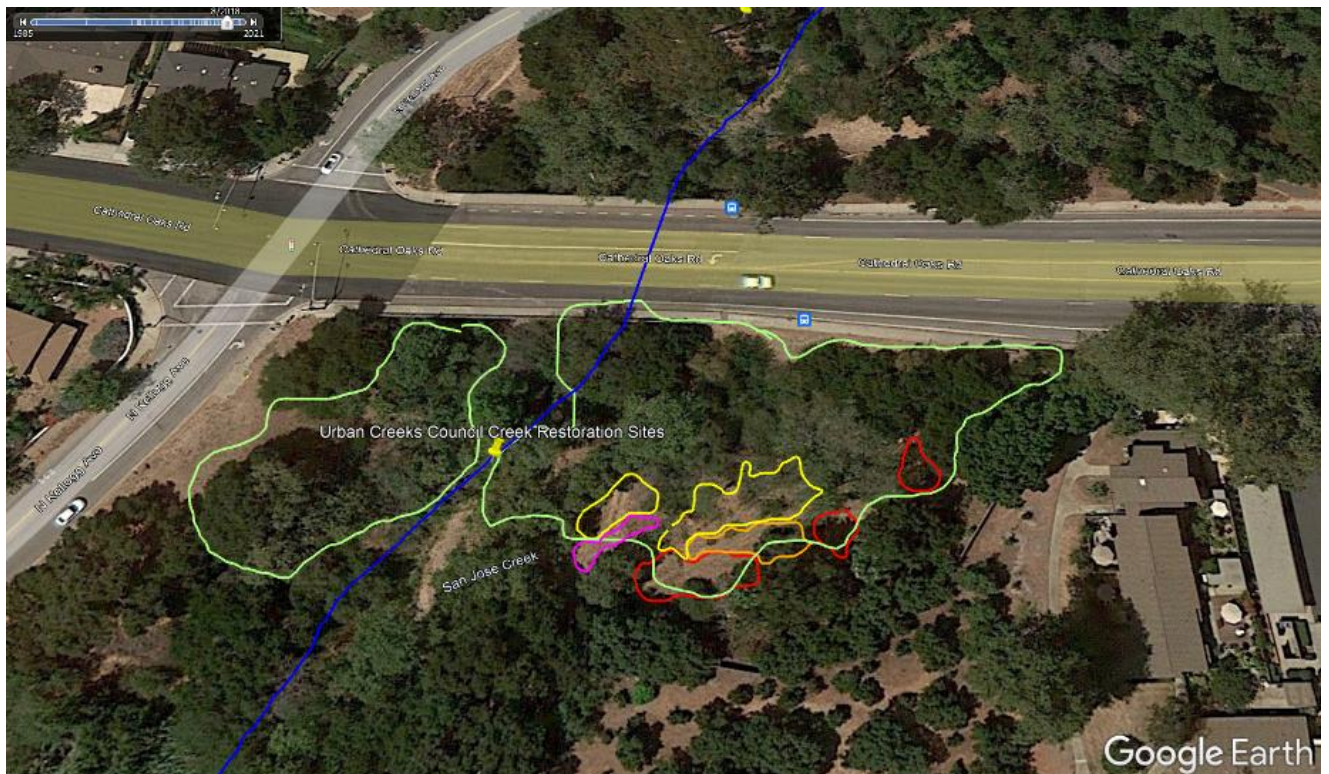
Figure 63. Further clearing of riparian habitat by COVA (purple polygon) in 2018. Google Earth. 2018.

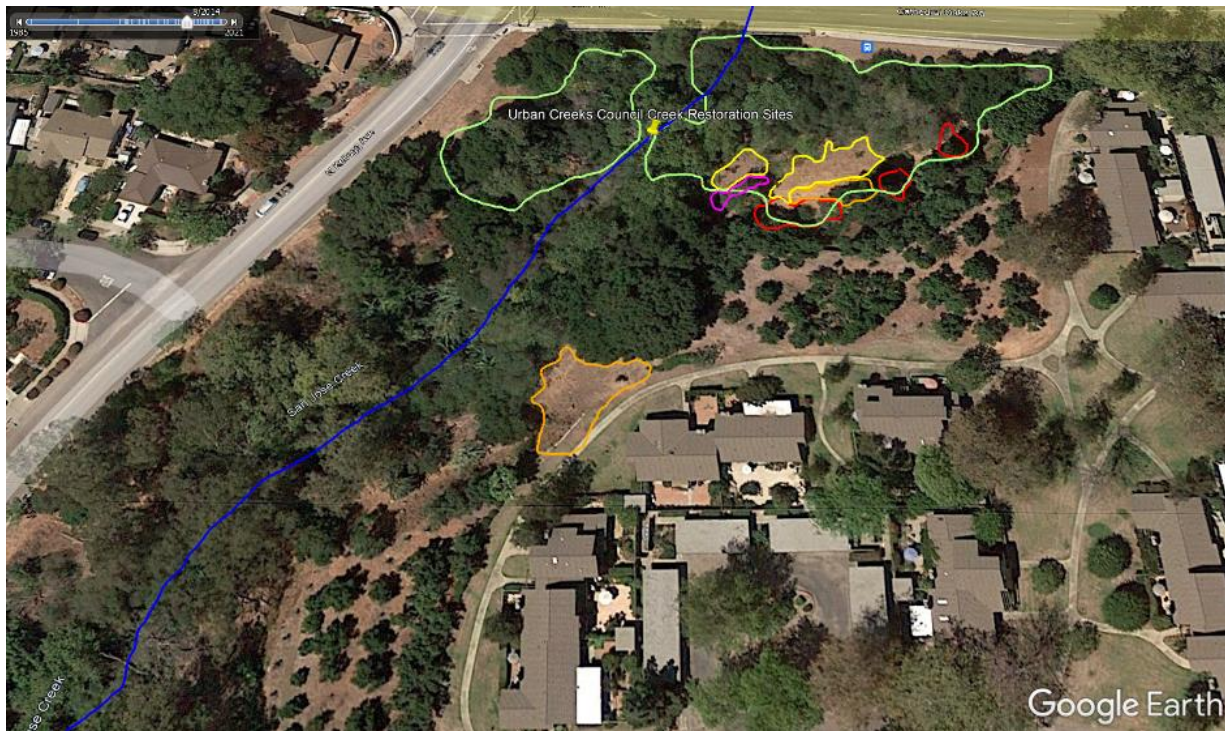
Figure 64. COVA cleared additional natural riparian habitat in 2014 (lower orange polygon in center of image). Google Earth. August 2014.

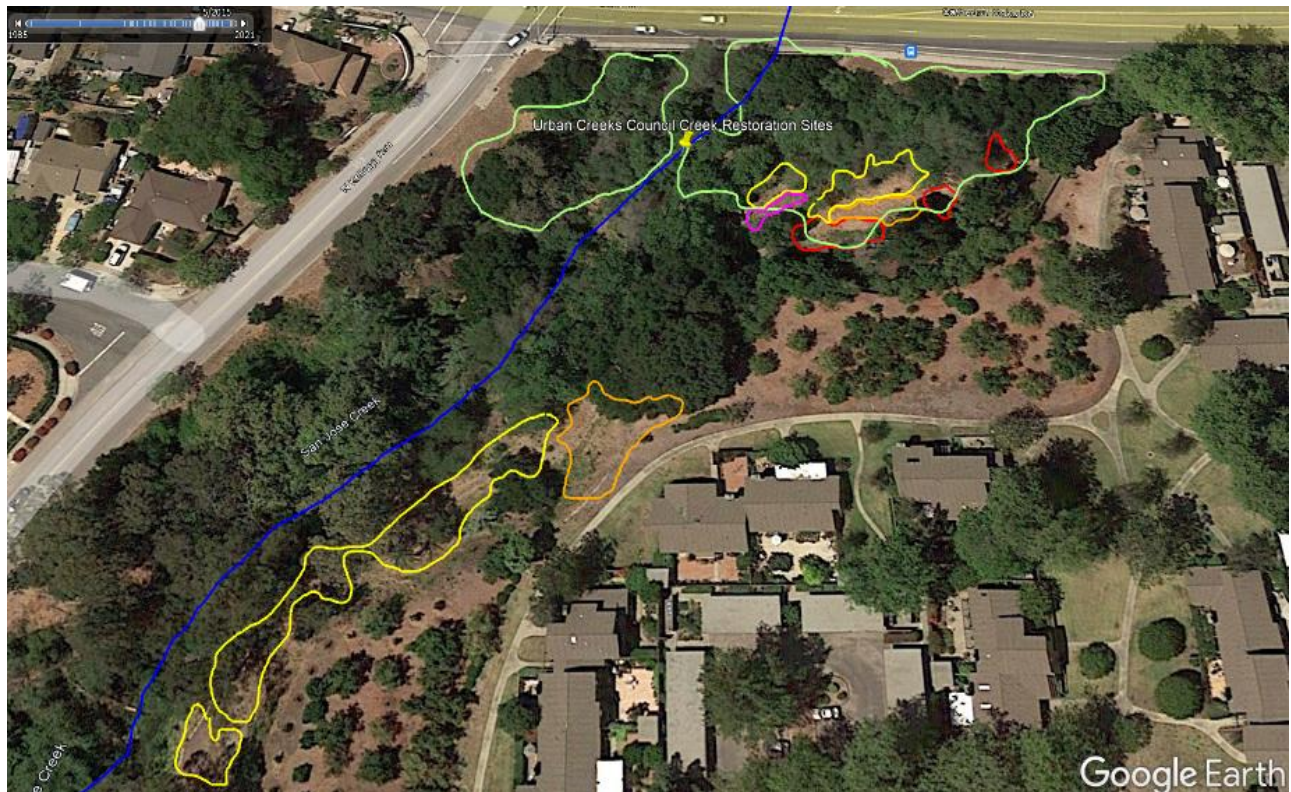
Figure 66. Riparian tree and understory vegetation appears to have been removed from additional areas east of the Creek adjacent to COVA between 2013 and 2015 (yellow polygons in center to lower left section of image). As shown in Figure 67 below, substantial portions of the two lower yellow polygons are located on Santa Barbara County property. Google Earth. 2015.

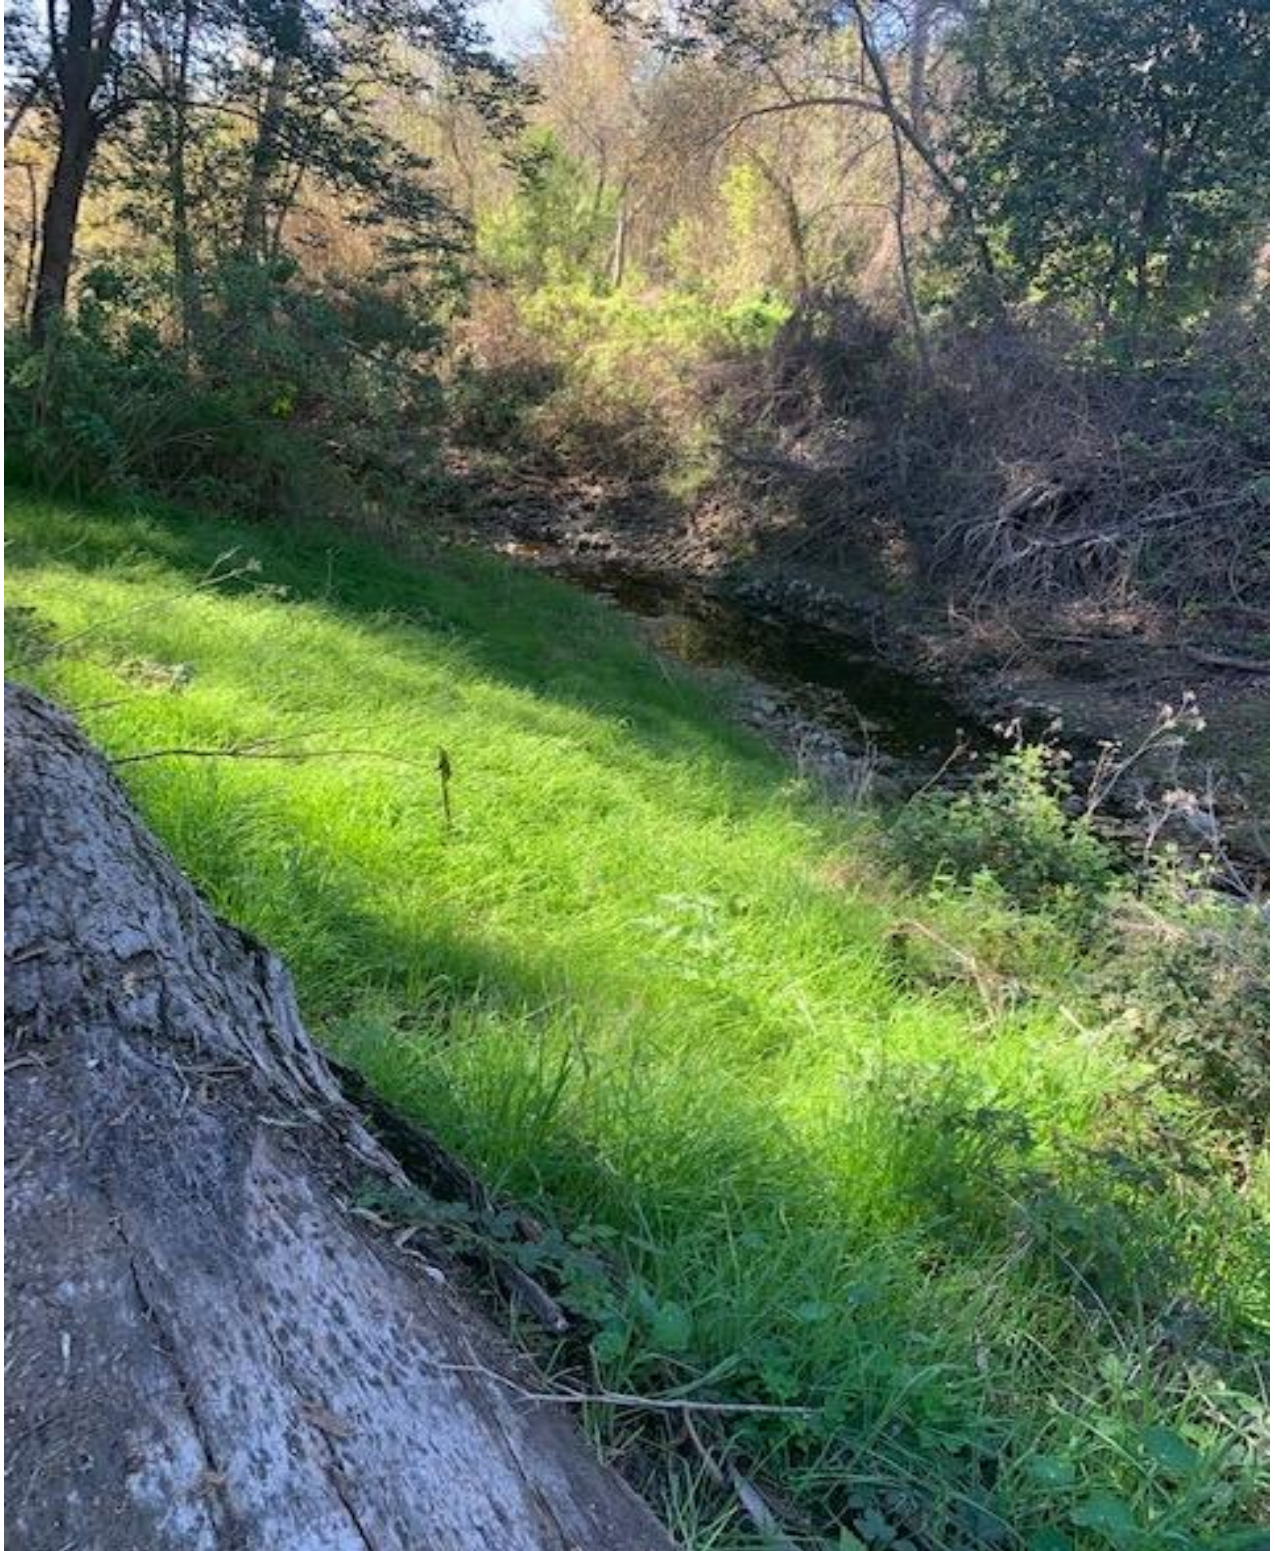
Figure 78. COVA cleared riparian woodland from approximately one hundred linear feet of the east bank of San Jose Creek on City property west of COVA Site #4. Looking downstream, south by southwest. Trautwein. January 30, 2022.

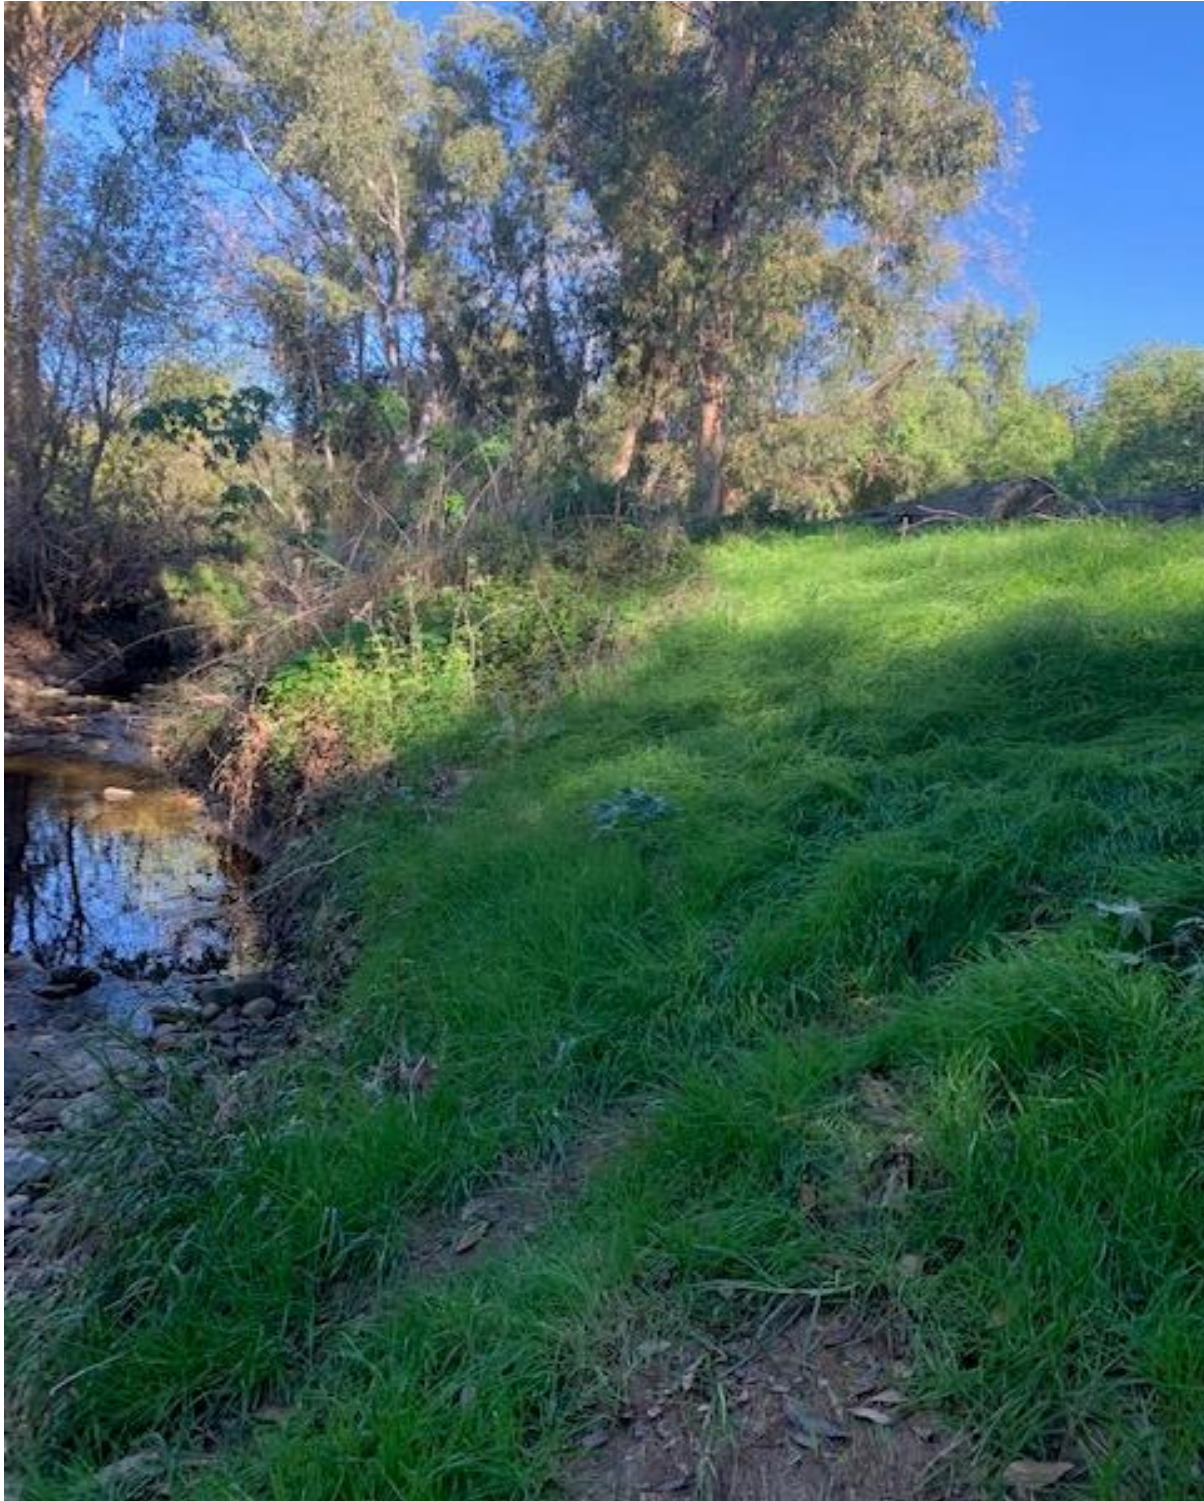
Figure 79. COVA cleared riparian woodland from approximately one hundred linear feet of the east bank of San Jose Creek on City property west of COVA Site #4. Looking upstream, north by northeast. Trautwein. January 30, 2022.

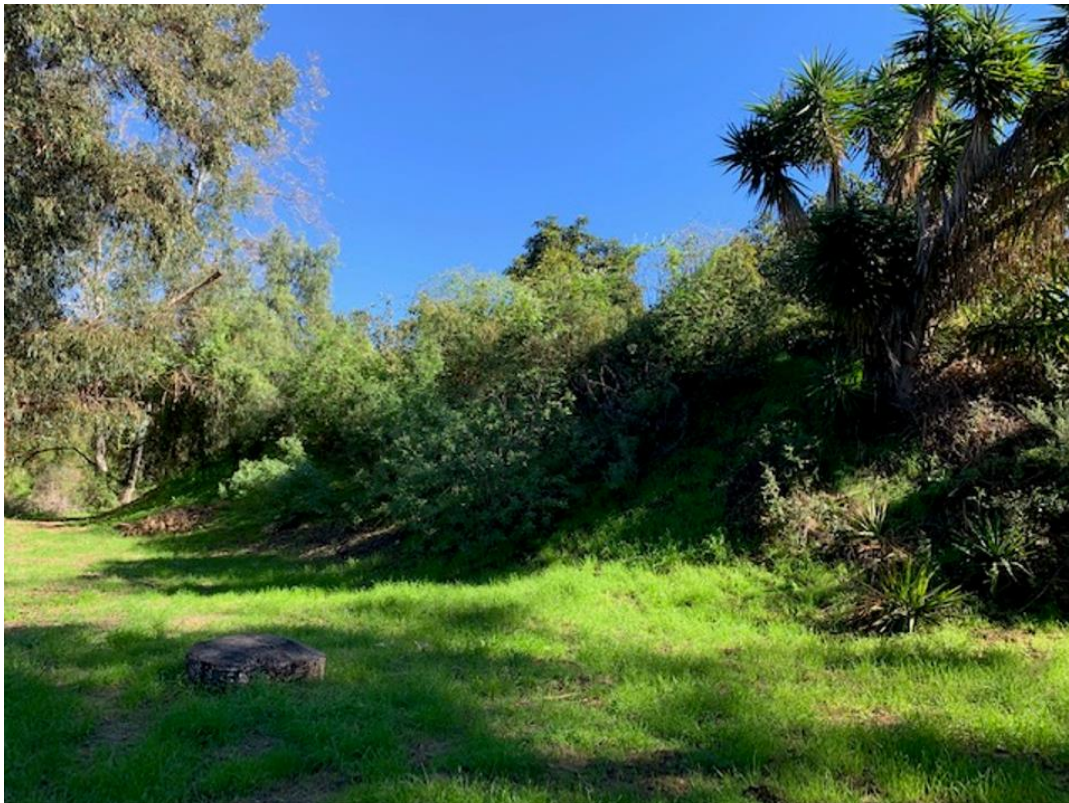
Figure 83. COVA Site #4 with native plants covering 75% of embankment. Note grassy area is where COVA cleared riparian habitat. Trautwein. January 23, 2022.

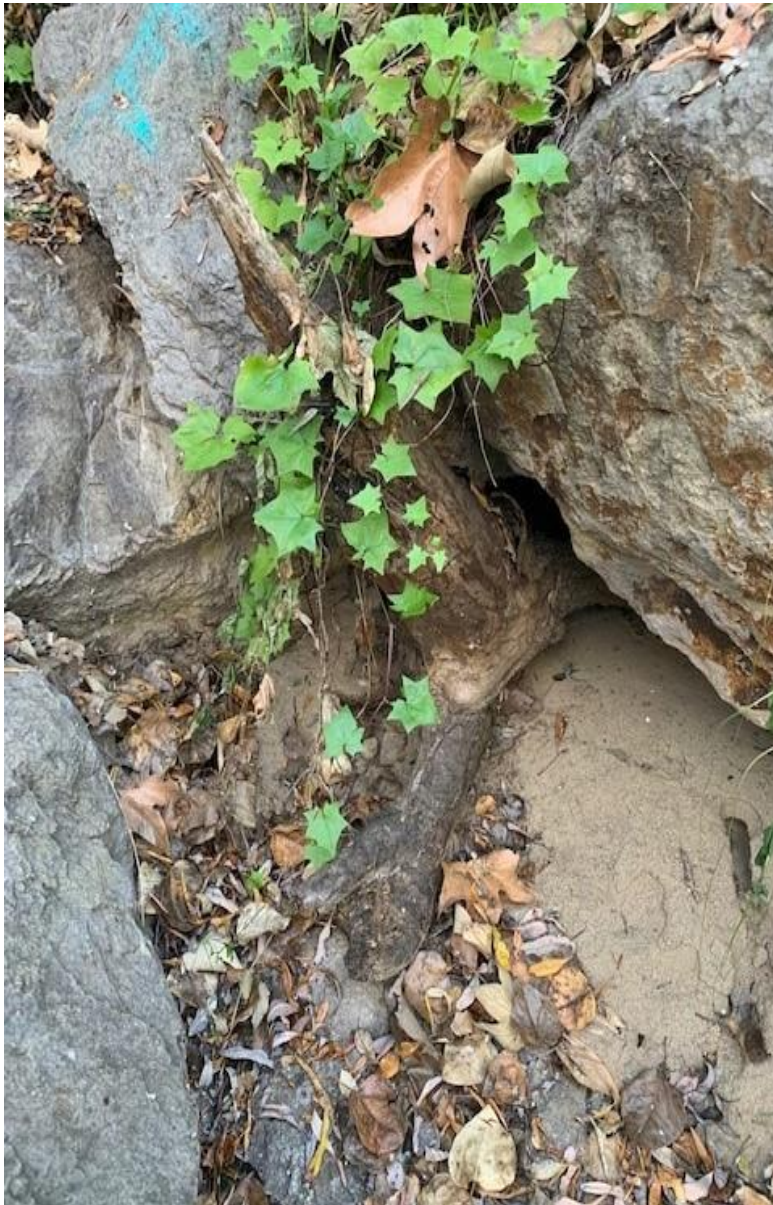
Figure 84. Nonnative, invasive Cape Ivy growing over installed rip rap. Trautwein. February 25, 2022.

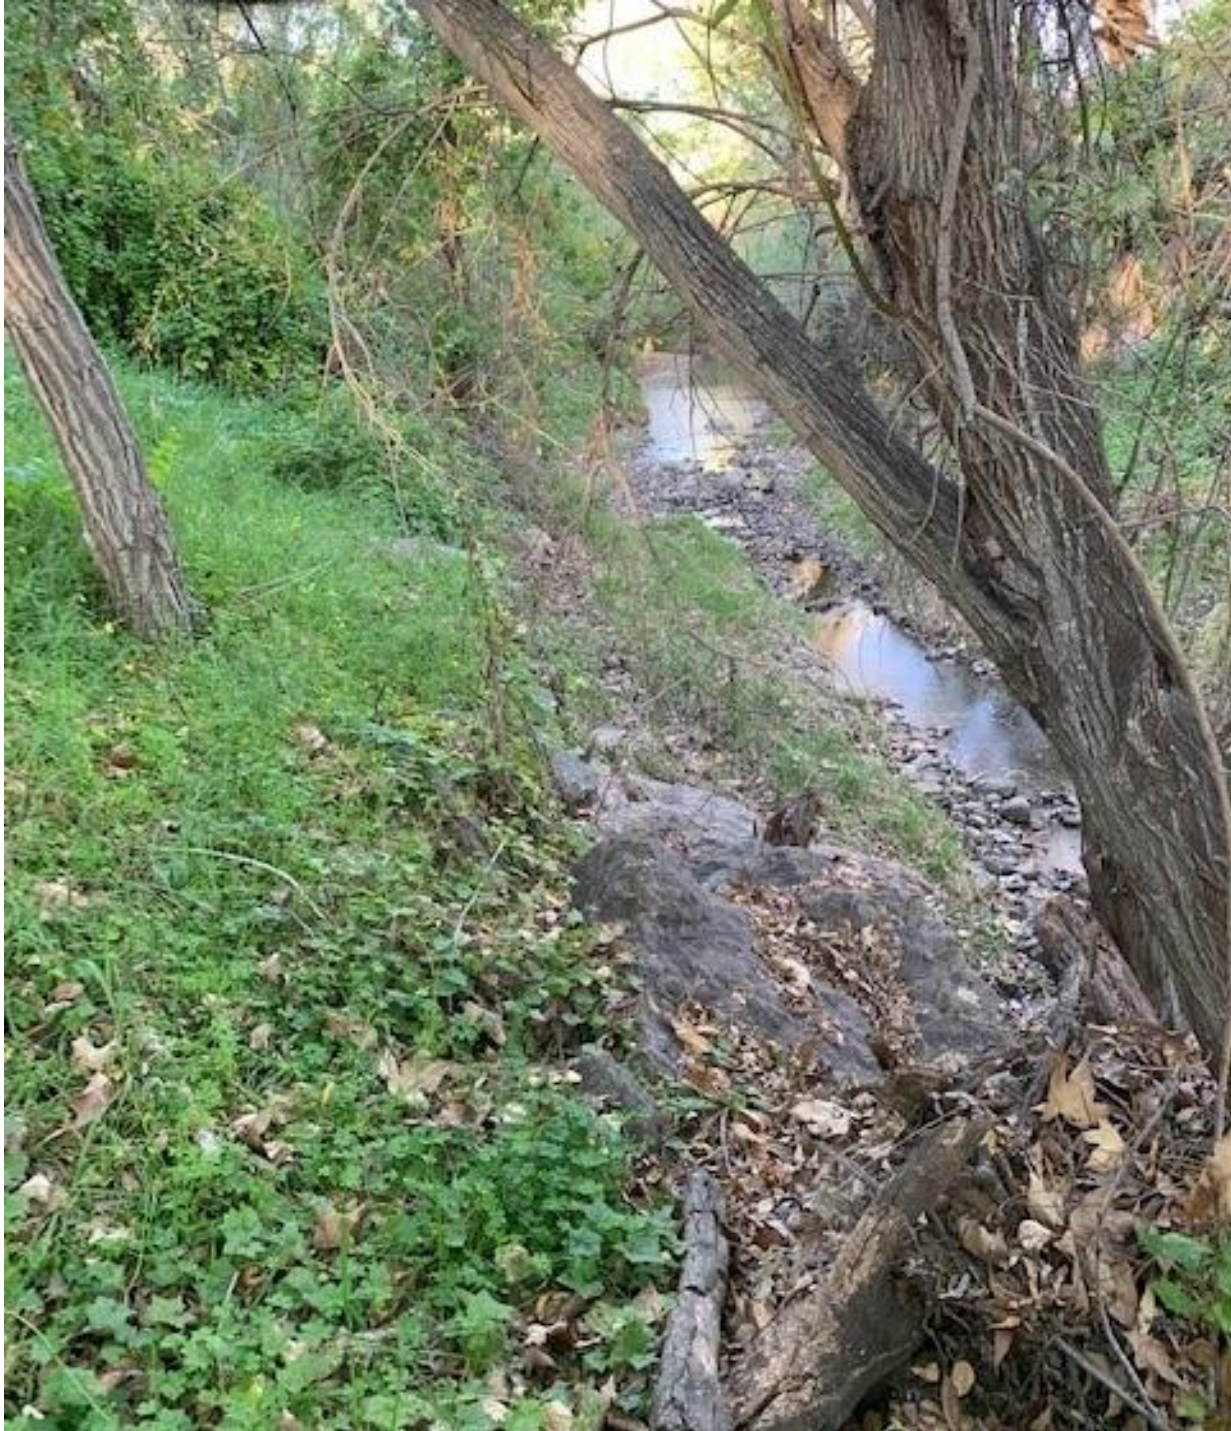
Figure 87. Looking up San Jose Creek at the Old Footbridge Site near University Circle Open Space. Rip rap was installed and is now overgrown with nonnative grasses, oxalis, and invasive Cape ivy. Woody tree in the foreground is one of two surviving willows believed to be installed as wattling in the rip rap in 1995. Trautwein. February 25, 2022.

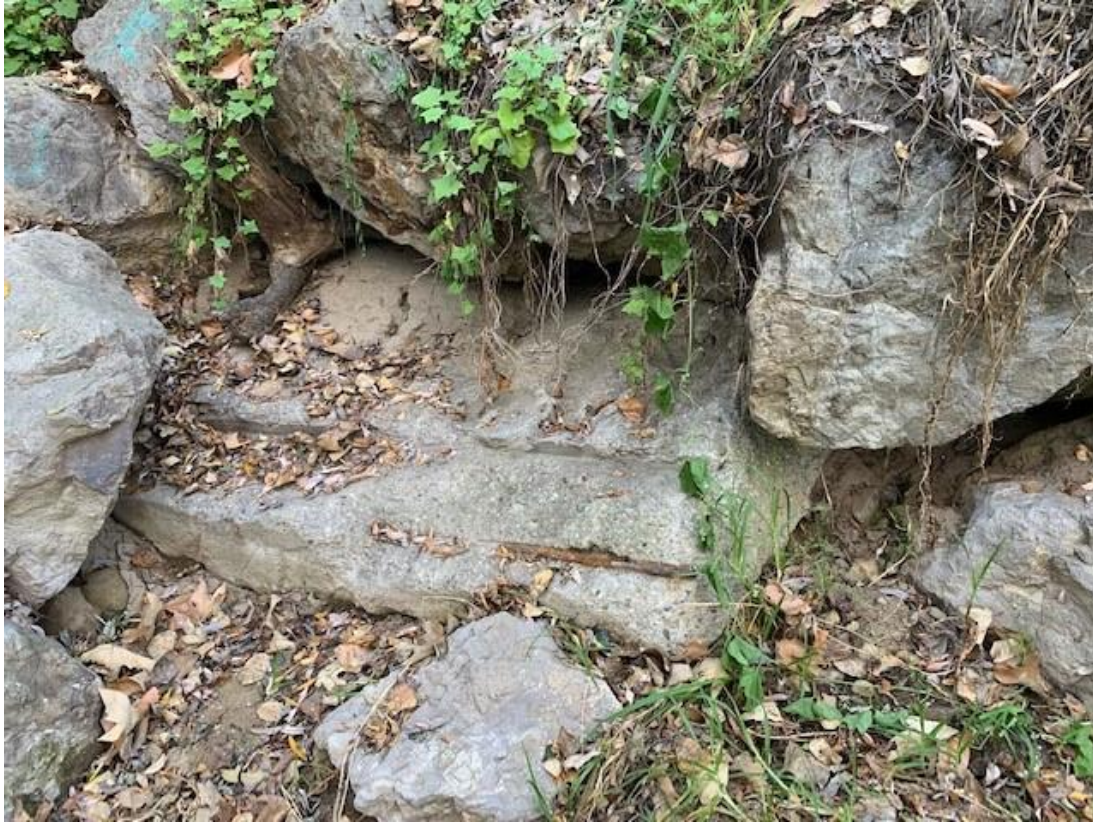
Figure 88. Rip rap includes and asphalt and concrete with rebar used as bank stabilization. Potential for concrete to alter pH of Creek water. Rebar also poses a potential safety hazard. Trautwein. February 25, 2022.
