San Jose Creek Flood Control Revegetation Sites **And Los Carneros Mitigation Bank** **Review and Recommendations**

ENVIRONMENTAL DEFENSE CENTER
October 24, 2022

Natalie Blackwelder, EDC Watershed Program Intern
Brian Trautwein, Senior Analyst / Watershed Program Director

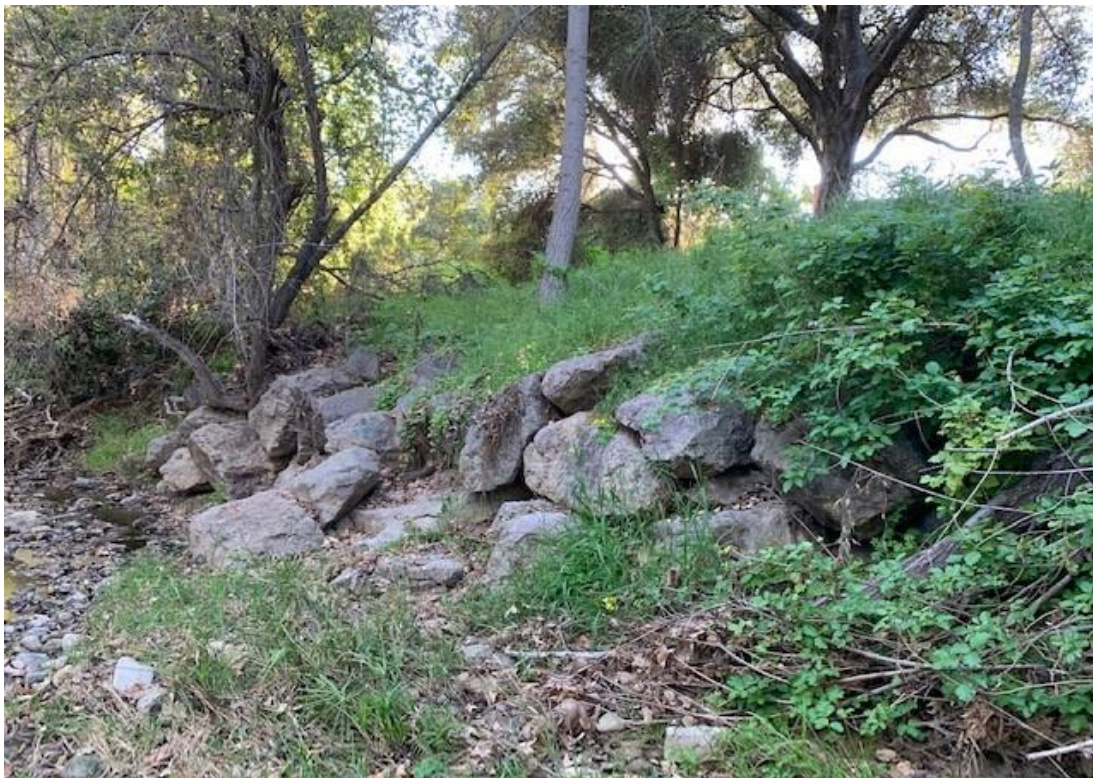
Figure 89. Rip rap covered with native poison oak and nonnative oxalis, kikuyu grass, and cape ivy. One of two remaining willow trees (left side of image) and one naturally-occurring black cottonwood tree is present on upper bank (center of image). Trautwein. February 25, 2022.

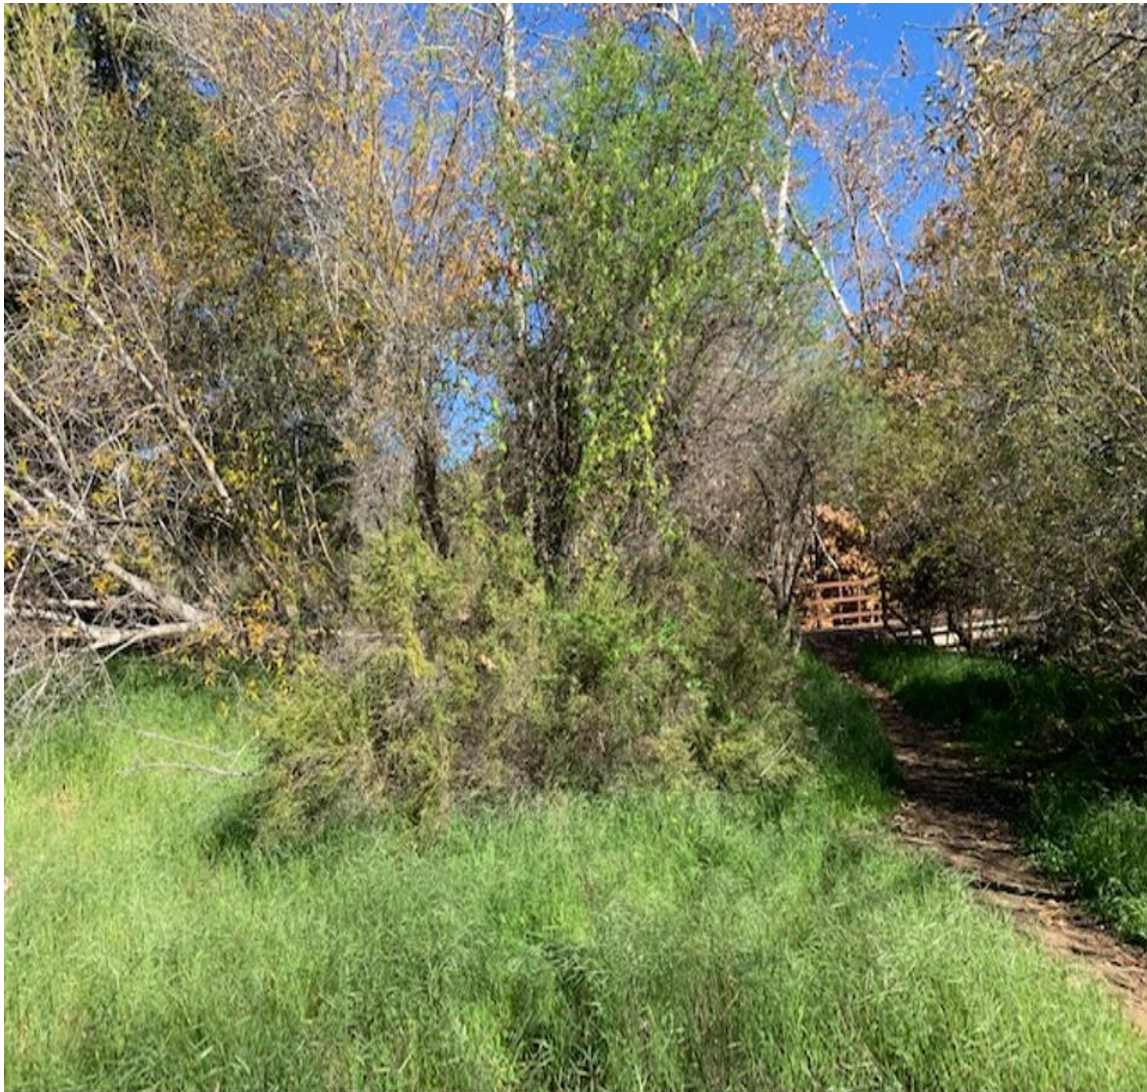
Figure 94.
Berkeley
Footbridge Site
East of Goleta
Water District
Well Building.
Willows,
elderberries, and
wild rose
present by
understory is
100% exotic
invasive
herbaceous
plants.
Trautwein.
January 23,
2022.

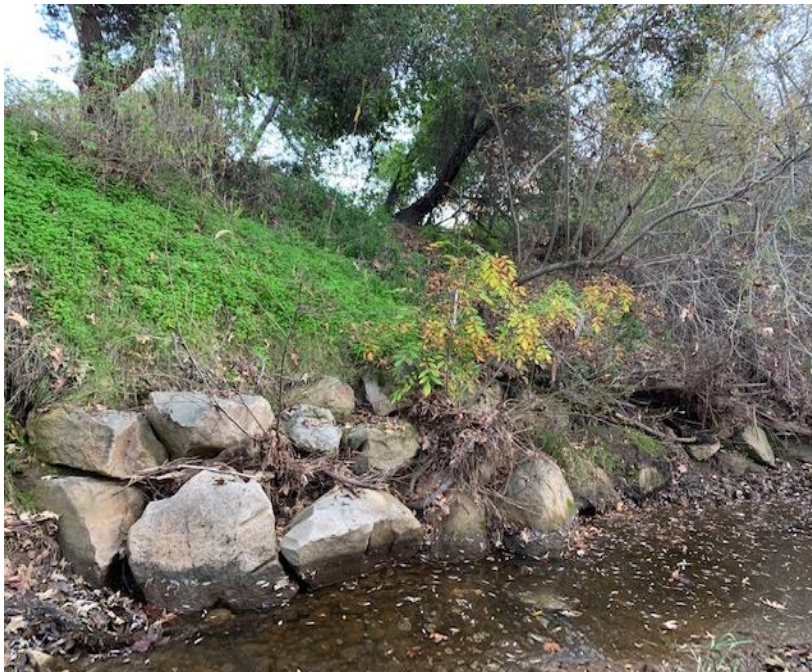
Figure 96. Bank repair. East bank of San Jose Creek approximately three hundred feet south of Berkeley Footbridge. Note invasive Shamel ash (green and yellow compound leaves) established at bank repair site. East bank above rip rap bank armoring supports nonnative invasive species. One single large willow appears to remain (behind ash tree) in upper right quadrant of image. Trautwein. January 27, 2022.

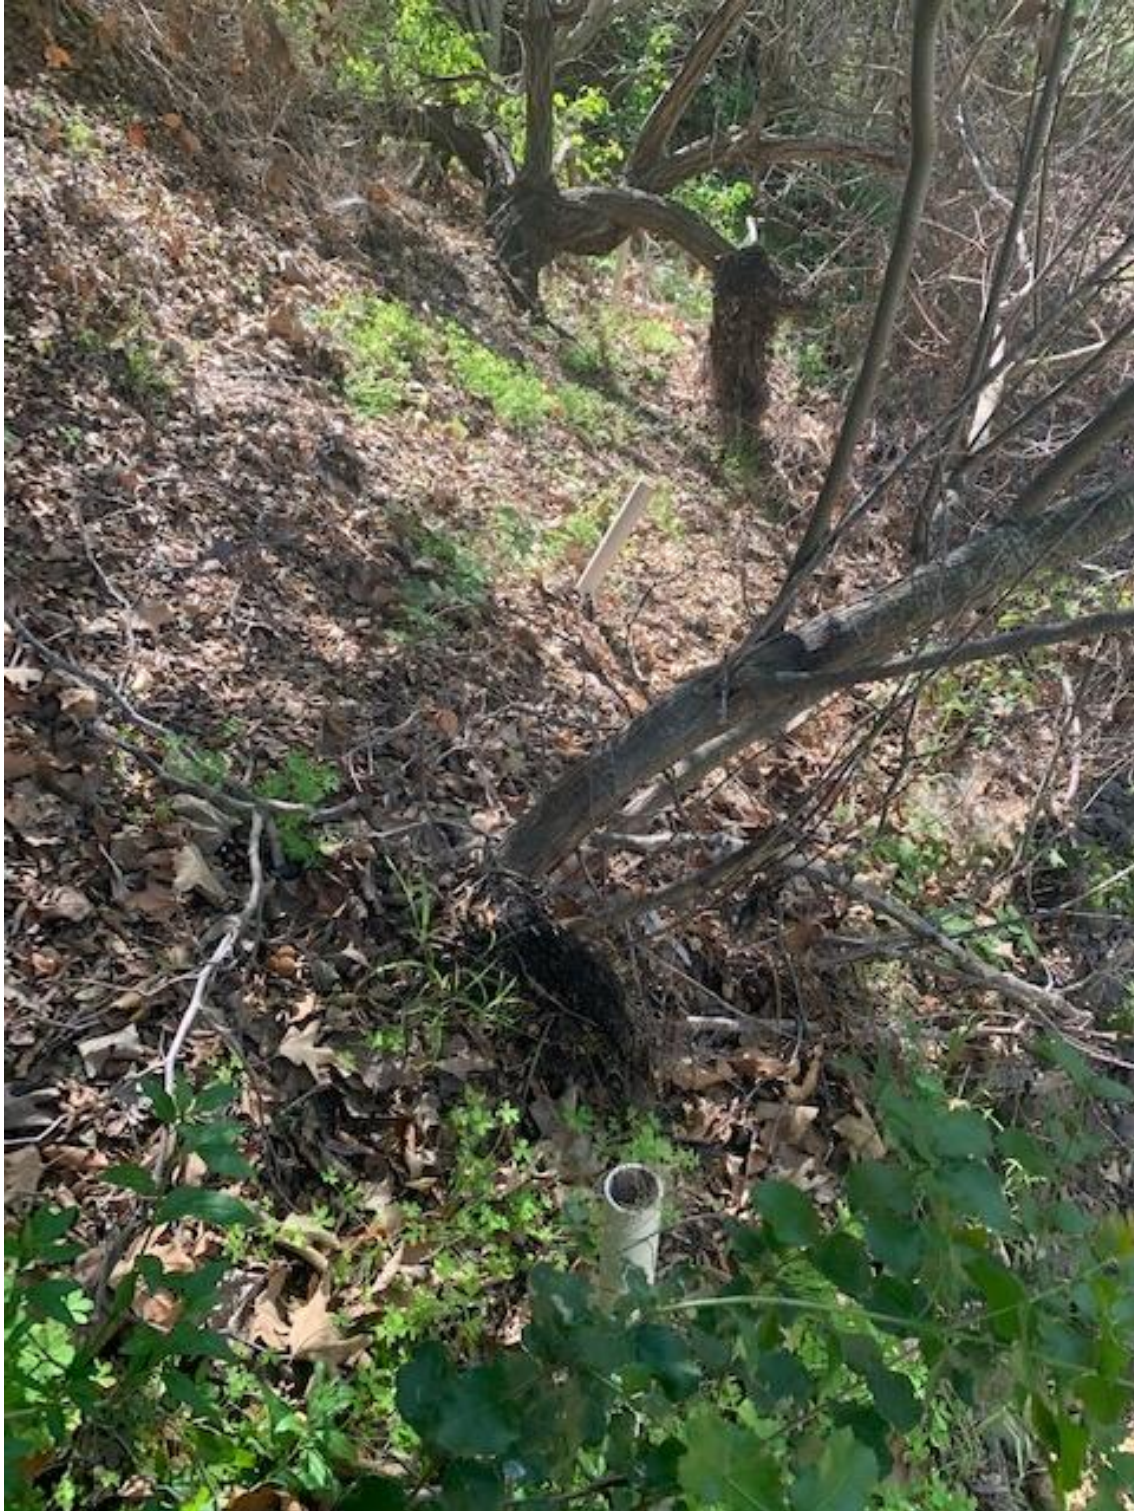
Figure 97. Site 23, approximately 300' downstream of Berkeley Footbridge on the east bank of San Jose Creek. Note: the white PVC pipe coming out of the foliage was installed to irrigate the layered willows that were placed between rip rap layers. Trautwein. March 7, 2022.

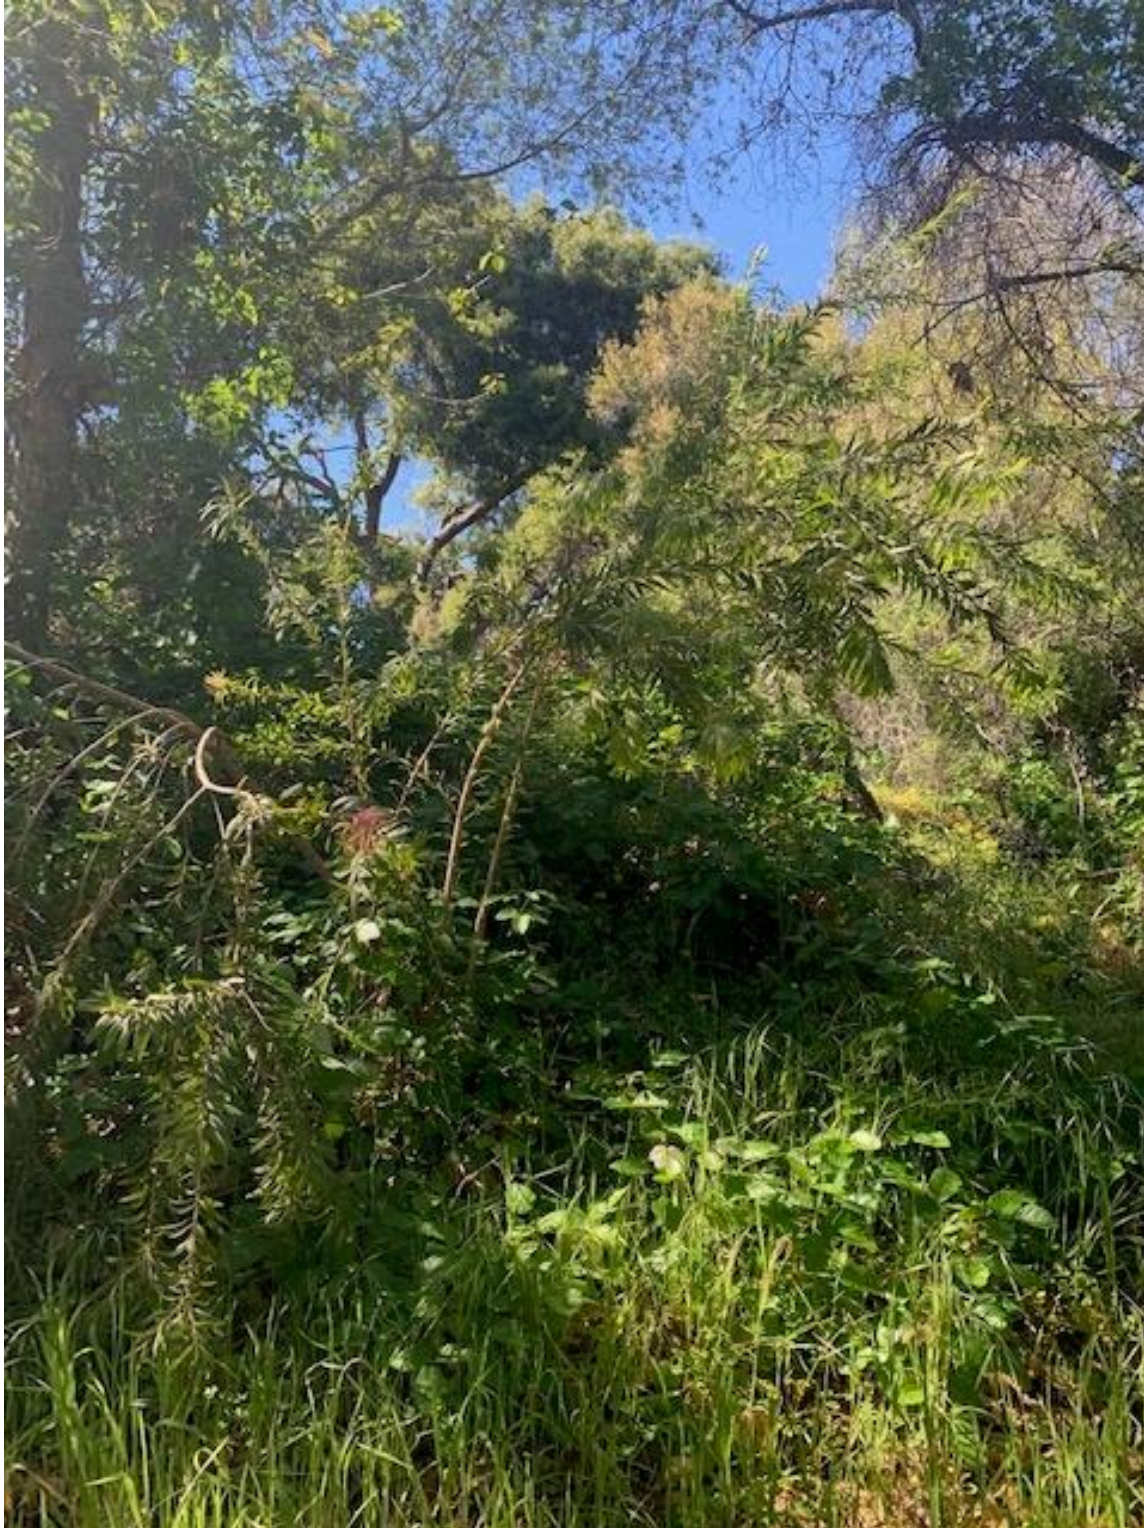
Figure 103. Site 23, approximately three hundred feet downstream of Berkeley Footbridge on the west bank. Note the nonnative, naturalized bottlebrush bush that is growing in the center of the photo. There are also nonnative grasses and nasturtium in the foreground, and willow and oak trees behind the bottlebrush. Trautwein. March 7, 2022.

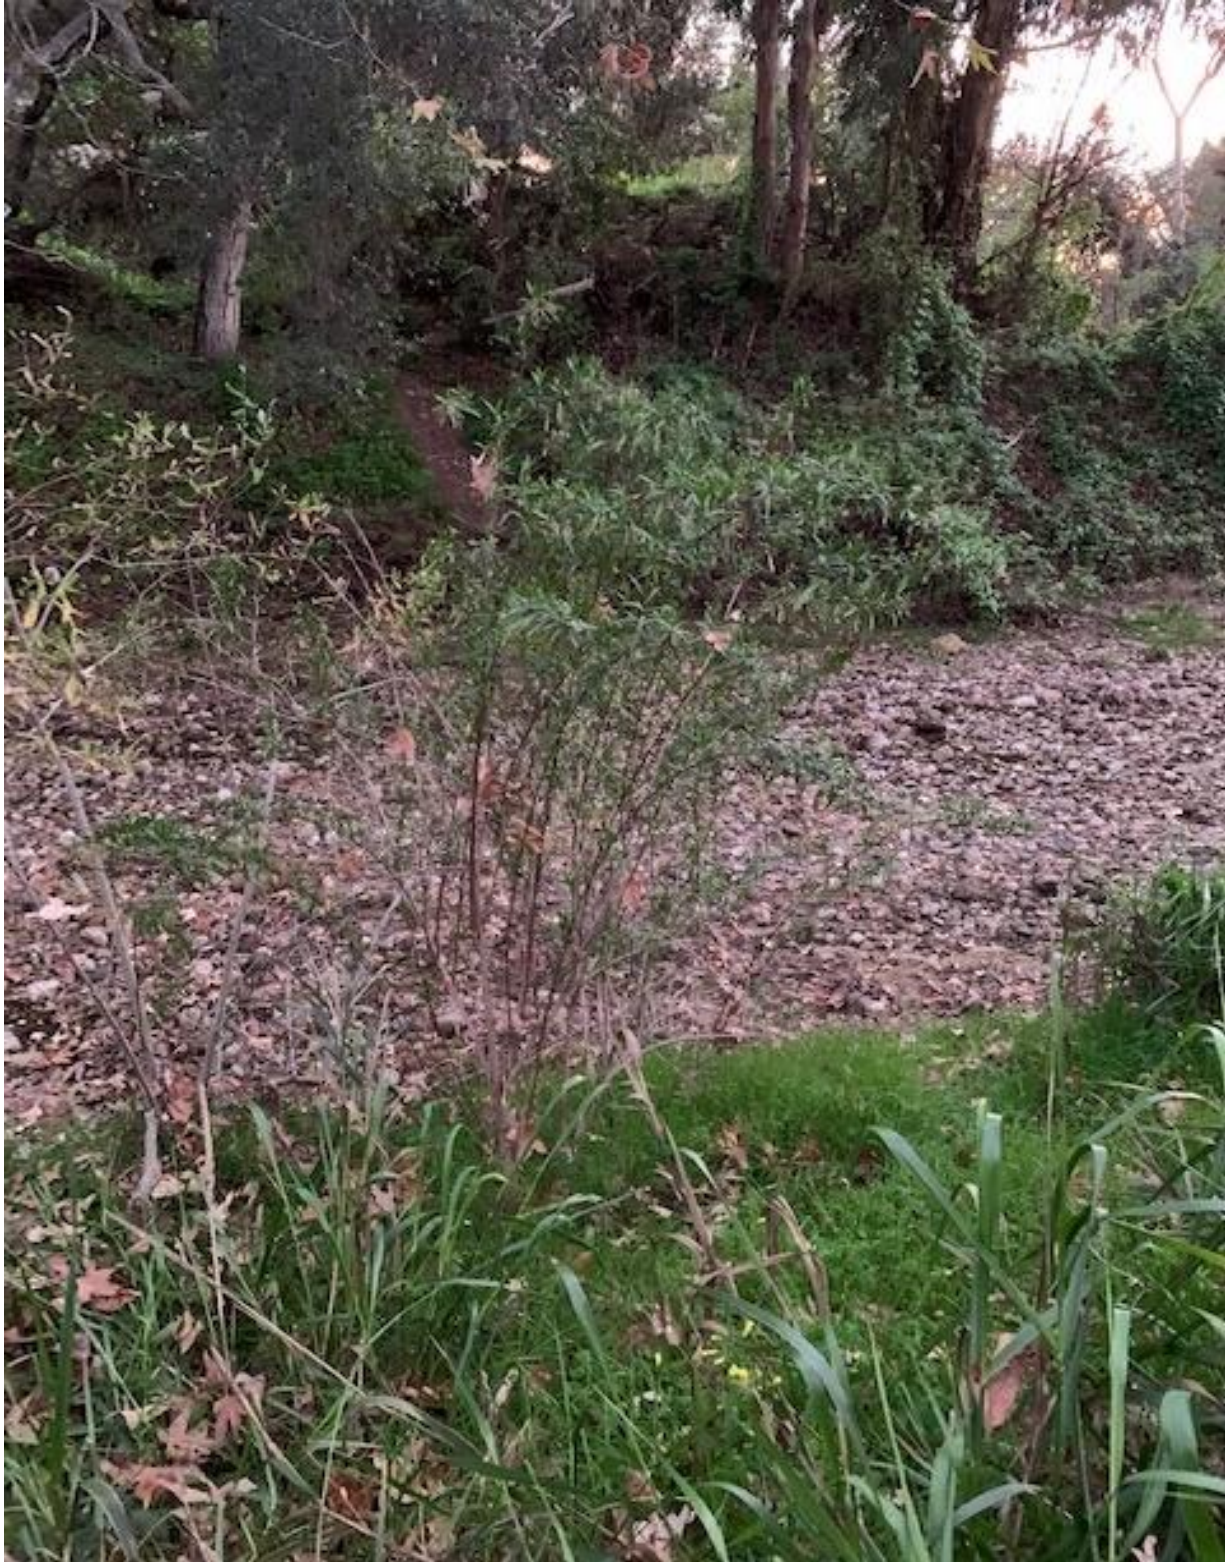
Figure 109. Somerset Access Ramp Site showing giant wild ryegrass (lower portion of image), mulefat (center of image), lone willow (left side of image), and herbaceous nonnative understory vegetation. Trautwein. January 27, 2022.

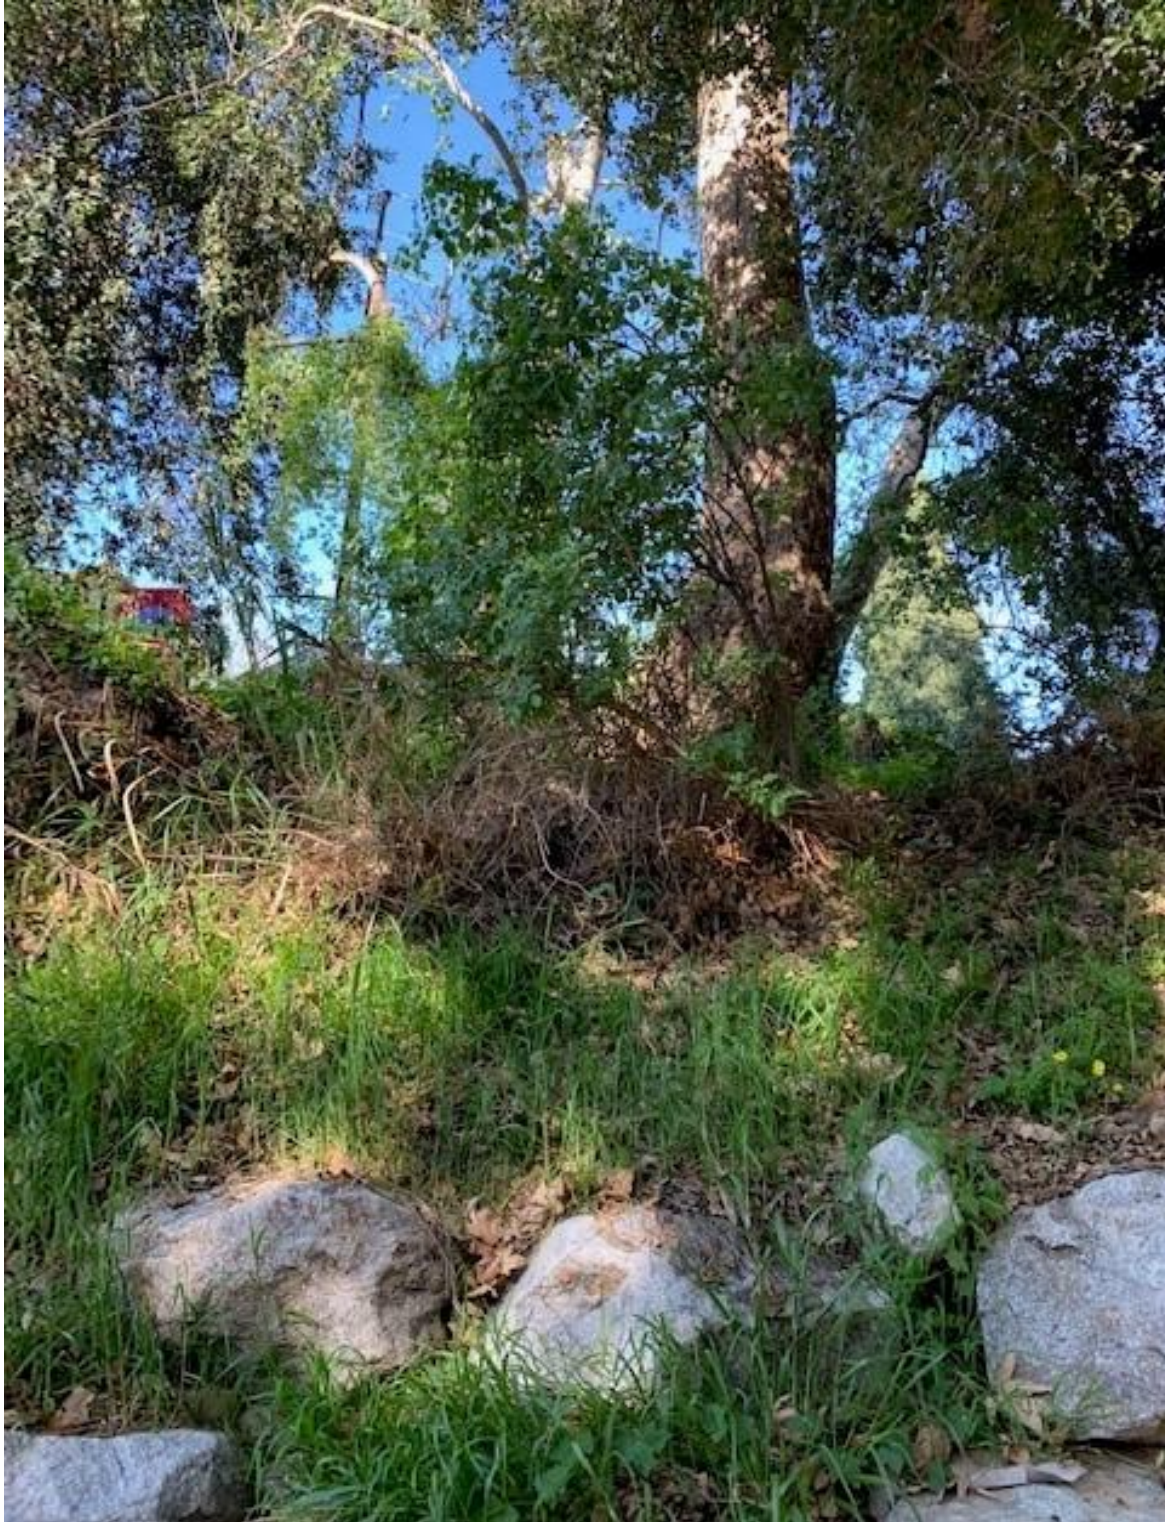
Figure 111. West bank of San Jose Creek at Somerset Access Ramp Site. Riprap in the foreground along the bottom edge of the image with oxalis and nonnative grasses, such as kikuyu. Large sycamore in the background center. SBCFCWCD installed willows, mulefat, several elderberries, and giant wild ryegrass at this Site. Trautwein. February 2022.

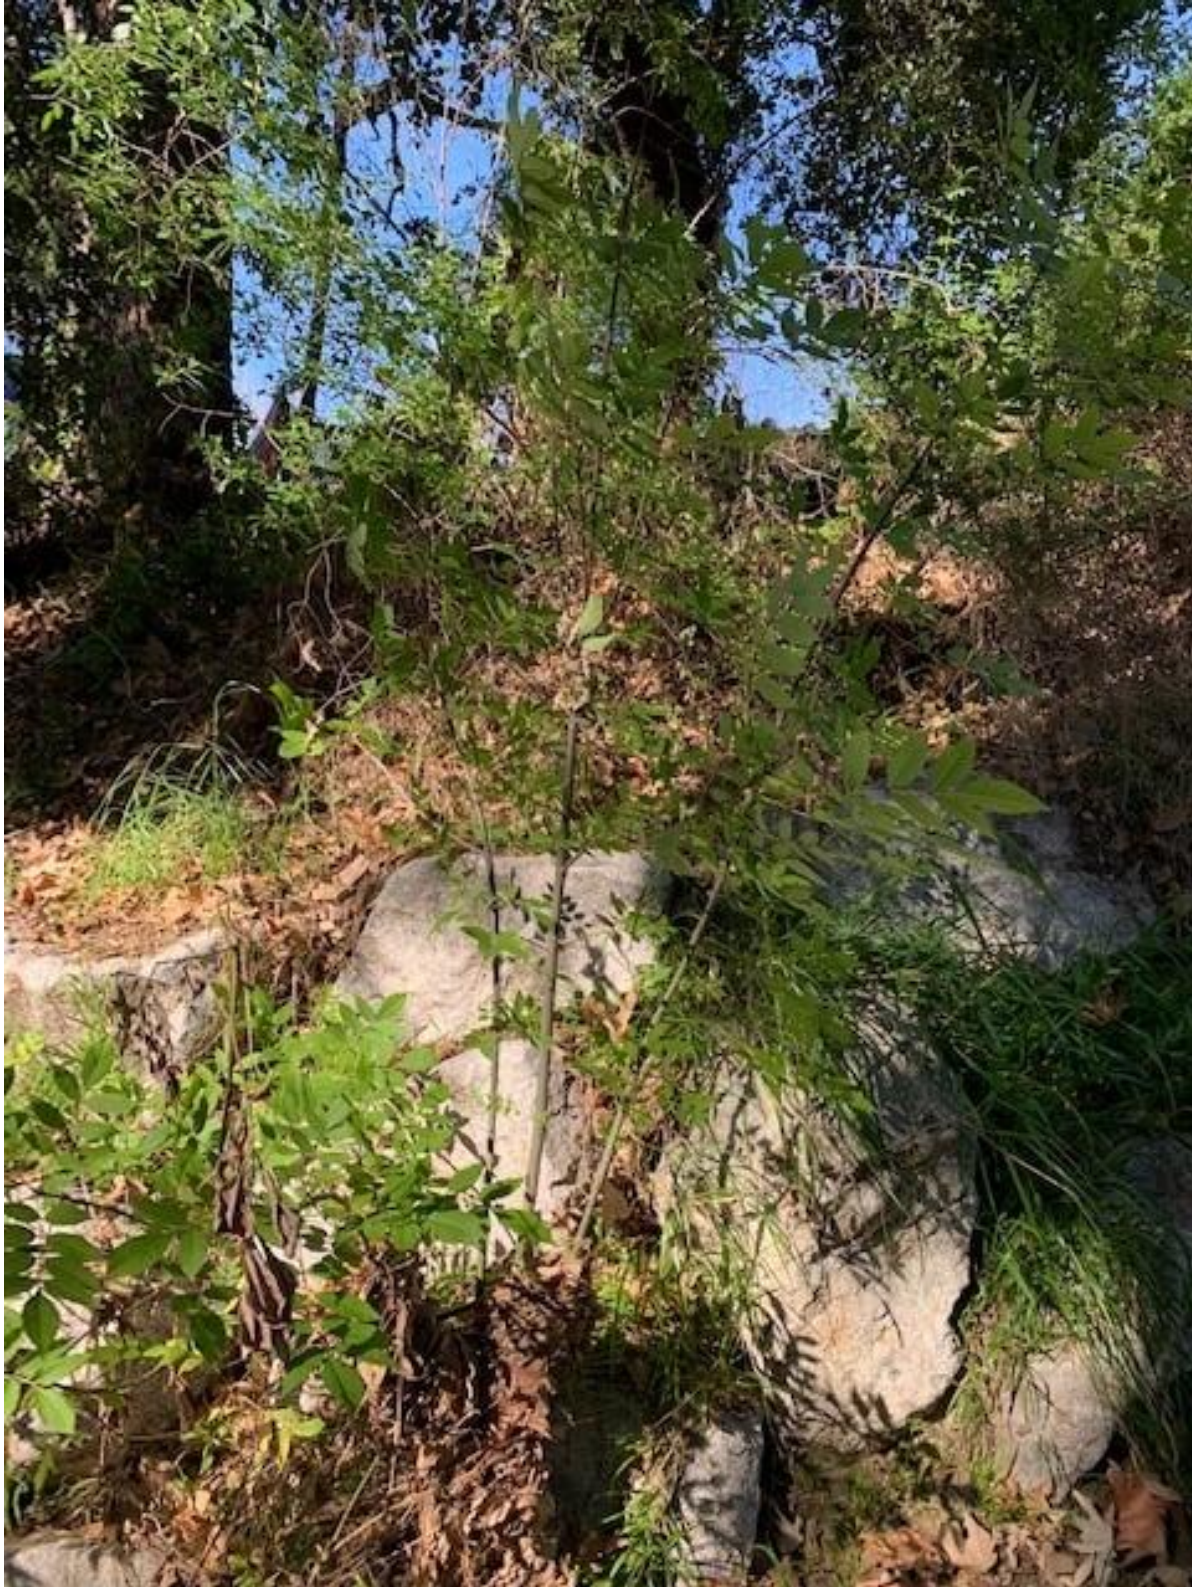
Figure 112. Nonnative Shamel ash sapling in the center foreground growing out of rock riprap along with nonnative grasses. Trautwein. February 2022.

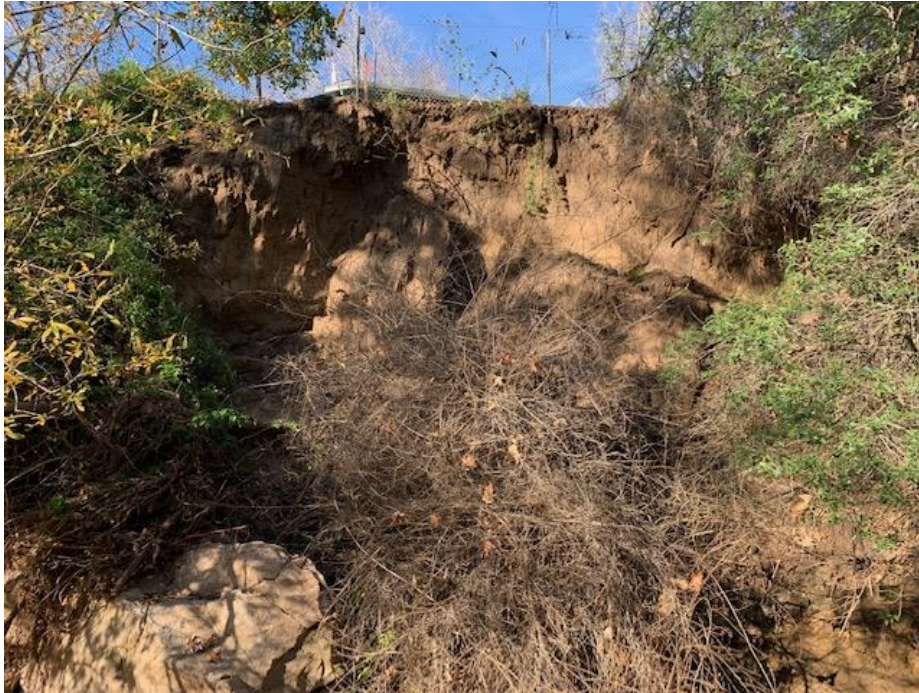
Figure 113. About one hundred to two hundred feet downstream the site of the decommissioned Somerset Drive Access Ramp on the west bank. Note the chain-link fence at the top of this slope delineates a backyard. This slope has eroded severely at the upstream end of SBCFCWCD's 1996 bank repair project. Consideration should be given to engineering and installing a live willow crib wall. Trautwein. February 2022.

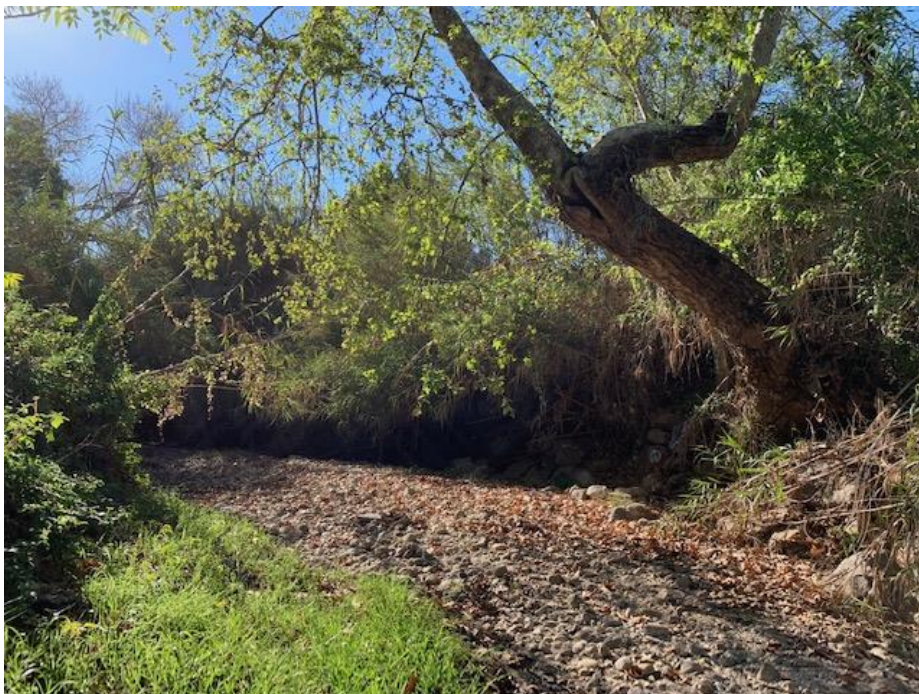
Figure 114. Looking down stream of San Jose Creek at the erosion site show above (Figure 113). A large sycamore stretches over the Creek bed providing shade. Nonnative Arundo is abundant on either side of the sycamore. Kikuyu grass is present in the bottom left corner. Trautwein. February 2022.

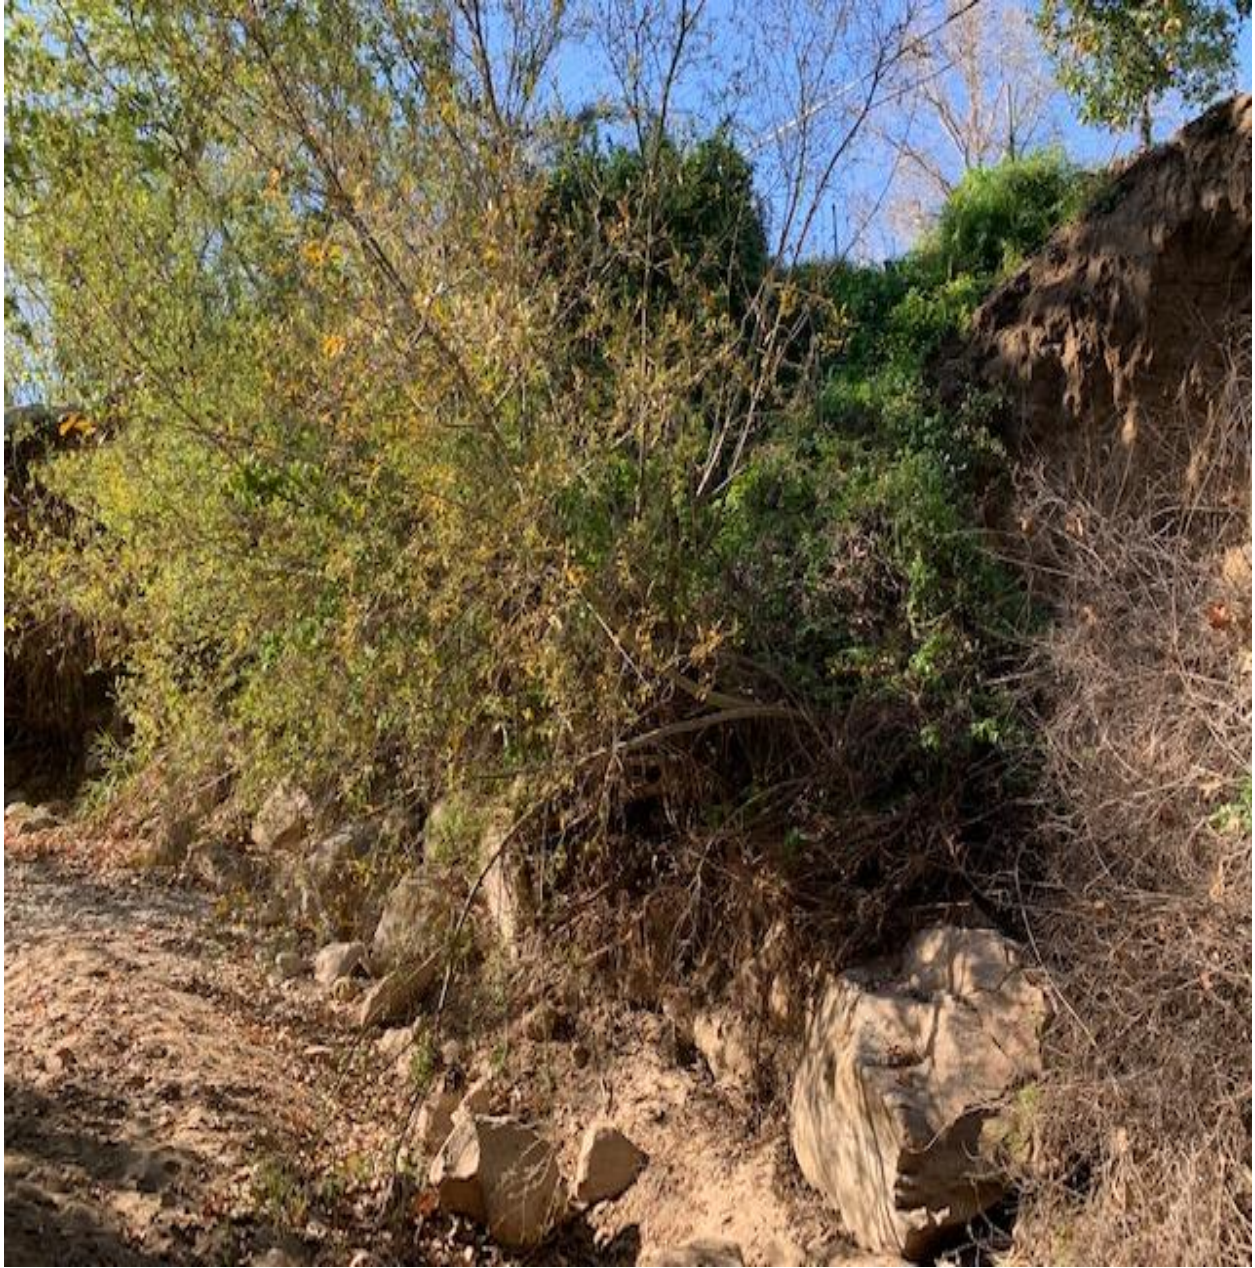
Figure 115. Eroded west bank of San Jose Creek one to two hundred feet downstream of the site of the decommissioned Somerset Drive Access Ramp. Displaced rip rap in the bottom right corner. Young willows grow out of the remaining riprap in the center of the photo. Trautwein. February 2022.

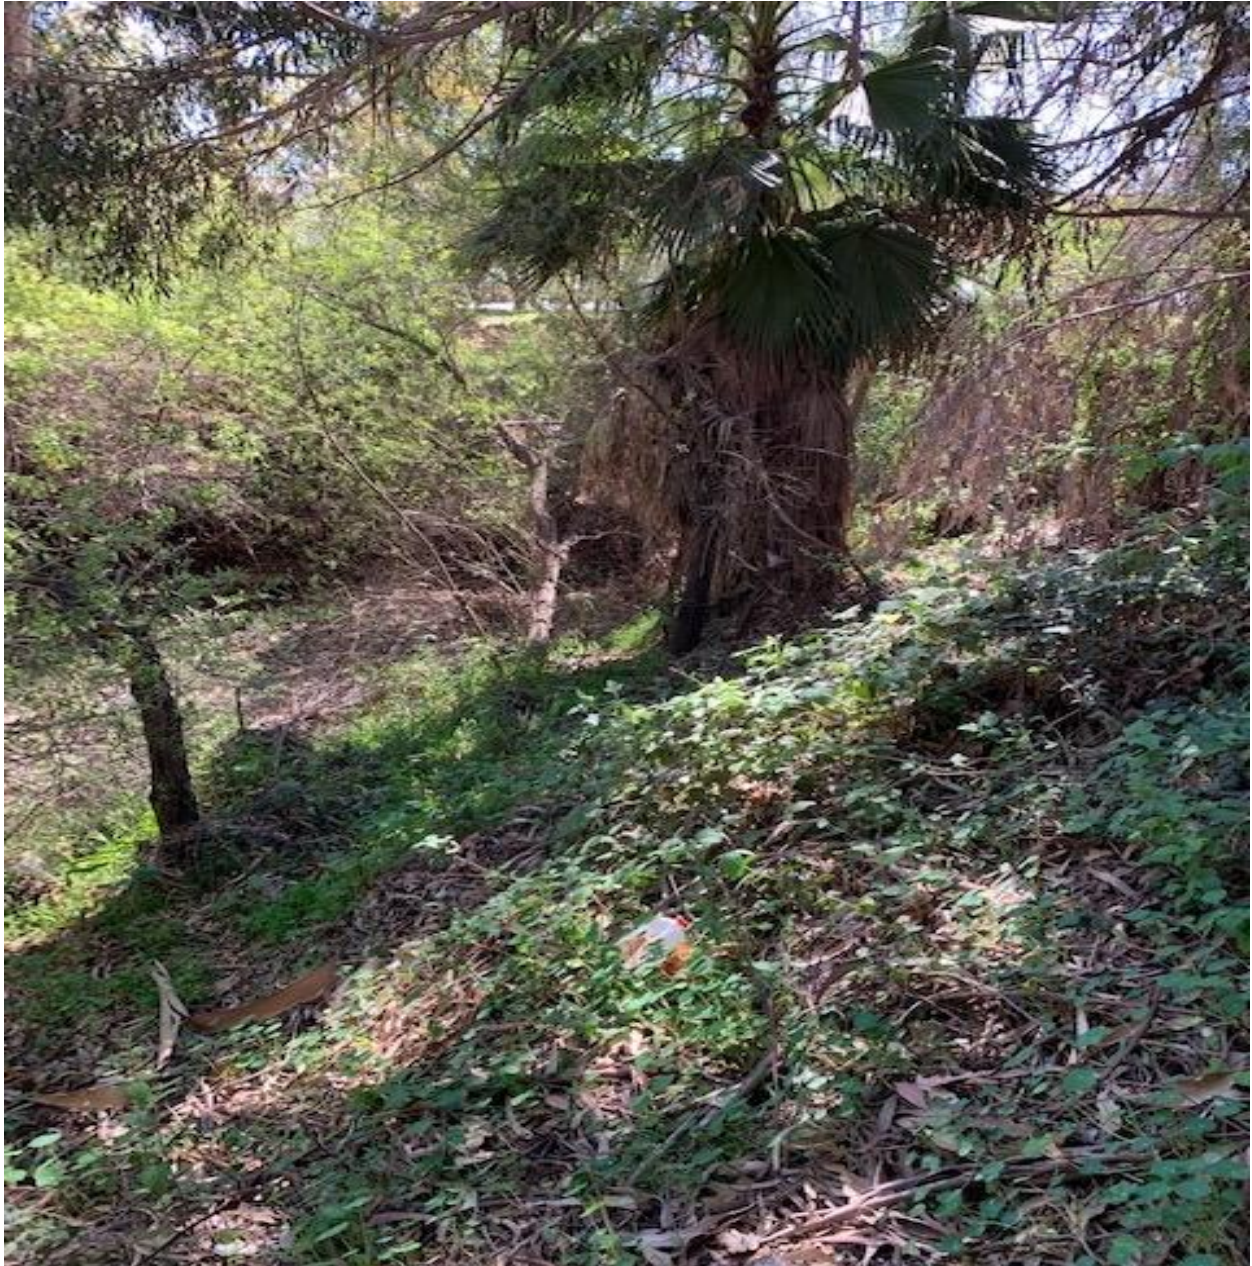
Figure 116. Nonnative understory of primarily nasturtium. Nonnative palm tree in background and eucalyptus canopy (upper portion of photo). Trautwein. February 18, 2022.

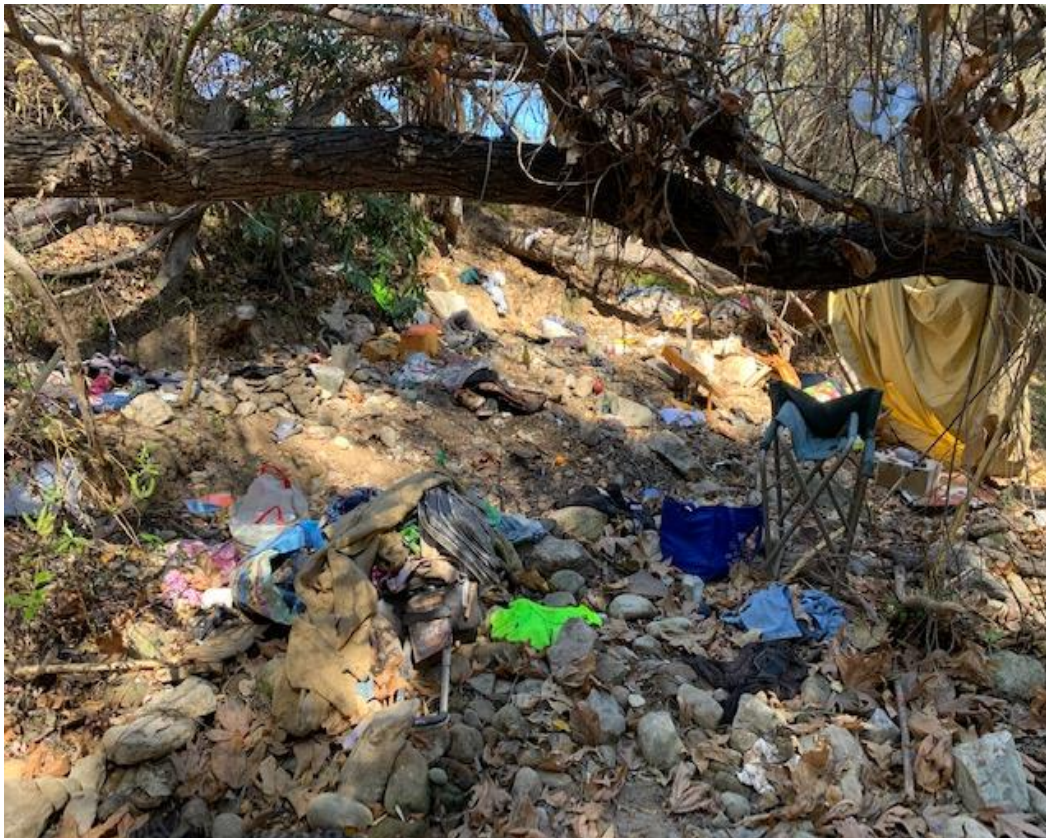
Figure 119. This is the West bank of the Hansen Aggregate site, located just downstream from the train tracks and along Hansen Aggregate company grounds. This site hosts a robust homeless population which collectively produces a lot of trash and subsequent creek pollution. Trautwein. February 18, 2022.

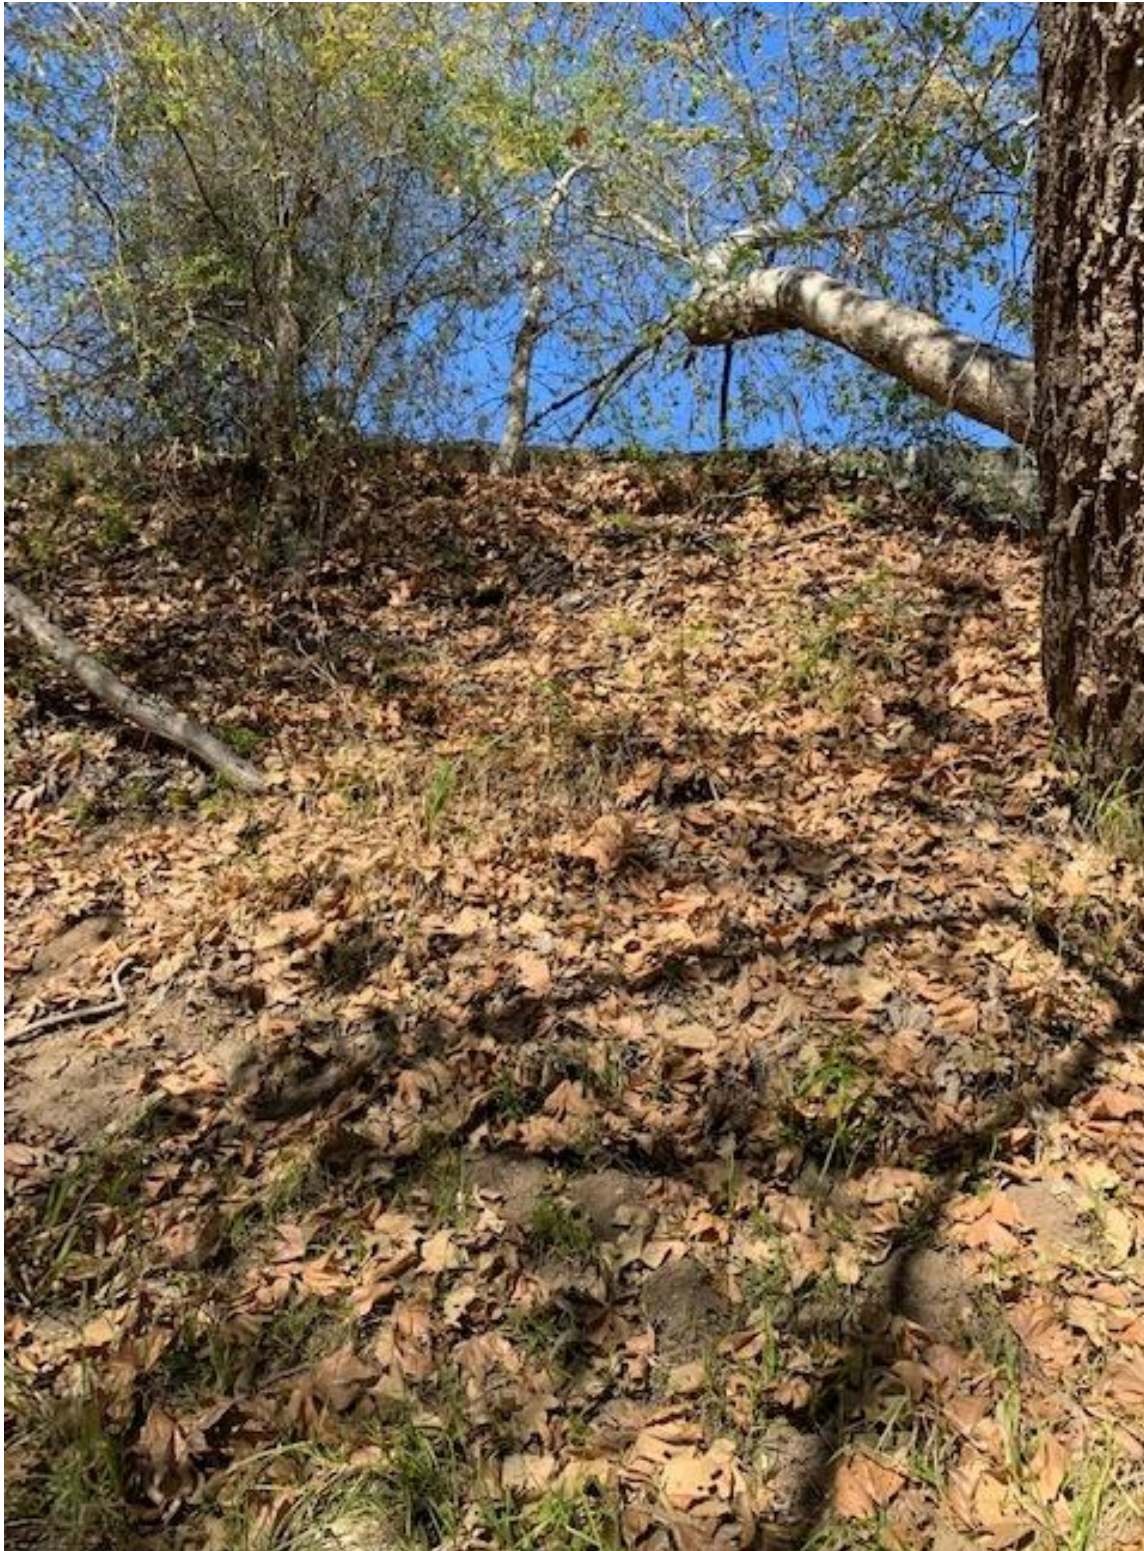
Figure 120. West bank of San Jose Creek at the Hansen Aggregate site. Slope is covered in nonnative grasses and fallen sycamore leaves from the large sycamore in the upper right corner of the photo. One of several remaining willow trees is shown in the upper left corner of the photo. Trautwein. February 18, 2022.

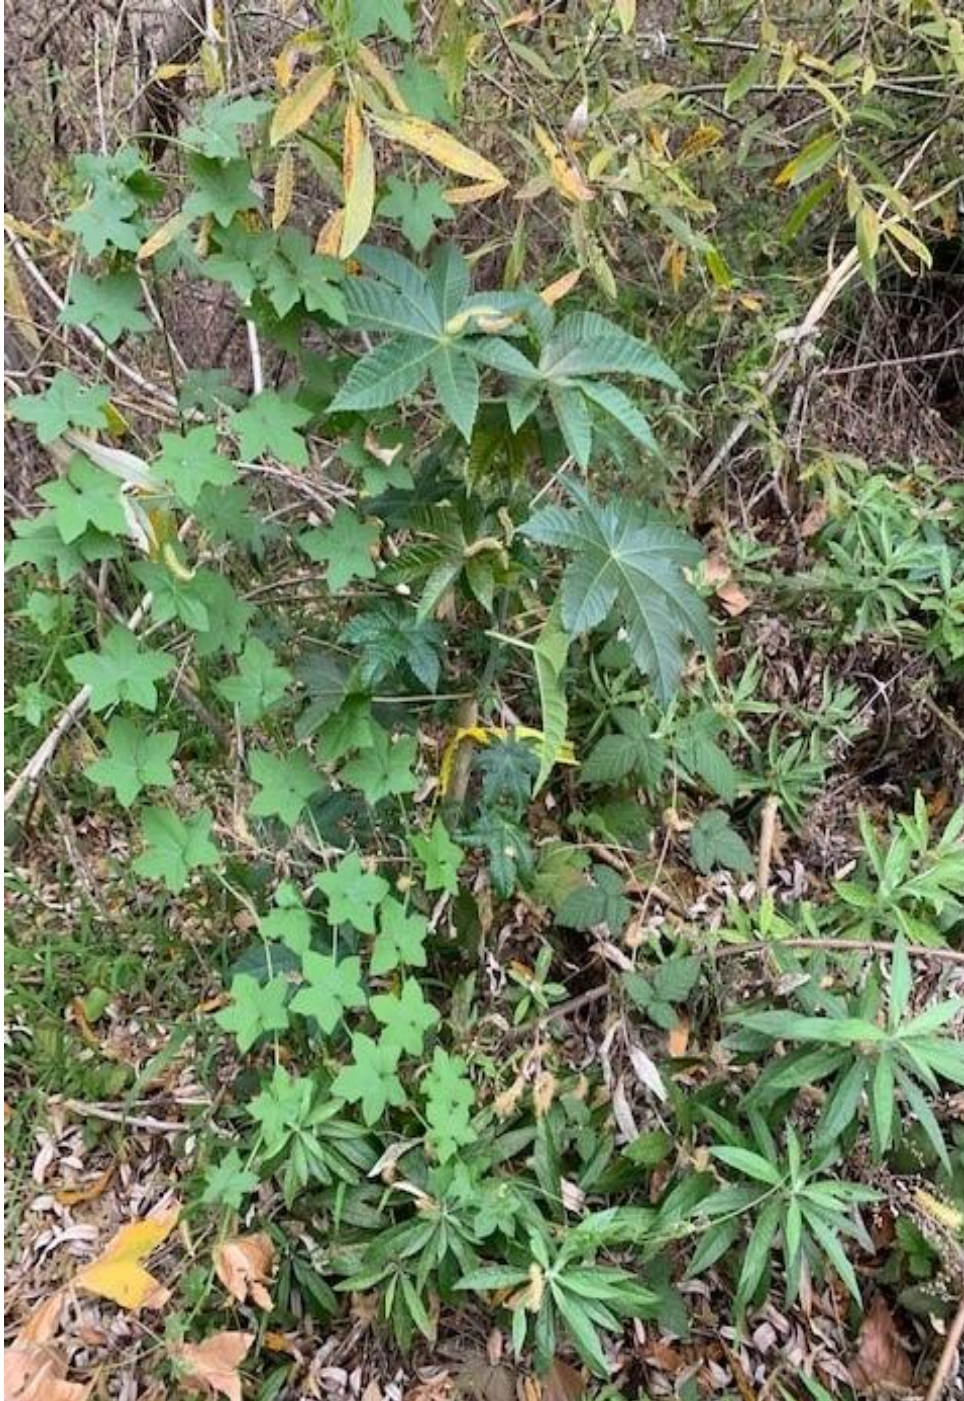
Figure 126. Castor bean at La Goleta Revegetation was flagged and retained. Trautwein. January 2022.

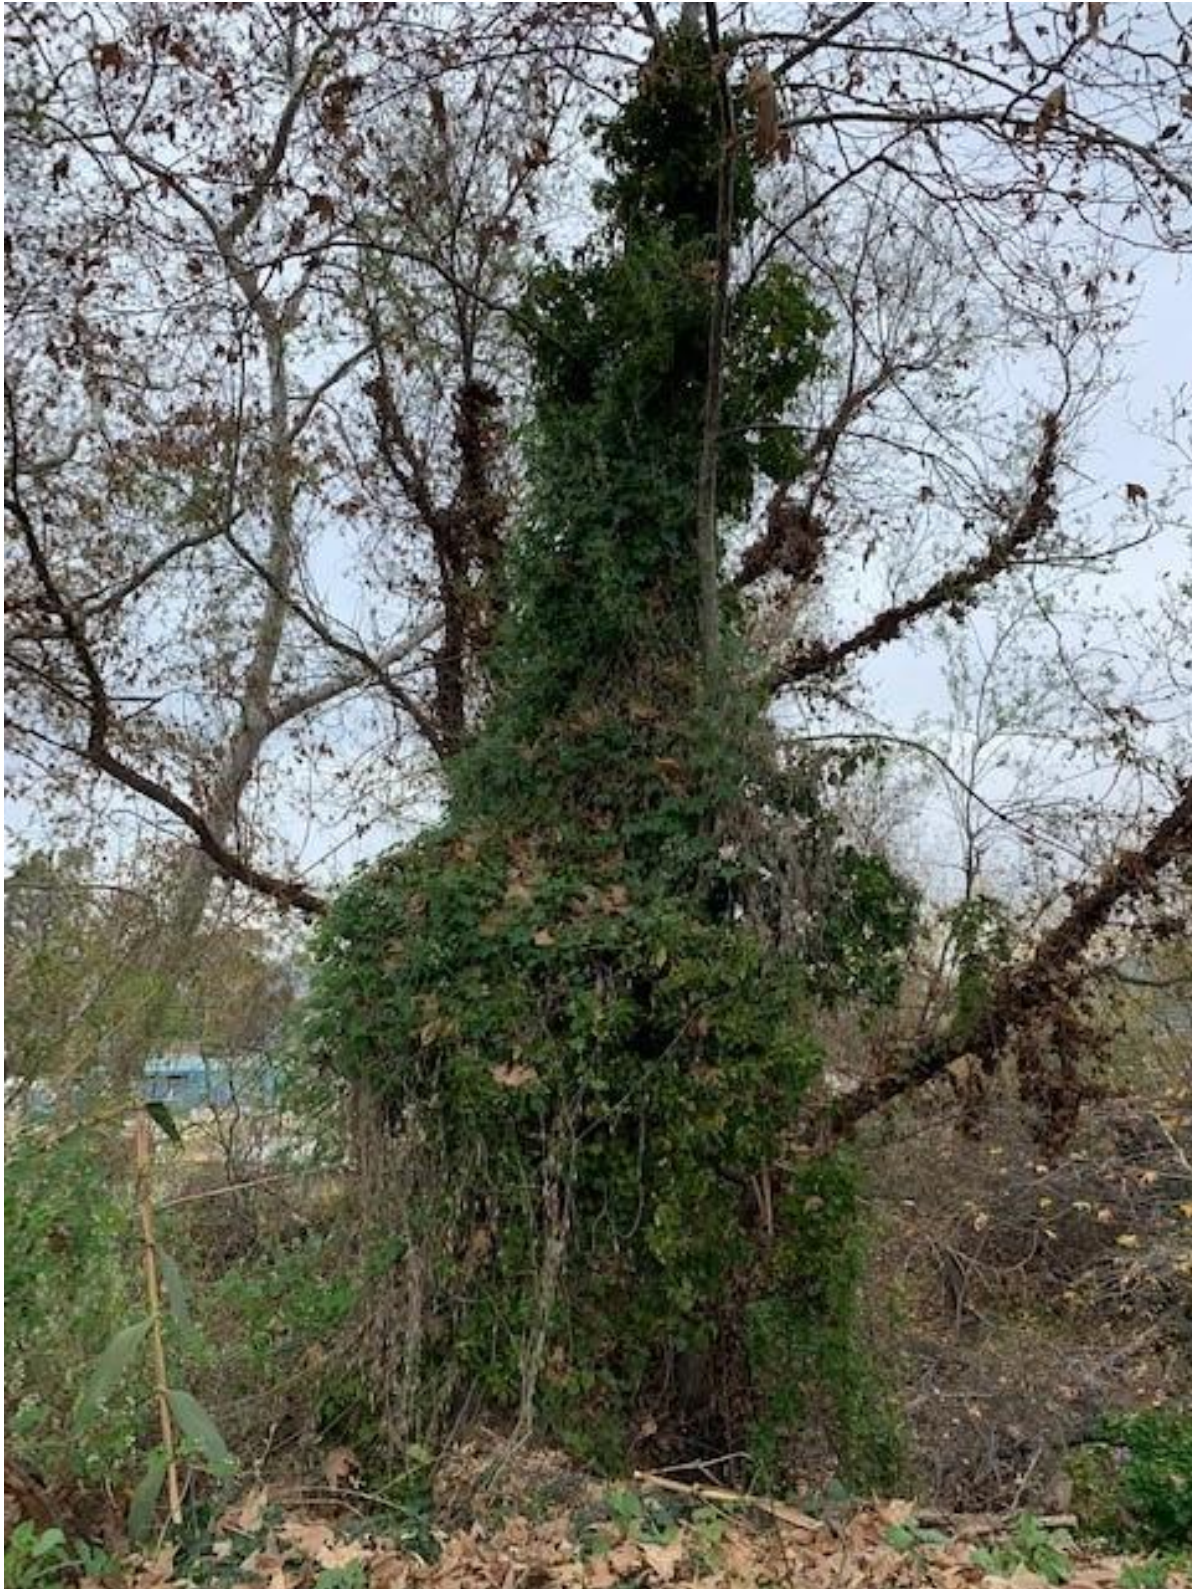
Figure 127. Algerian ivy at the La Goleta Site Section #4 is smothering this native tree. Trautwein, January 2022.
