San Jose Creek Flood Control Revegetation Sites **And Los Carneros Mitigation Bank** **Review and Recommendations**

ENVIRONMENTAL DEFENSE CENTER
October 24, 2022

Natalie Blackwelder, EDC Watershed Program Intern
Brian Trautwein, Senior Analyst / Watershed Program Director

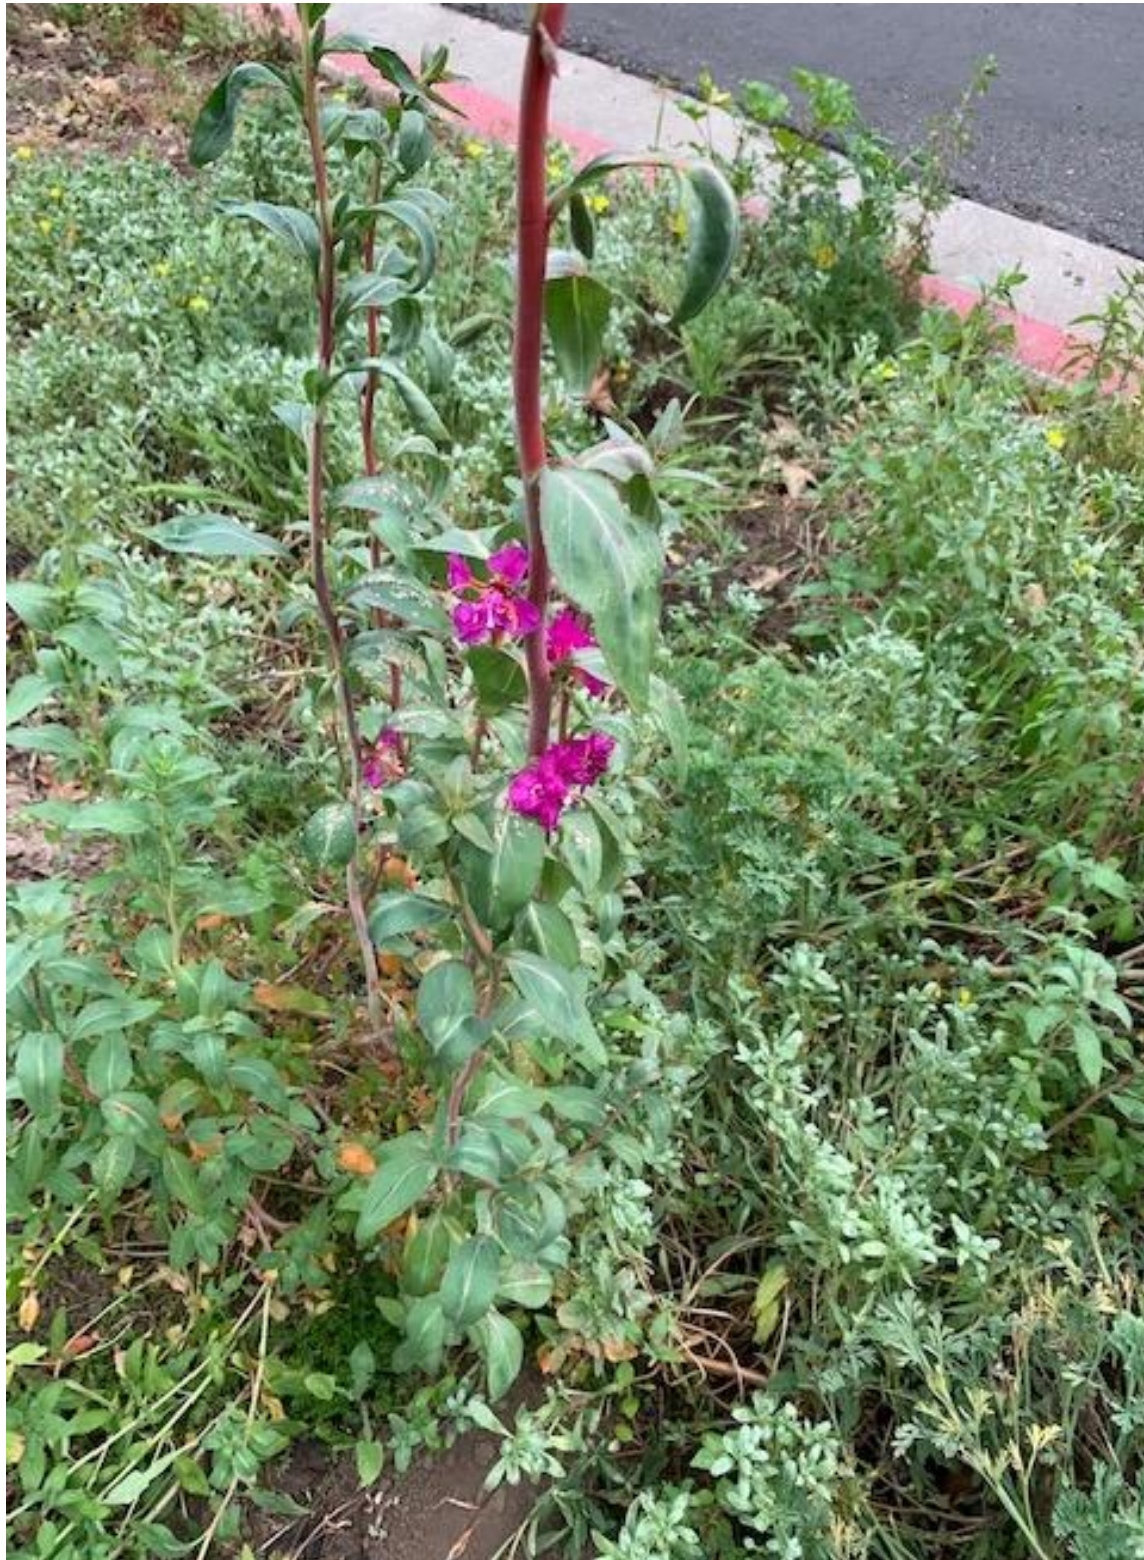
Figure 129. The La Goleta Condominium Pollinator Garden. The seed mix planted here contains California natives and non-local horticultural varieties of local native species, such as the elegant clarkia above. It is not habitat restoration and not riparian habitat. It was not counted toward SBCFCWCD's mitigation requirements. Trautwein. January 31, 2022.

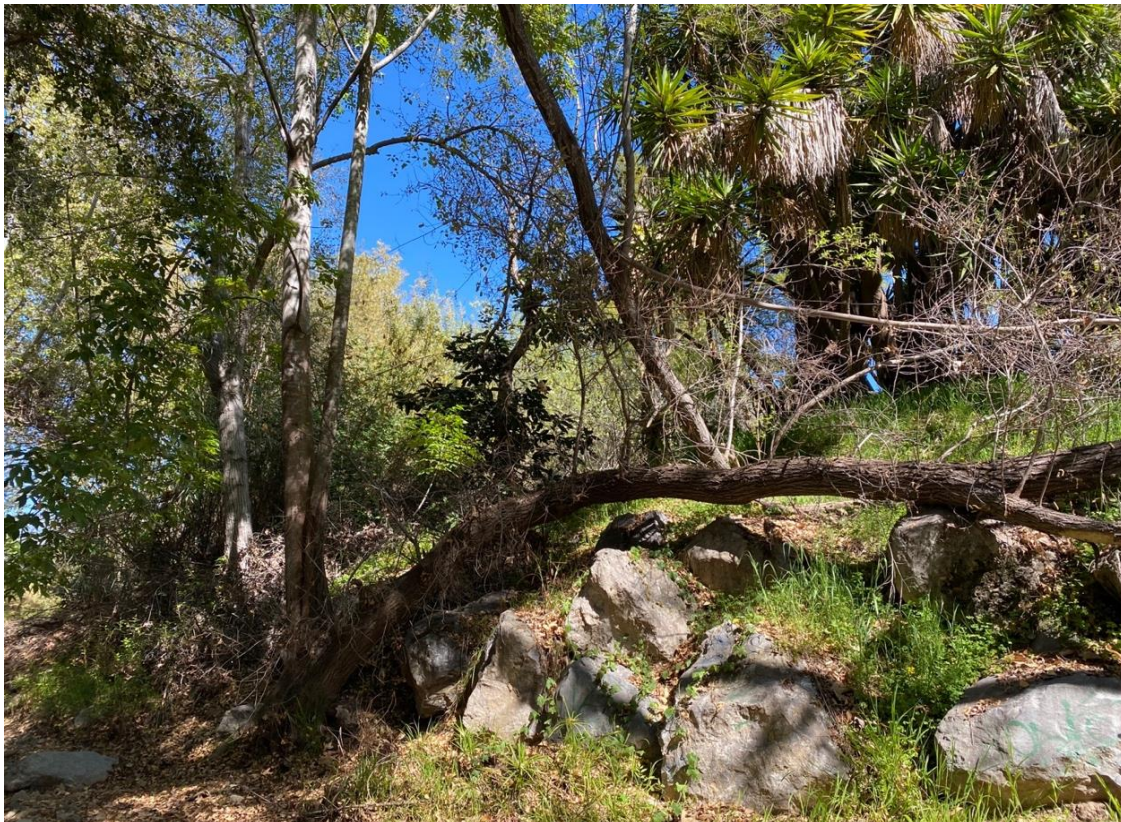
Figure 132. Rip rap at the Armitos Road Site. Horizontal willow with several new up shoots. In the back left corner is a nonnative, invasive Shamel ash tree. Middle left is a nonnative eucalyptus tree. Upper right corner is a nonnative Yucca tree. The vines growing over the riprap are native wild cucumber. Blackwelder. February 28, 2022.
