# **GOLETA'S CREEKS AND WATERSHEDS: OPPORTUNITIES FOR ENHANCEMENT AND RESTORATION**

**\*2020 ADDENDUM\***

## **ENVIRONMENTAL DEFENSE CENTER GOLETA WATERSHED PROTECTION AND EDUCATION PROGRAM**

**June 10, 2020**

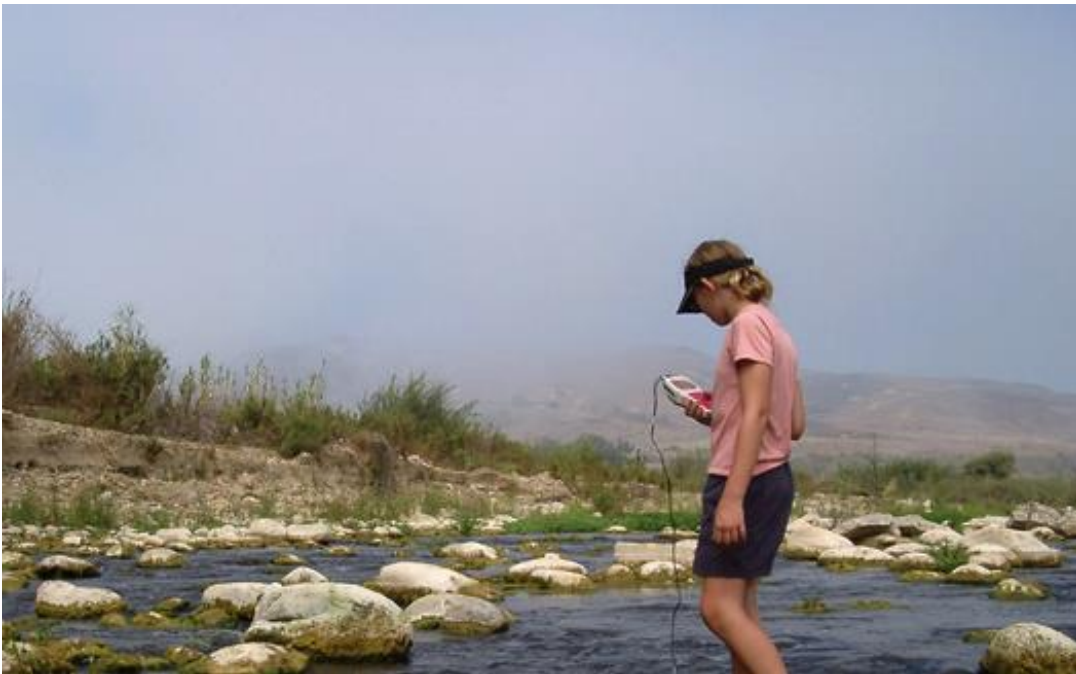
- Regulation of Upstream Agriculture Runoff into Devereux Creeks
  - **Problem Devereux A1:** The upper portion of the Devereux Creek Watershed is zoned for agriculture. Agricultural activities that fail to control soil erosion have the potential to degrade water quality and stream habitats particularly during and following storm events when excessive sediment is deposited in the creek bed, filling in pools and riffles, and suspended as sediment in the water column degrading water quality and harming fish and wildlife.

Figure 1. Water quality testing of a creek. Sourced from Santa Barbara Channel Keeper. (<https://www.sbck.org/>)

- **Recommendation Devereux A1A:** Conduct regular water quality monitoring in Devereux Creek through, for example, enhanced collaboration between the City of Goleta, UCSB, and Santa Barbara Channelkeeper.
- **Community Benefits:** Recommendation Devereux A1A will ensure that Devereux Creek and Devereux Slough contain clean water and may result in better control of agricultural erosion and sedimentation in the Creek. If the Creek and Slough water are not clean, monitoring will disclose pollution and then actions can be taken to control pollution. Members of the community can be reassured of

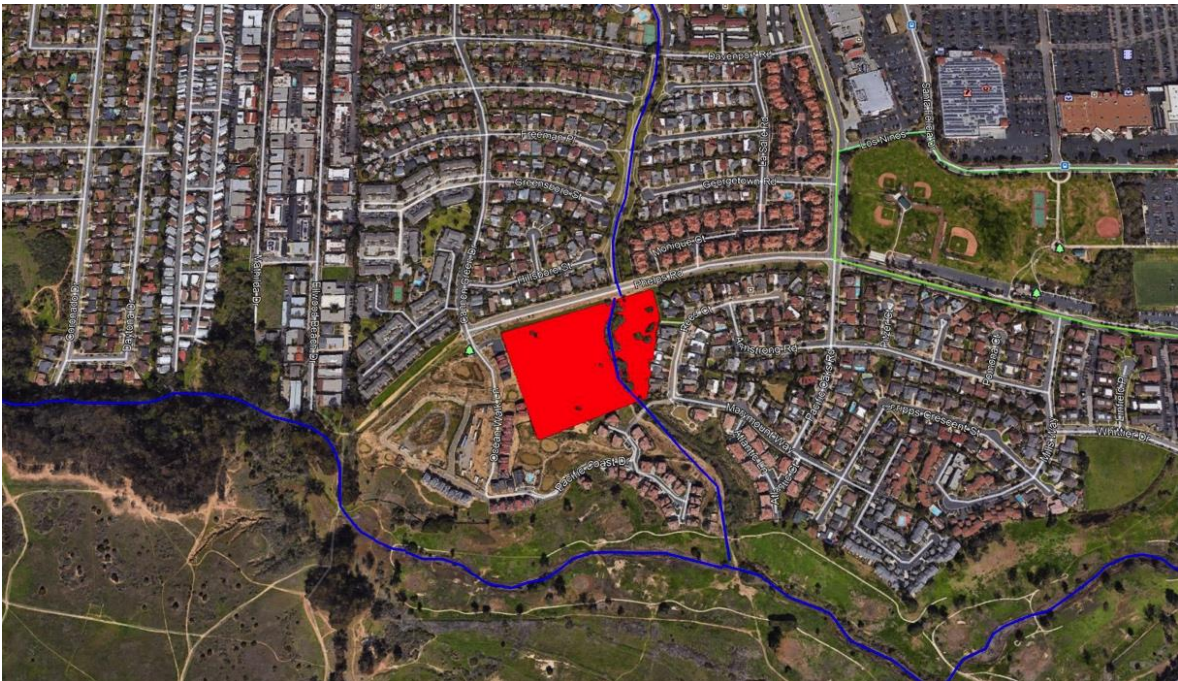
Figure 3. Goleta Union School District Wetlands Parcel on Phelps Road recommended for acquisition by City of Goleta.

- **Recommendation Devereux A3A:** Purchase the parcels for conservation, environmental restoration, passive recreation, and environmental education purposes.

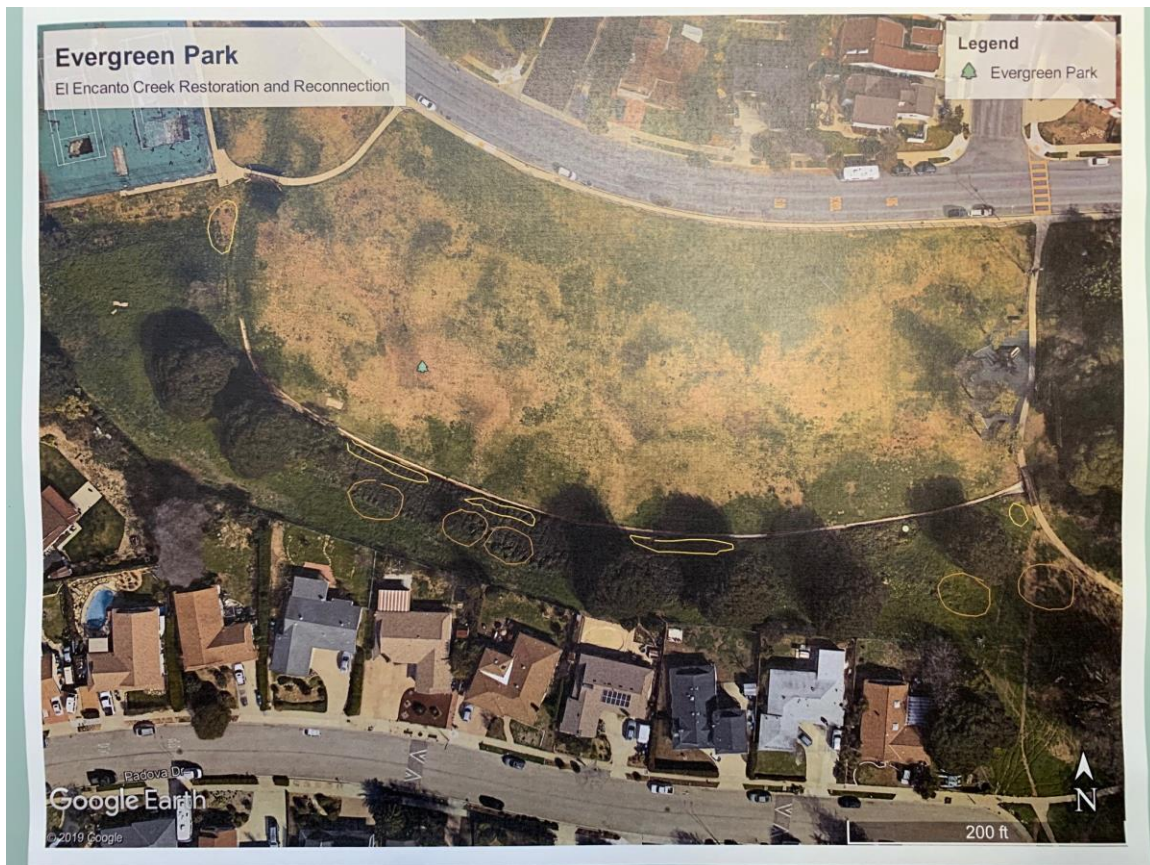
- **Next Step:** The City of Goleta should contact the Goleta Union School District, the owner of the parcel, to inquire regarding acquisition.
- **Problem Devereux A4:** The western branch of El Encanto Creek within Evergreen Park east of Brandon School was placed in a 600-foot long concrete ditch on the southern side of a lawn. Construction of the ditch eliminated this tributary's riparian habitat and may reduce groundwater recharge and contribute to water quality problems such as thermal pollution (artificial warming of creek water).

Figure 4. Map showing location of proposed willow and oak planting (yellow and orange polygons) and concrete ditch (white) removal or infiltration facility installation in Evergreen Park.

- **Recommendation Devereux A4A:** Plant arroyo willow trees to reclaim riparian habitat along the ditch and plant several coast live oak trees on the north-facing slope south of the tributary and lawn. Consider removal of concrete and/or addition of infiltration facility to enhance both groundwater recharge and baseflow in El Encanto Creek.
- **Community Benefits:** This recommendation would reestablish and extent riparian habitat further west connecting to the tributary upstream in the park which includes native white alders and coast live oak plantings and a footbridge. Neighborhood aesthetics would be enhanced. Planting native trees will help sequester carbon dioxide and fight climate change.

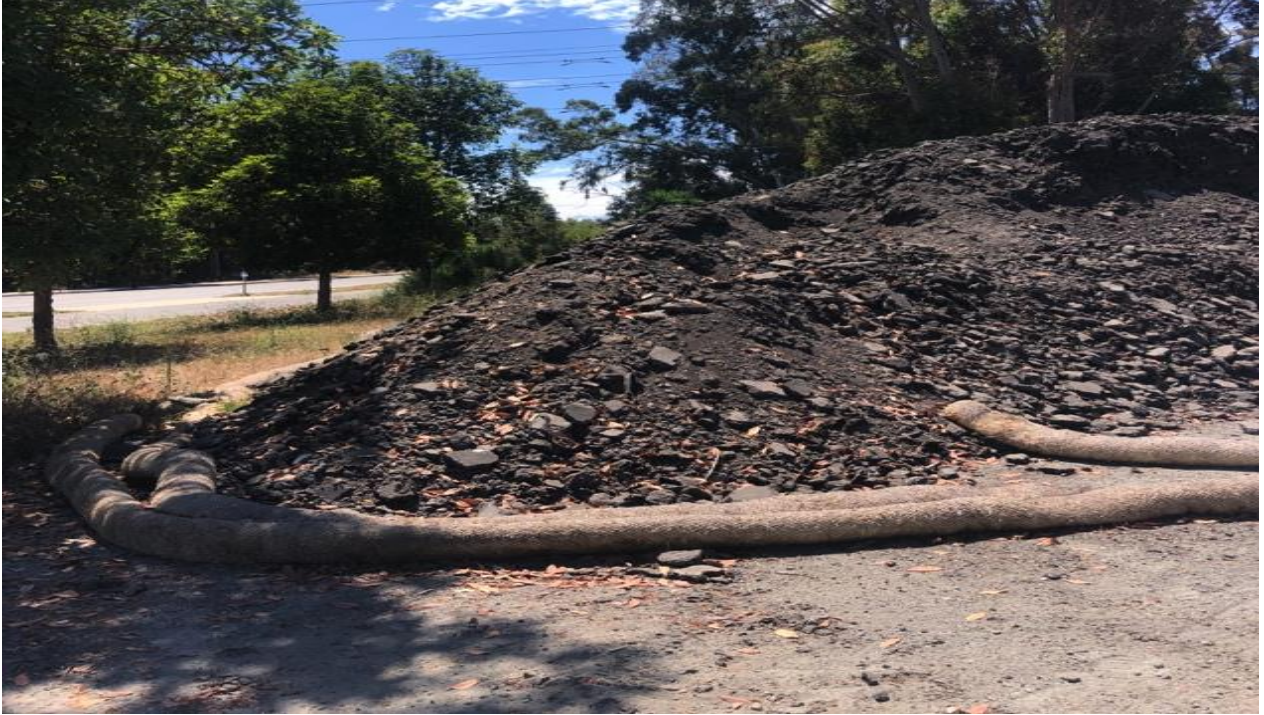
Figure 5. The construction staging and stockpiling site adjacent to Glen Annie Creek at the corner of Cathedral Oaks and Glen Annie Roads degrades the Creek, harms water quality, is an eyesore, and attracts illegal dumping.

- **Problem Glen Annie A1<sup>2</sup>:** The land located at the northwest intersection of Cathedral Oaks Road and Glen Annie Road is used for constructing staging, asphalt and soil stockpiling, and illegal dumping. The erosion control coir is not properly installed allowing contaminants to escape containment and enter Glen Annie Creek to the west.
  - **Recommendation Glen Annie A1A:** Work with County Public Works to install an additional “No Dumping” sign at this turnout.
  - **Recommendation Glen Annie A1B:** Work with County Public Works to secure the erosion control coir to the ground to prevent asphalt, hydrocarbons, and soil from escaping containment and being transported by rainwater under the coir into the Creek.

- **Recommendation Glen Annie A1C:** Remove stockpiled soil, asphalt, and other materials from within 100 feet of the riparian habitat and restore riparian habitat in buffer.
- **Community Benefits:** Recommendations Glen Annie A1A, A1B, and A1C will help support a healthy and pollution-free Glen Annie Creek and riparian ecosystem. The project will increase public awareness and education about the Creek and beautify the area.
- **Next Steps:** Meet with the County of Santa Barbara Public Works Transportation and Project Clean Water staffs to discuss the feasibility of these recommendations.
- Soil Erosion in Orchards Within the Glen Annie Creek Watershed

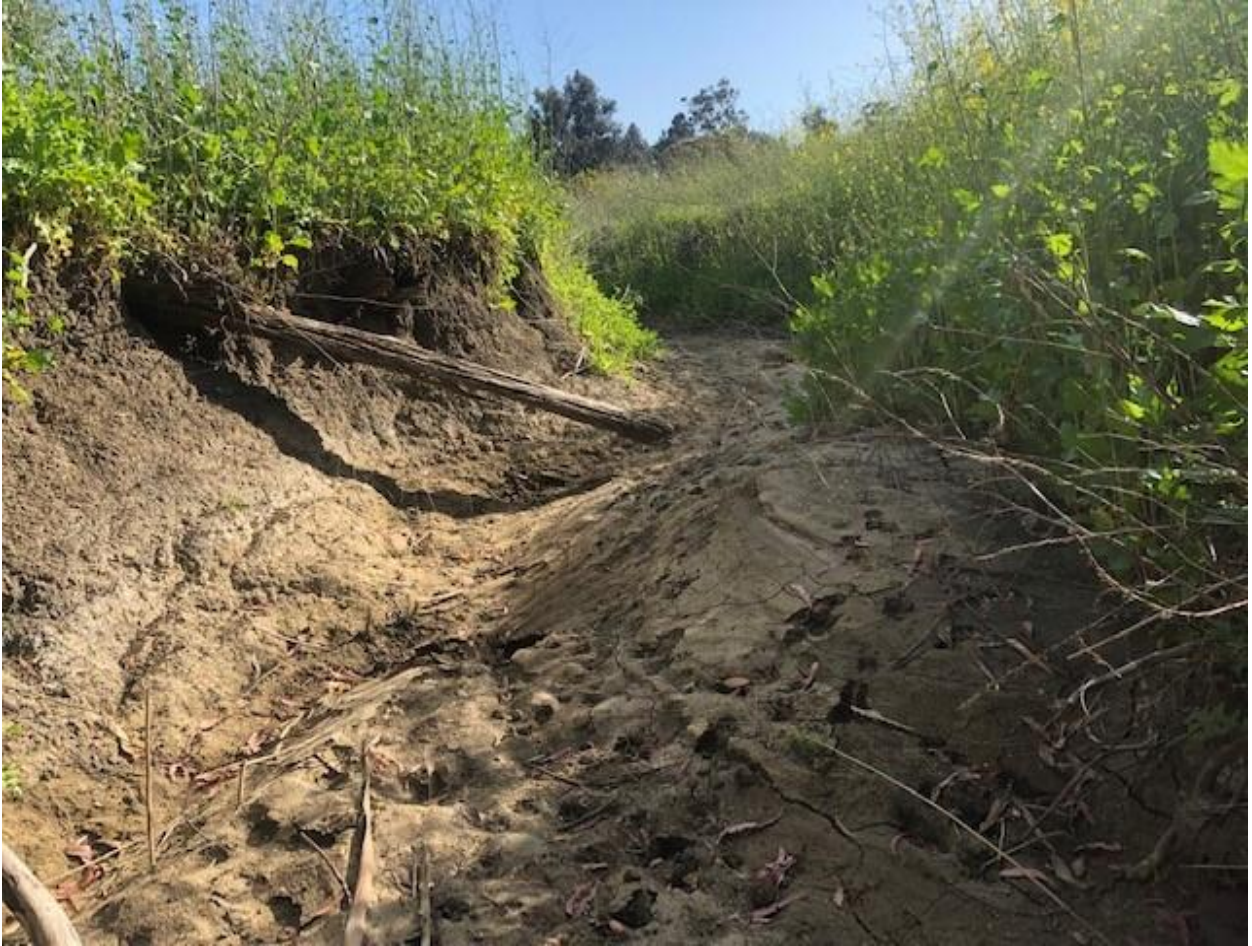
Figure 7. Sediment eroded from the new orchard is filling in a tributary to Glen Annie Creek and fouling the Creek.

- **Recommendation Glen Annie A2A:** Incentivize or require orchards near the Creek and its tributaries to install sedimentation basins and cover their topsoil to prevent its erosion. Sediment from the basins can be reused on farm fields.
- **Recommendation Glen Annie A2B:** Require or incentivize orchards to use contour plowing methods to reduce erosion.

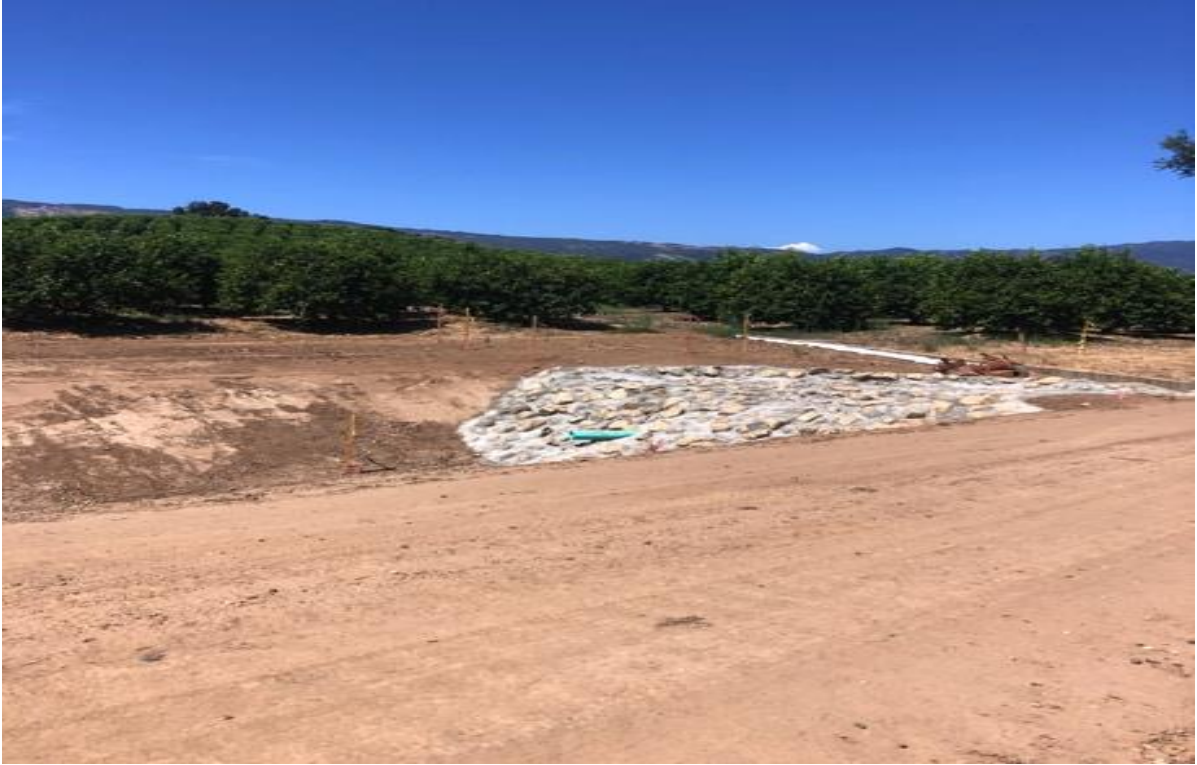
Figure 8. A sediment basin installed in 2019 to trap sediment from eroding orchards along Cathedral Oaks Road.

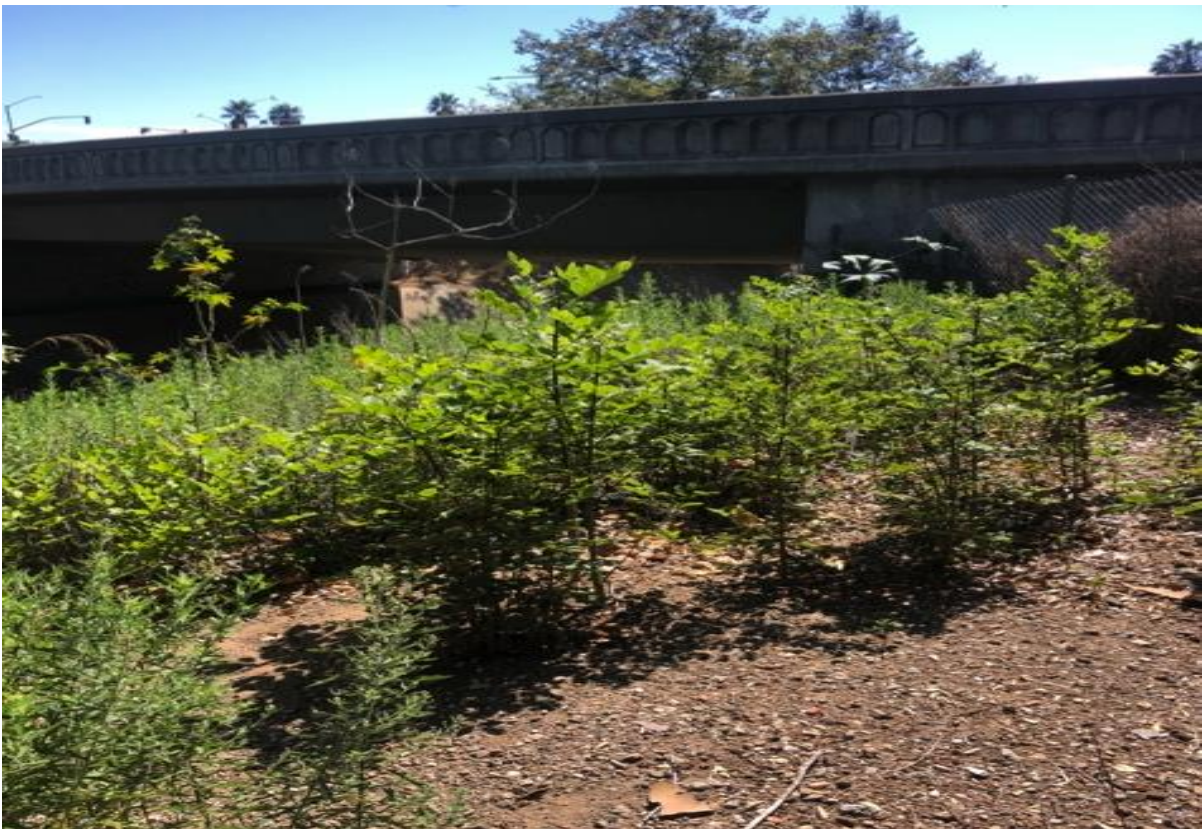
Figure 9 The young nonnative, invasive Shamel ash tree saplings in Glen Annie Creek near Highway 101 are small enough to be removed without extensive equipment or herbicides.

- **Problem Glen Annie A4:** Exotic Shamel ash trees are growing by the Highway 101 Northbound Glen Annie/Storke Road Onramp.
  - **Recommendation Glen Annie A4A:** The invasive exotic Shamel ash trees should be removed, and the area should be replanted with native tree species that naturally occur on the upper creek-banks. These include coast live oak (*Quercus agrifolia*), black cottonwood (*Populus trichocarpa*), and

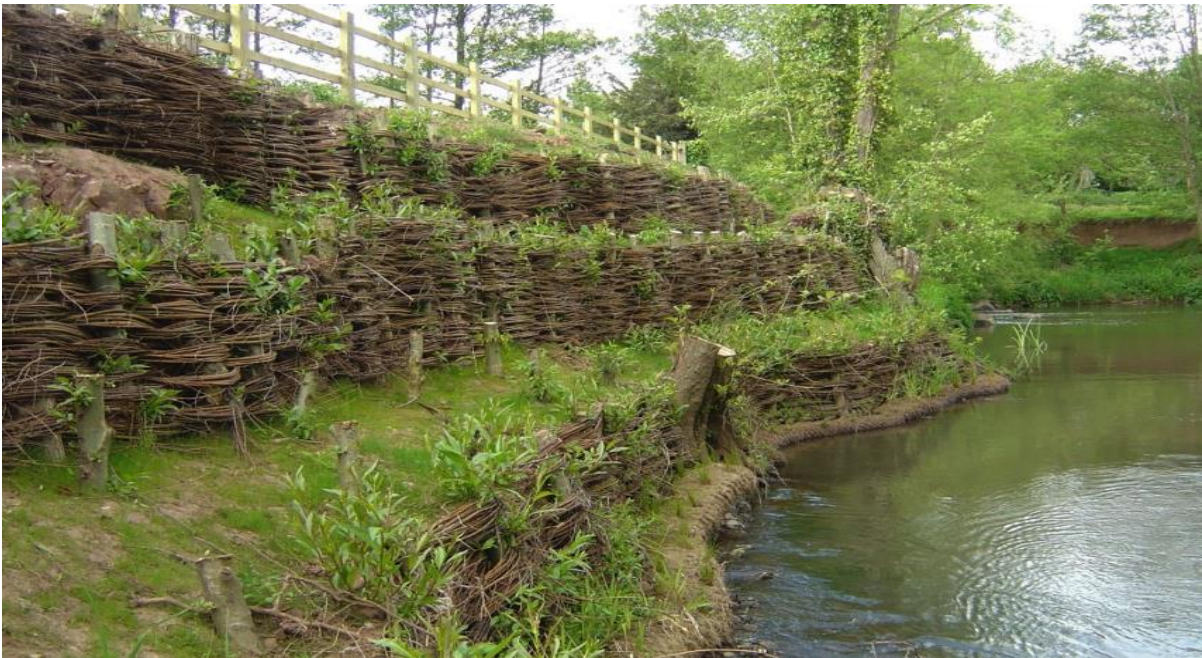
Figure 10 An example of a live willow crib wall. Sourced from Salix. (<https://www.salixrw.com/product/live-willow-revetments/>)

- **Problem Glen Annie A5:** The pipe and wire revetments along the banks of Glen Annie Creek inhibit wildlife movement between the Creek and the riparian environment and prevent establishment of natural points and bars in the stream. In addition, the revetments collect debris, such as tires, cans, and bottles that leach substances into the Creek as they decay. The pipe and wire revetments are unsightly blights in the Creek.

- **Recommendation Glen Annie A5A:** Remove pipe and wire wherever feasible and install live willow “boxes” or live willow crib walls on the Creek’s banks to prevent erosion. Pictured is an example of this method of biotechnical stream bank stabilization. Live crib walls are wooden log type structures that are built into stream banks and filled with soil, live willow cuttings, and rock.

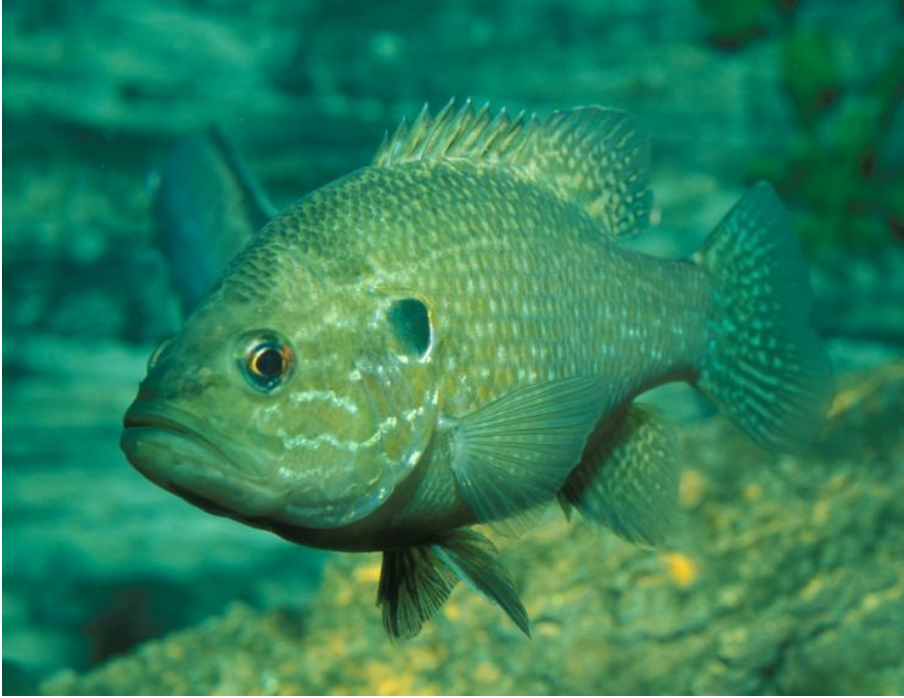
- Exotic Fish in Glen Annie Creek
    - **Problem Glen Annie A6:** In 2019, during an EDC creek cleanup, invasive exotic green sunfish were documented to have established a population in Glen Annie Creek near the Union Pacific Railroad Bridge and the Highway 101 Bridge. This species competes with and preys upon native fish and wildlife including steelhead and red-legged frogs.

Figure 11. Green sunfish have invaded Glen Annie Creek, threatening native fish and wildlife.

- **Recommendation Glen Annie A6A:** Survey Glen Annie Creek from the Goleta Slough upstream to and including McCoy Creek and the Glen Annie Reservoir.
- **Recommendation Glen Annie A6B:** Eradicate green sunfish from the Glen Annie Creek Watershed before winter rains allow them to spread.
  - **Community Benefits:** Removal of green sunfish will allow native fish and wildlife to flourish and will serve as an educational tool to inform residents of the problems caused by invasive species.
  - **Next Step:** Contact California Department of Fish and Wildlife (“CDFW”) to inquire regarding the status of their eradication efforts.

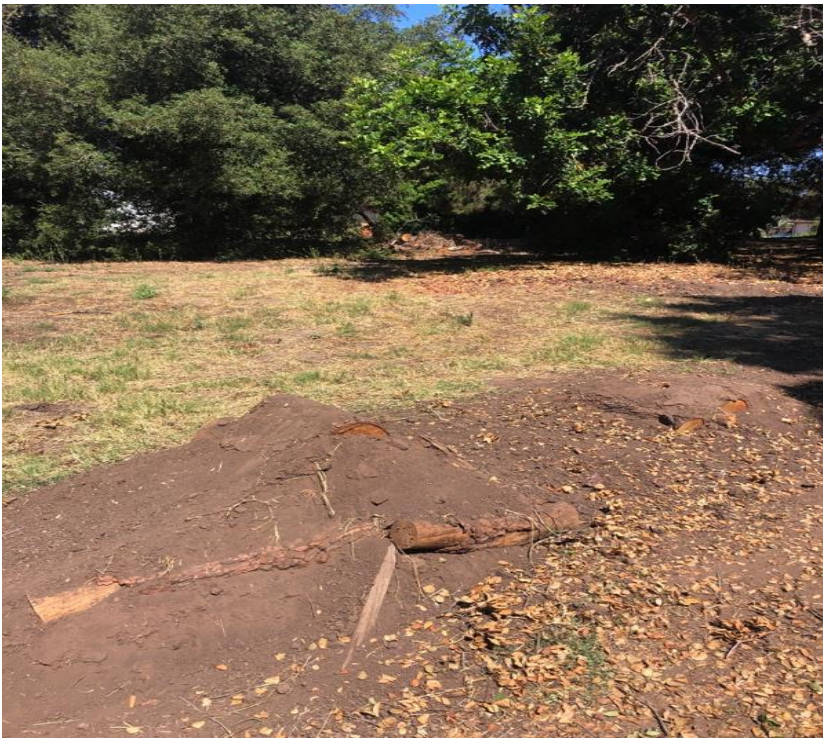
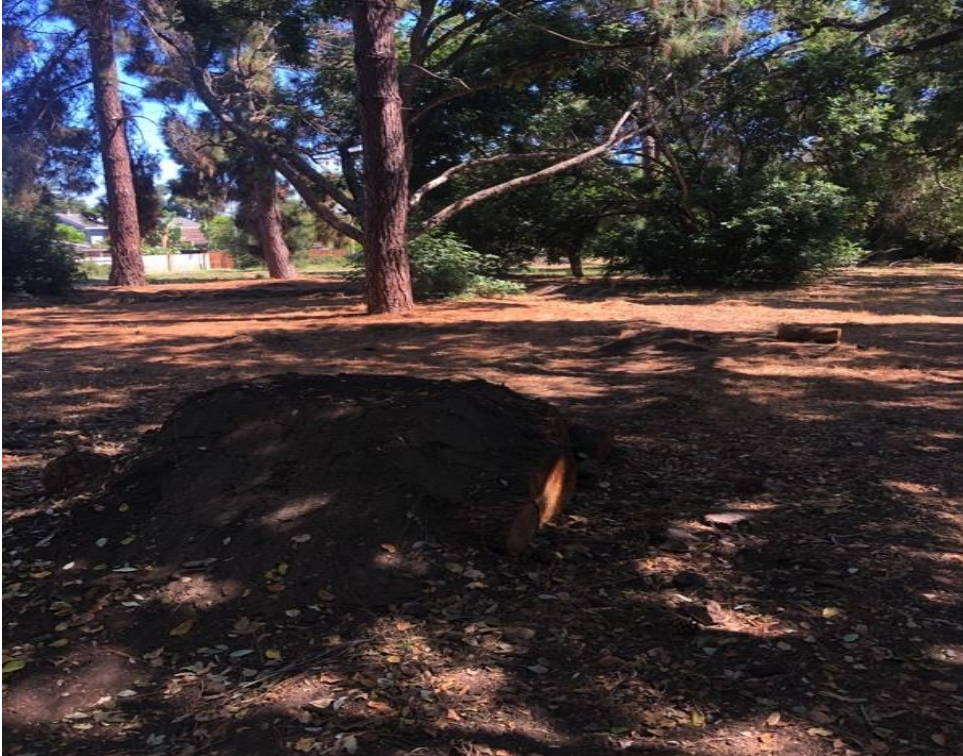
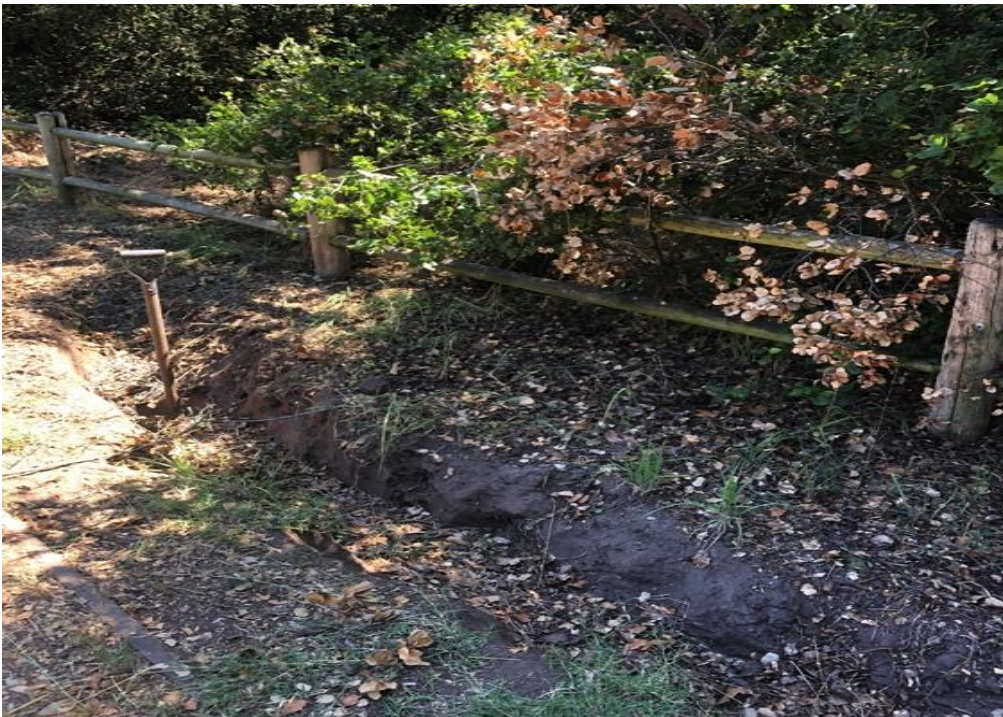
- Open Space Park Landscaping and Oak Woodland Restoration
  - **Problem San Pedro A1:** Area youth have constructed a BMX course in the City of Goleta's Open Space located south of Cathedral Oaks Road and immediately east of San Pedro Creek. These alterations to the landscape increase erosion and adversely affect wildlife and riparian habitat. The earthen jumps and turns carved into the landscape are an eyesore when viewed from the recreational path and present potential danger for the public. Several unsafe ditches were created near the pathway during the grading.

Figure 12. An unofficial BMX course has been graded within the City of Goleta's Open Space located east of San Pedro Creek south of Cathedral Oaks Road.

Figure 13. An additional photo of the unofficial BMX course within the City of Goleta's Open Space.

Figure 14. The City of Goleta's Open Space along San Pedro Creek south of Cathedral Oaks contains dangerous ditches adjacent to the recreation path.

- **Recommendation San Pedro A1A:** Post signs around the City of Goleta's Open Space warning that the creation of BMX courses is prohibited. Have City Park Rangers monitor the site and speak with people using the BMX course.

- **Recommendation San Pedro A1B:** Deconstruct jumps and turns. Refill the ditches with soil used to make the jumps and berms and remove shovels from the Open Space. Develop a landscape plan installing native riparian, oak woodland, and/or coastal sage scrub species that will deter this activity, such as wild rose, and incorporate it into the City Parks Department's land scape and maintenance plan for this Open Space.

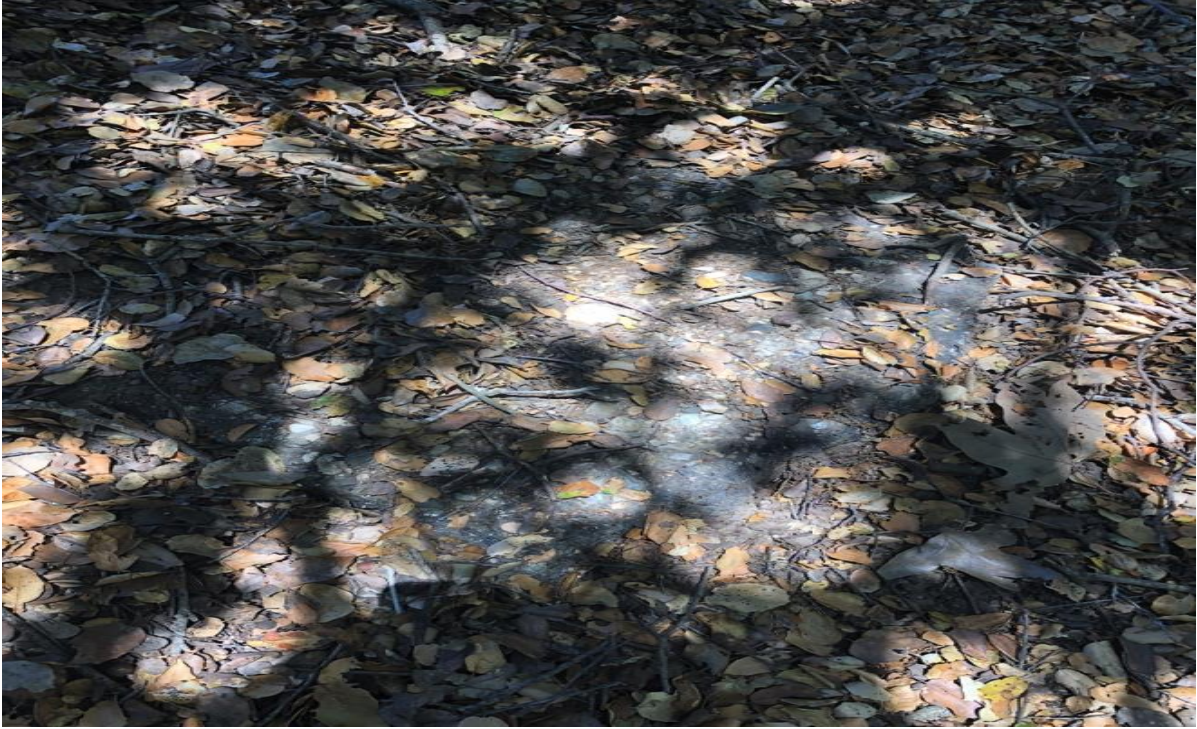
- Asphalt in the Creek Bed
    - **Problem San Pedro A2:** Throughout San Pedro Creek between Cathedral Oaks and Stow Canyon Road are chunks of asphalt that contain hydrocarbons, which can leach into the Creek and pollute the water.

Figure 15. Asphalt pieces found in the San Pedro Creek bed.

- **Recommendation San Pedro A2A:** Remove the chunks of asphalt that are in the Creek bed.
- **Community Benefits:** Recommendation San Pedro A2A will prevent the leaching of hydrocarbons into the Creek. This will improve water quality for integral species such as the southern California steelhead and the California red-legged frog.
- **Next Step:** Discuss the concept of a creek bed cleanup with City Parks and SBCFCWCD, as well as other potential partners such as Santa Barbara Channelkeeper.

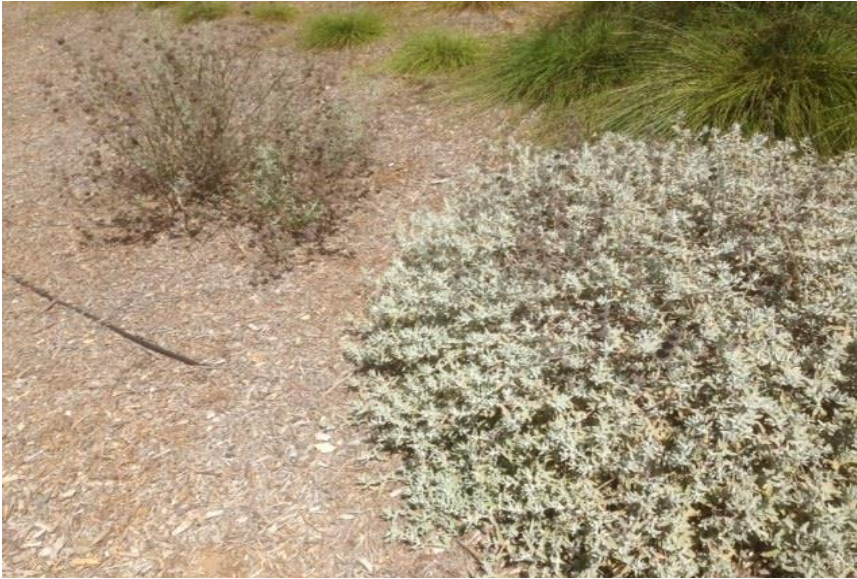
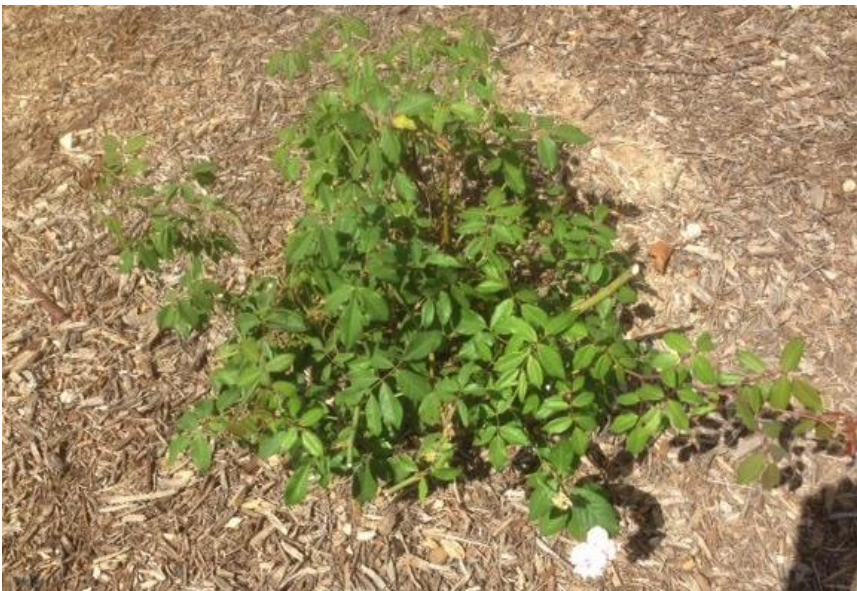
- Tree Farm Housing Project Vegetation on San Jose Creek
  - **Problem San Jose A1:** The revegetation done as mitigation for the Tree Farm Housing Project along San Jose Creek near Patterson used non-native plants, or non-local varieties of native plants including non-local varieties of purple sage (*Salvia leucophylla*) and wild rose (*Rosa californica*).

Figure 16. A photo of the non-local purple sage planted along San Jose Creek.

Figure 17. A photo of the non-local wild rose varietal planted along San Jose Creek.

- **Recommendation San Jose A1A:** Request the County Planning Department consulting biologist evaluate whether plants installed as habitat mitigation for the Tree Farm Housing Project are appropriate for planting along the Creek. Replace them if they are not local native plants.

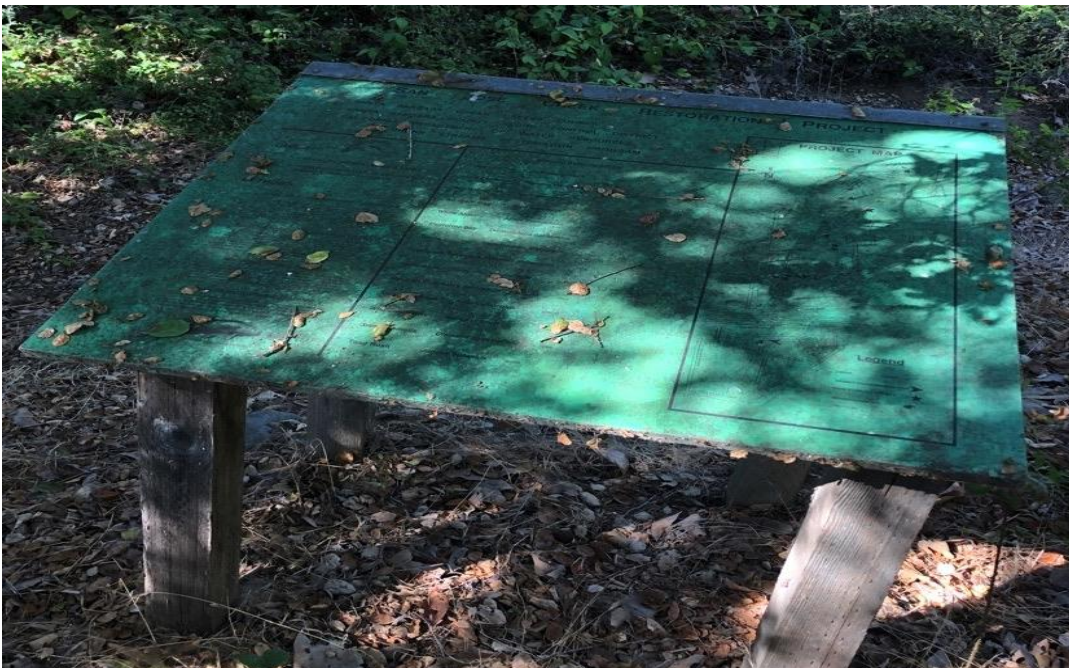
- Repairs at Berkeley Footbridge
  - **Problem San Jose A2:** The wooden fence lining the Berkeley Footbridge over San Jose Creek is dilapidated. Several boards are broken or missing. The San Jose Creek Restoration Project informational sign about has been damaged. There are also many weeds invading the area along the Footbridge.

Figure 18. A damaged educational sign outlining the San Jose Creek Restoration Project, located on the Berkeley Footbridge.

- **Recommendation San Jose A2A:** Clean, touch-up, and replace the Plexiglas on the informational sign so that it is

legible. Repair the wood rail fence. Remove weeds from along the Footbridge path.

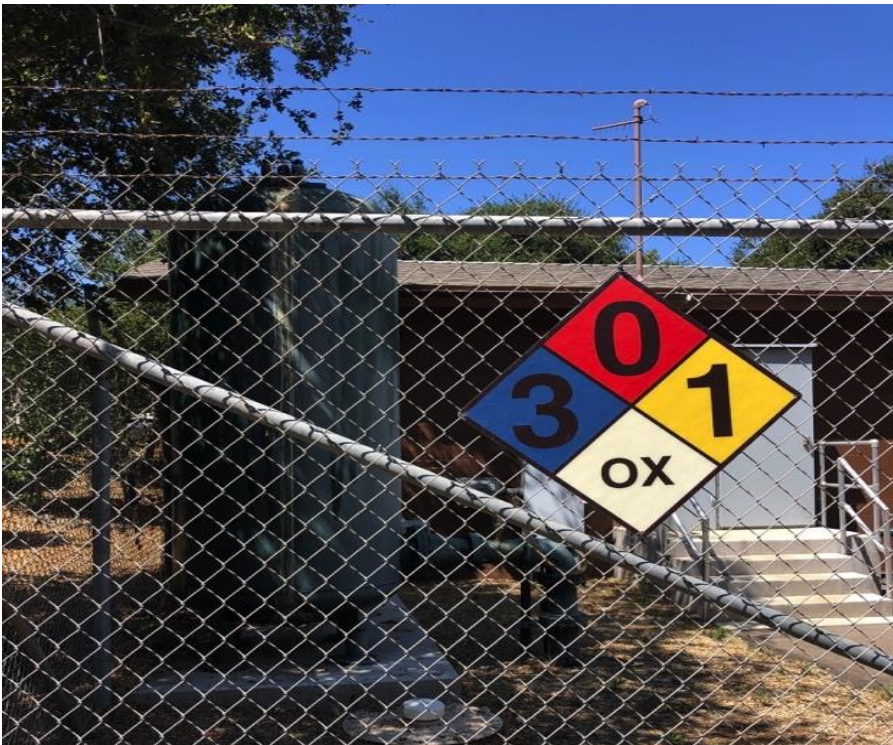
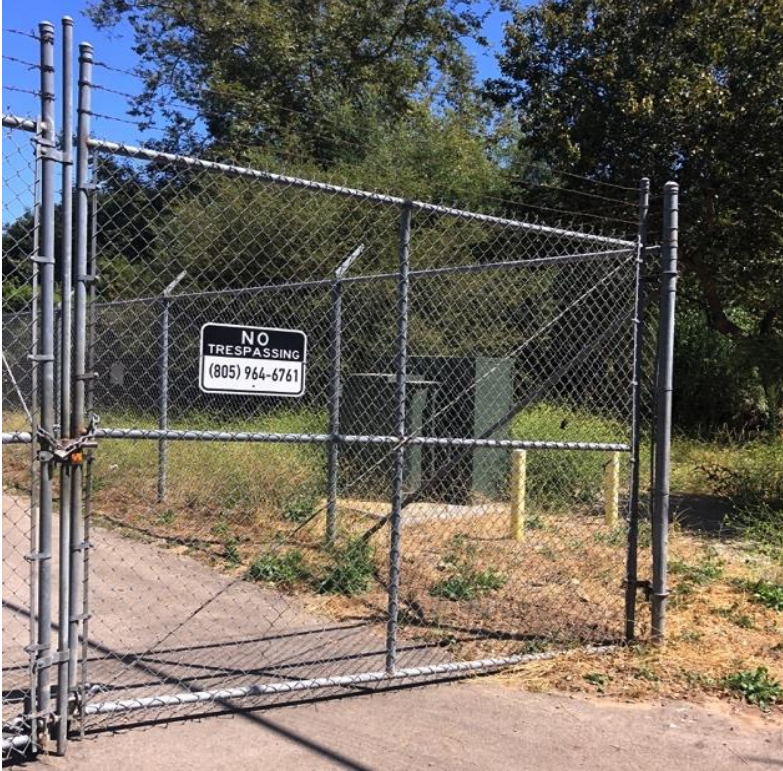
Figure 19. The sign identifying potentially noxious chemicals at the building on the bank of San Jose Creek.

Figure 20. The perimeter of the Goleta Water District facility near the bank of San Jose Creek.

- **Recommendation San Jose A3A:** While the doors to this facility are elevated and/or apparently sealed to flood waters, a flood could still damage this facility or carry chemicals into the Creek, Goleta Slough, and ocean. Create a low floodwall around this building to protect the facility and prevent the potential for chemicals to contaminate San Jose Creek.

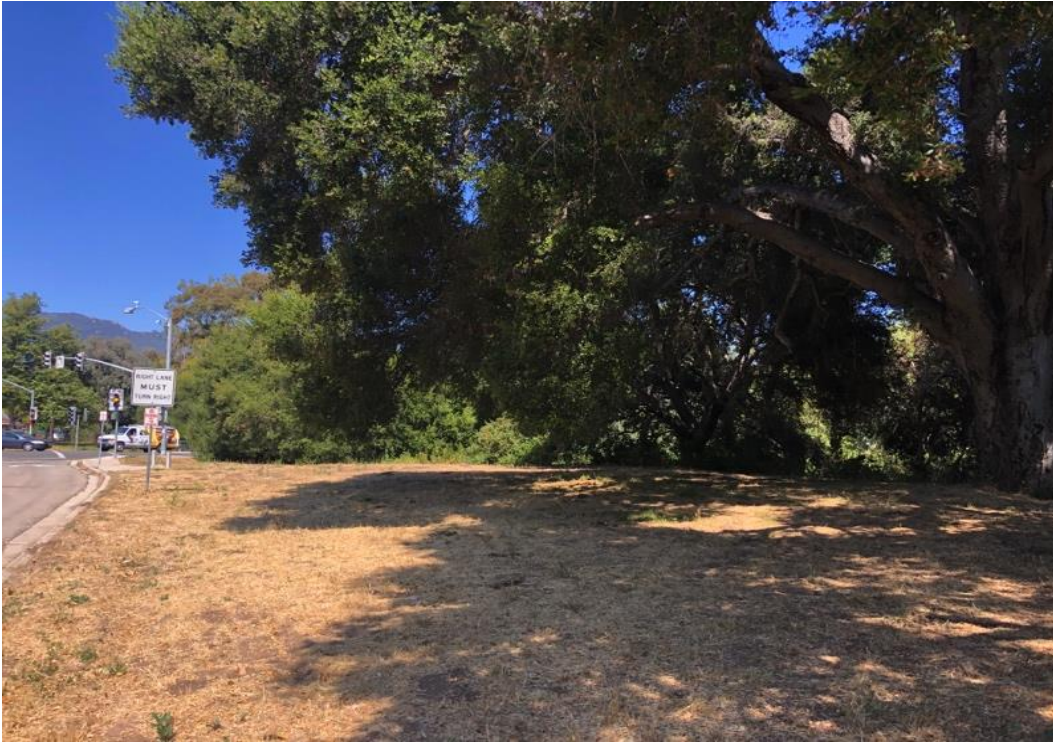
Figure 21. The bare upper western terrace of San Jose Creek on Kellogg Avenue south of Cathedral Oaks Road.

- **Recommendation San Jose A4A:** Plant native coast live oaks (*Quercus agrifolia*) and native understory vegetation (e.g., wild rose (*Rosa californica*) and hummingbird sage (*Salvia spathacea*) from below the top of the west bank outward to within ten feet of Kellogg Avenue, avoiding underground utilities where necessary.
  - **Community Benefits:** Recommendation San Jose A4A will proactively protect and restore riparian habitat within the SPA. It will enhance the buffer between the Kellogg Avenue and the Creek and improve neighborhood aesthetics.
  - **Next Steps:** Meet with City Parks staff to discuss planting native coast live oaks and native understory plants in this location.
- Algerian Ivy Eradication
    - **Problem San Jose A5:** The native sycamore trees along San Jose Creek are being adversely impacted by Algerian ivy (*Hedera algeriensis*).

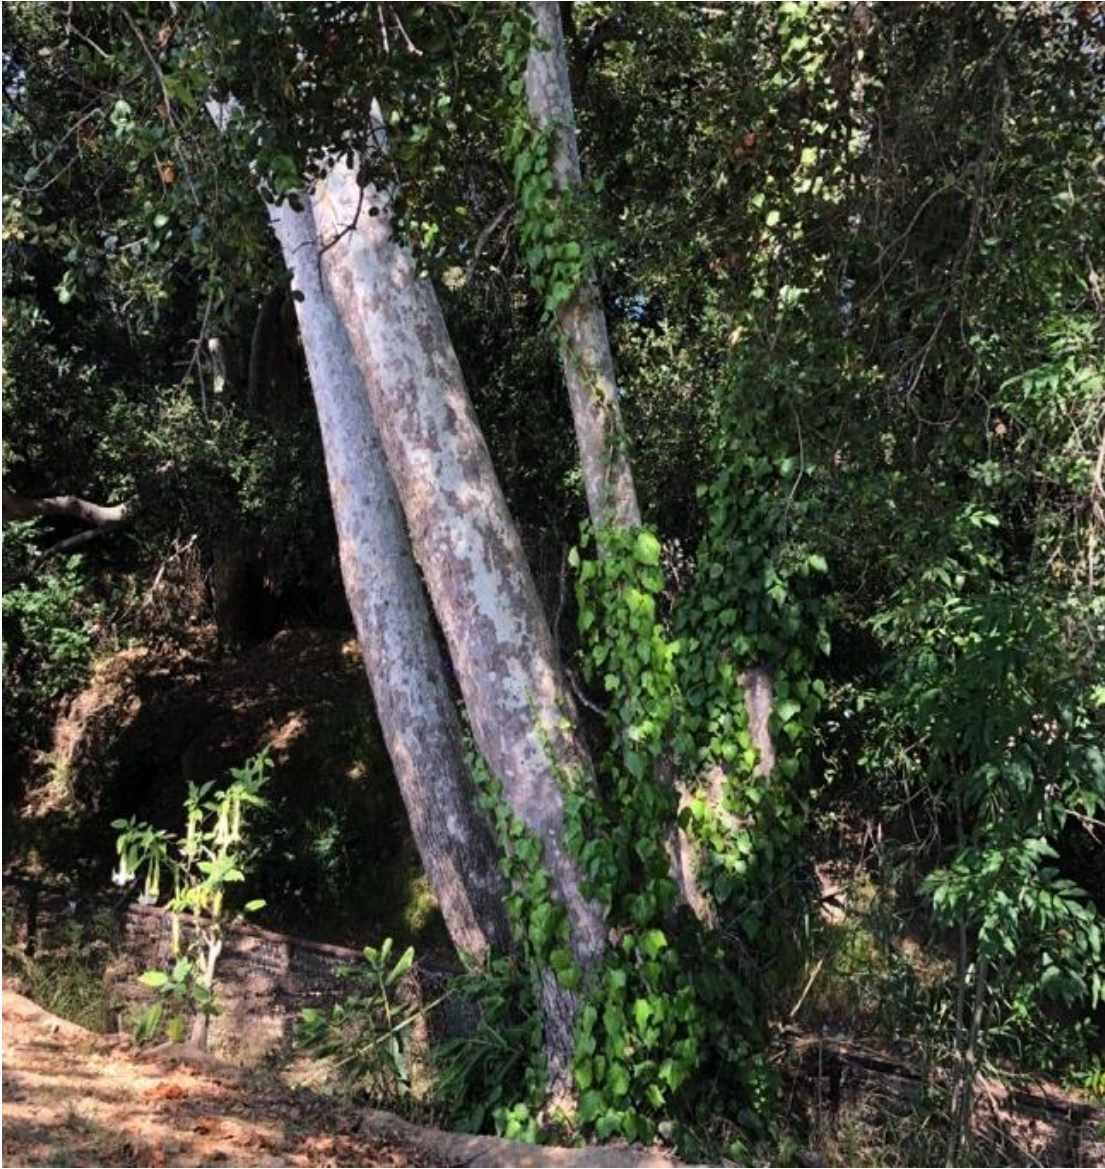
Figure 22. Algerian ivy suffocating a California sycamore tree on the bank of San Jose Creek.

- **Recommendation San Jose A5A:** Eradicate the Algerian Ivy along San Jose Creek, particularly around Jonny D. Wallis Park where the largest western sycamore (*Platanus racemosa*) in the USA resides.
- **Community Benefits:** Recommendation San Jose A5A will support the ecosystem around San Jose Creek and protect the largest California sycamore tree in the nation. This recommendation will increase public interest and education about native creek ecosystems.
- **Next Steps:** Discuss eradication efforts of invasive Algerian ivy with City Parks, SBCFCWCD, and habitat restoration agencies.

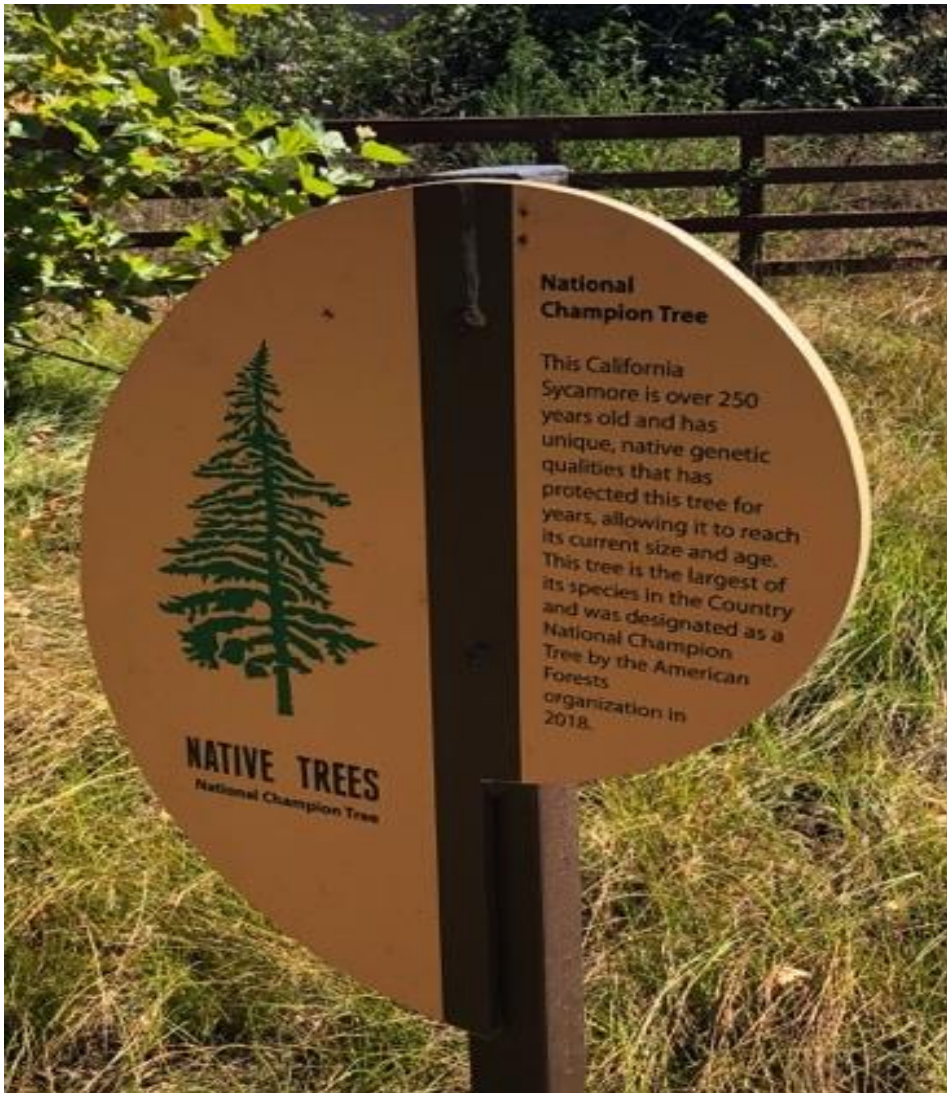
Figure 23. Description of the largest western sycamore tree in the USA, located adjacent to Jonny D. Wallis Park on San Jose Creek.

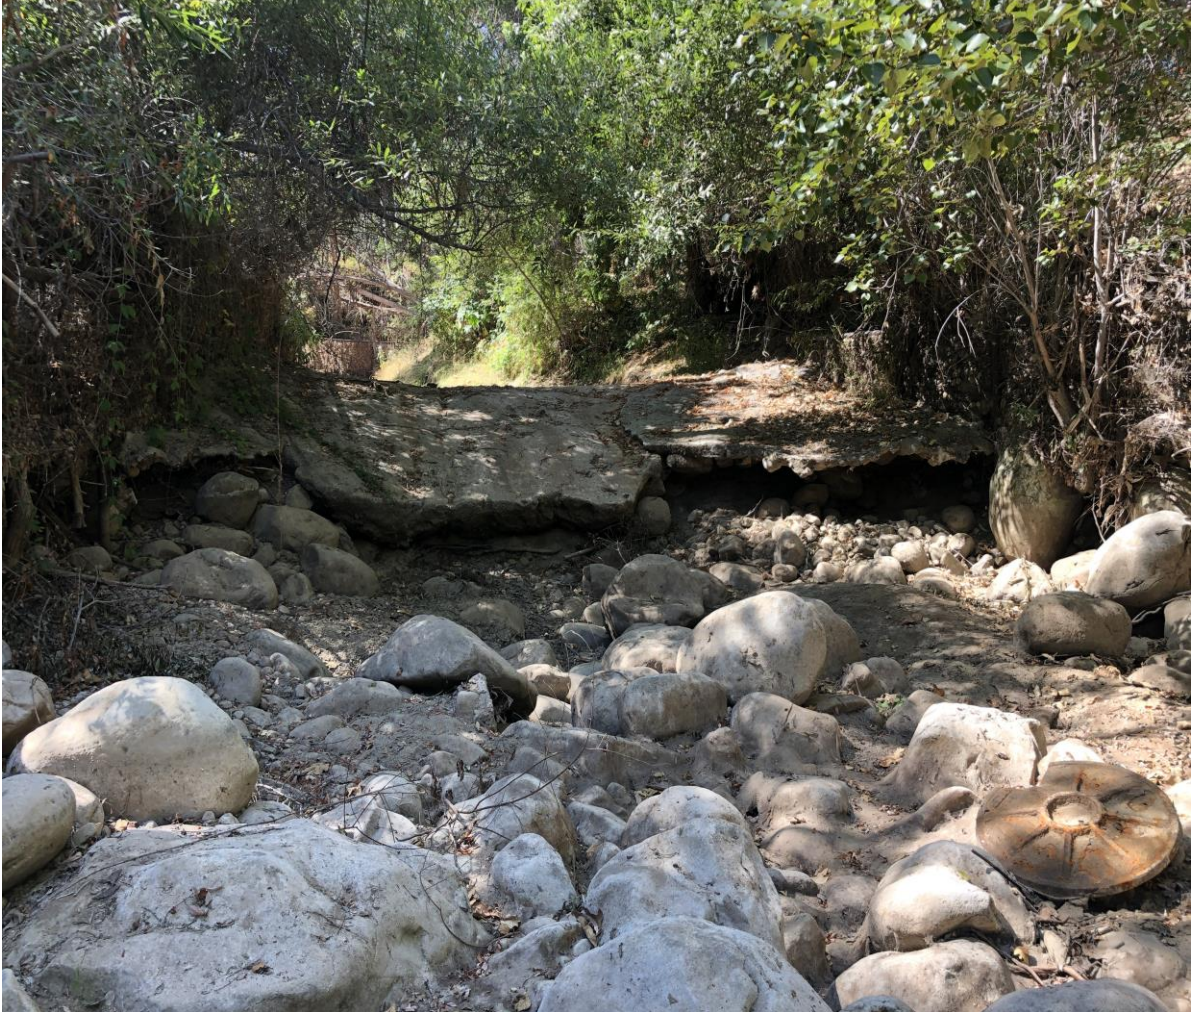
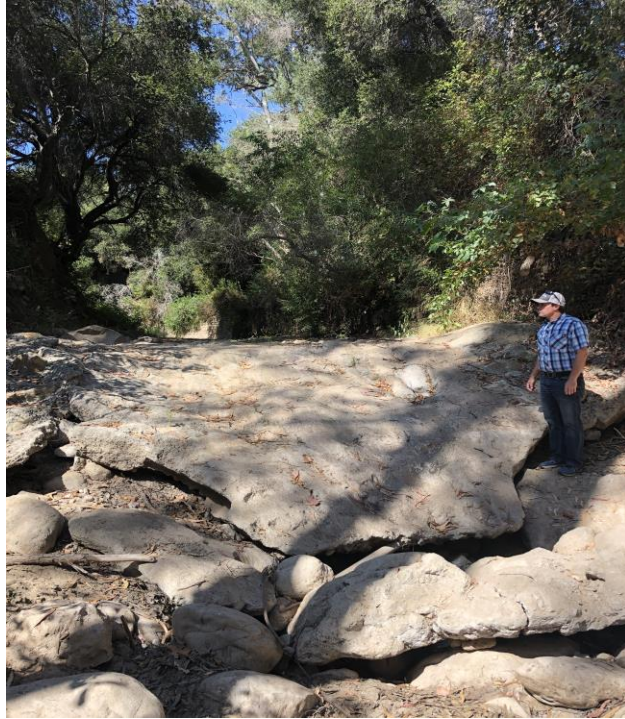
- Undercut Concrete Dams
  - **Problem Maria Ygnacio A1:** The flow of Maria Ygnacio Creek has undercut several old, possibly obsolete concrete dams located downstream from Cathedral Oaks Road. These dams impair migration of the endangered southern California steelhead due to the height of the dams above the Creek bed.

Figure 25. This obsolete concrete dam inhibits southern steelhead migration south of Cathedral Oaks Road.

Figure 26. A second concrete dam in Maria Ygnacio Creek.

- **Recommendation Maria Ygnacio A1A:** Remove the concrete dams to eliminate impediments to steelhead, if feasible, or modify the Creek channel to eliminate these migratory impediments.
  - **Community Benefits:** Recommendation Maria Ygnacio A1A will enhance the migratory corridor for endangered southern California steelhead by allowing them to migrate to spawning grounds located in perennial reaches of the Creek upstream from Cathedral Oaks Road.
  - **Next Step:** Identify the owner of the dams. Contact SBCFCWCD regarding the feasibility of removing the dams.
- Stormwater Run-off from Foothill Elementary School
    - **Problem Maria Ygnacio A2:** The large asphalt playground at Foothill Elementary School is slanted so that storm water will flow directly into Maria Ygnacio Creek.
