# **GOLETA'S CREEKS AND WATERSHEDS: OPPORTUNITIES FOR ENHANCEMENT AND RESTORATION**

**\*2020 ADDENDUM\***

## **ENVIRONMENTAL DEFENSE CENTER GOLETA WATERSHED PROTECTION AND EDUCATION PROGRAM**

**June 10, 2020**

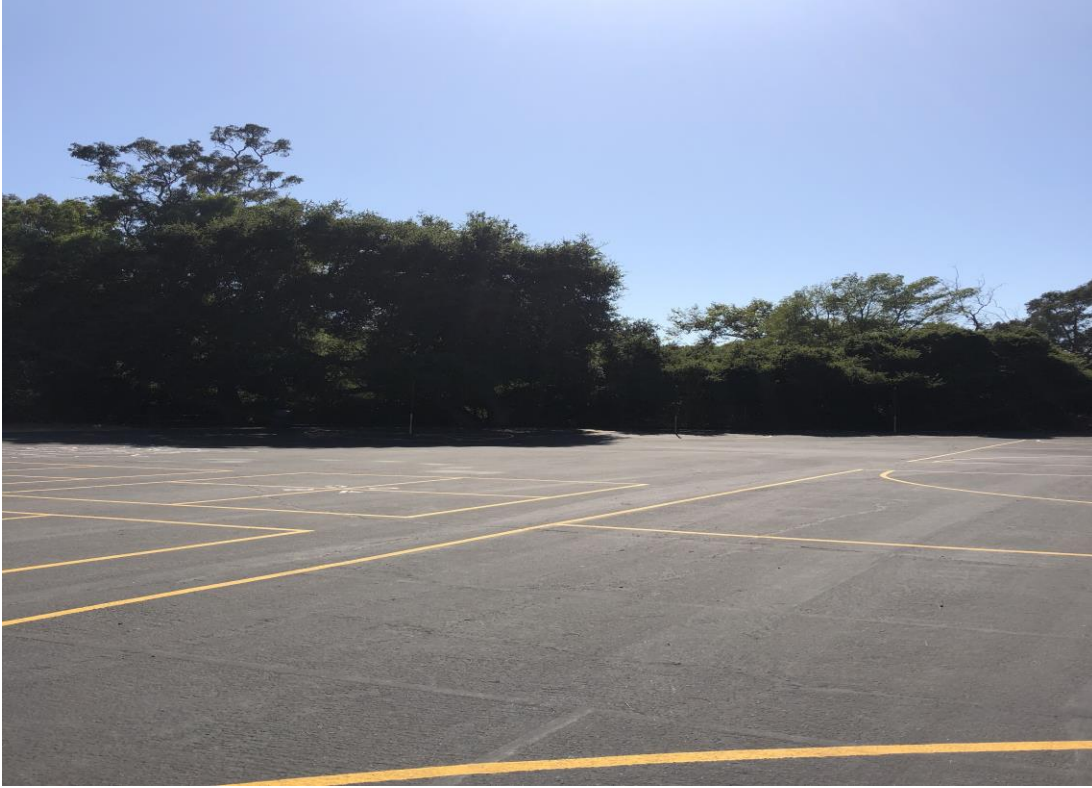
Figure 28. The asphalt playground at Foothill Elementary School directs stormwater runoff to Maria Ygnacio Creek.

- **Recommendation Maria Ygnacio A2A:** Install a bioswale between the playground and the Creek. Bioswales are drainages comprised of living plants, and they naturally filter stormwater runoff so that it is less polluted when it enters the flowing Creek where fish and other wildlife reside.
- **Community Benefits:** Recommendation Maria Ygnacio A2A will increase community engagement in the Creek's health, improve water quality, increase aesthetic appeal, and enhanced habitat for fish and wildlife. The Foothill School community can get involved in this solution by educating students about watersheds and helping to create the bioswale.
- **Next Step:** Contact Foothill Elementary School and County Project Clean Water to discuss the possibility of creating a bioswale.

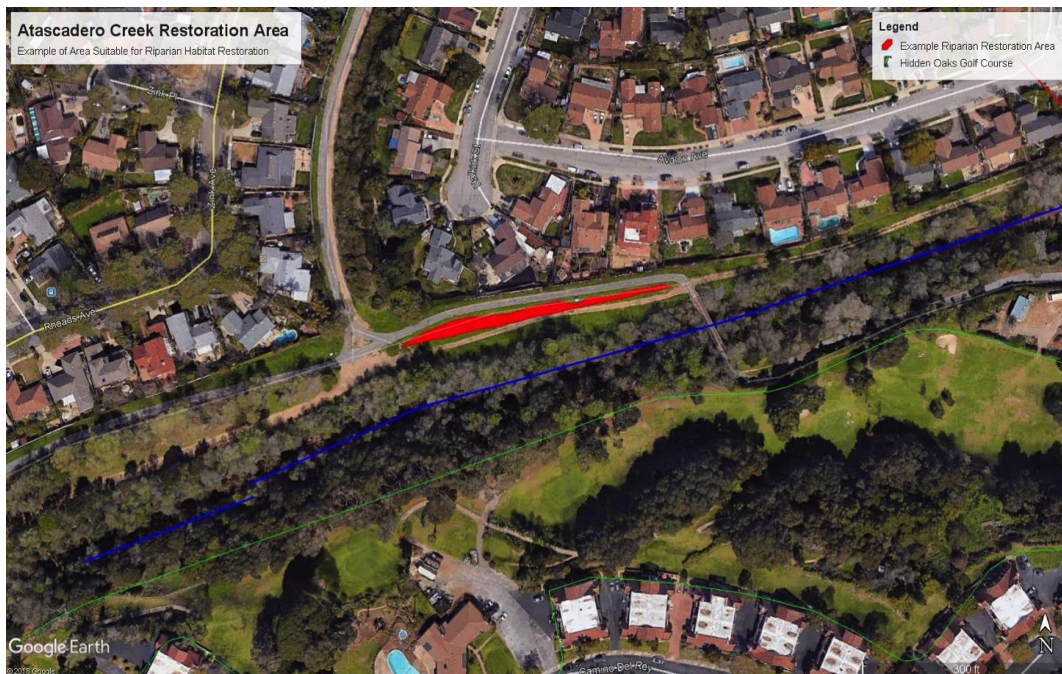
Figure 30. Example of a potential riparian restoration site along Atascadero Creek Bike Path near Turnpike Avenue and Zinc Avenue.

- **Recommendation Atascadero A2A:** Restore the unvegetated areas between the Creek and the Atascadero Bike Path near Turnpike Avenue and near the southern terminus of Gwynne Avenue, leaving room for SBCFCWCD equipment access and avoiding existing utilities where necessary.
- **Community Benefits:** Recommendation Atascadero A2A will greatly enhance the riparian habitat and protect the

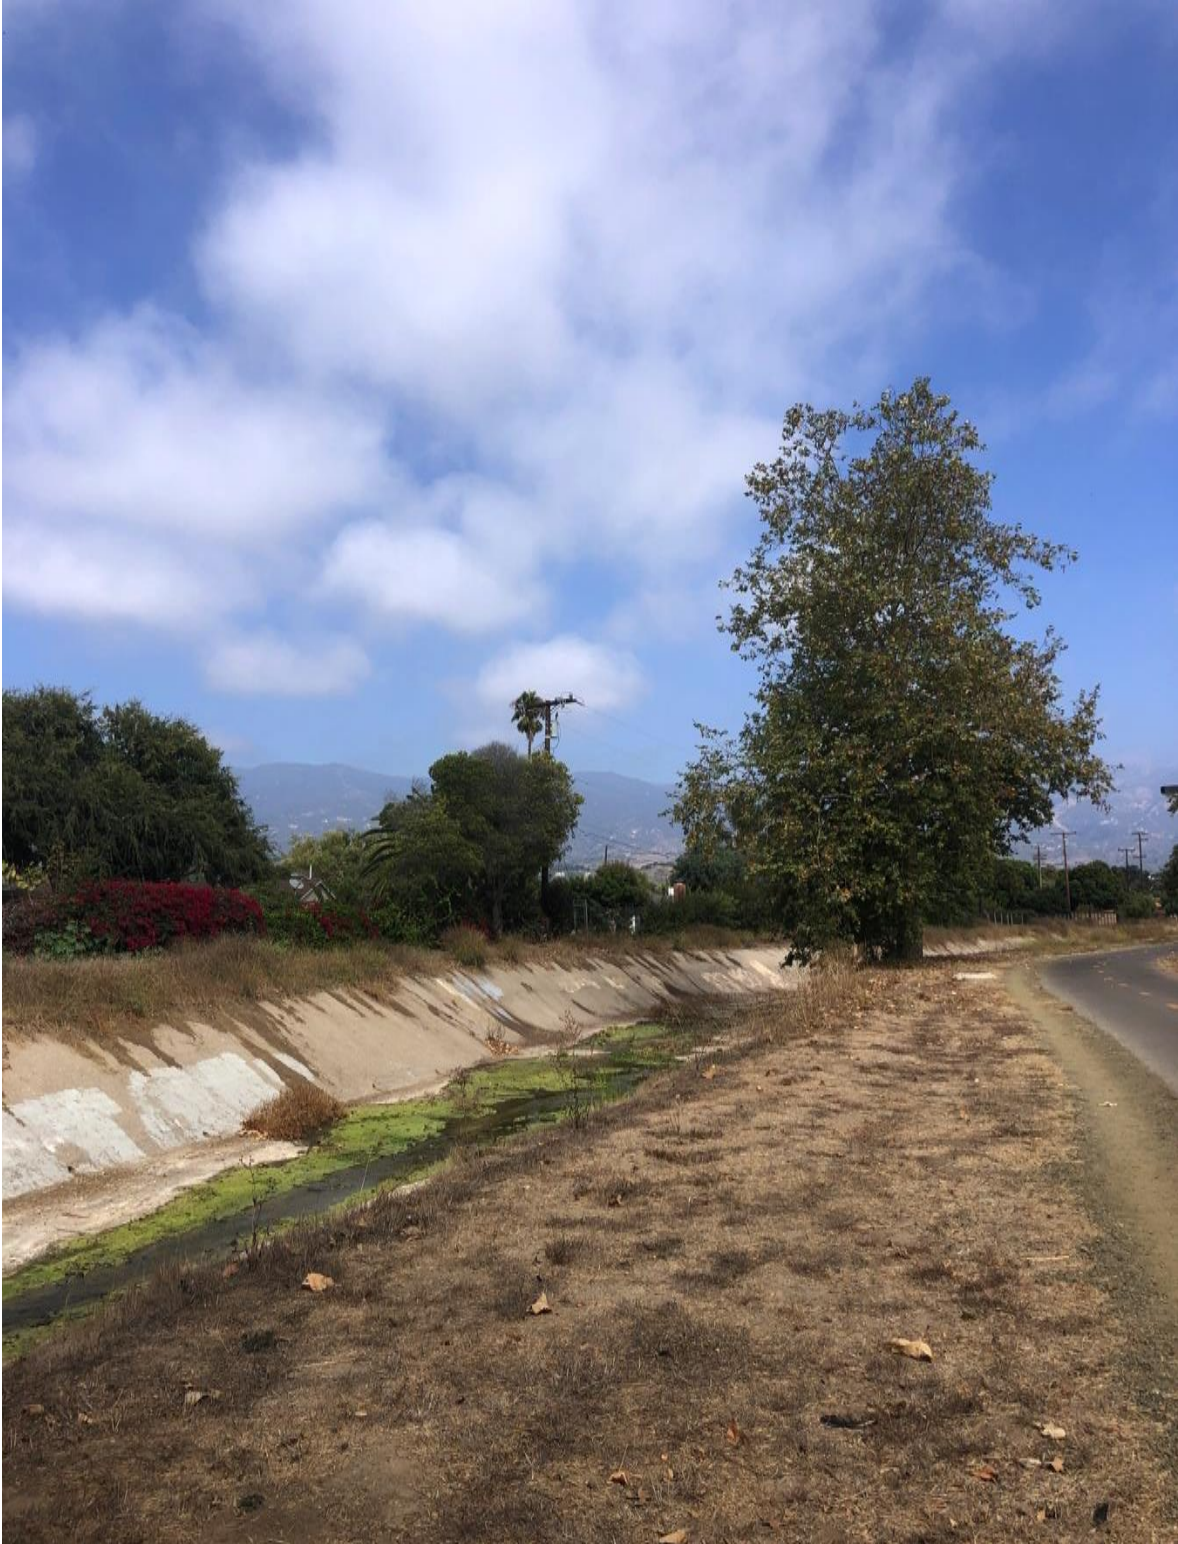
- **Problem Atascadero A3:** The section of Atascadero Creek starting below Puente Road and extending upstream to Arroyo Road is over-saturated with sun, heating the water and causing algal blooms, which can result in a lack of dissolved oxygen available for the survival of fish.
  - **Recommendation Atascadero A3A:** Plant appropriate native trees including willows (*Salix*), western sycamores (*Platanus racemosa*) and coast live oaks (*Quercus agrifolia*) that will shade Atascadero Creek.
  - **Community Benefits:** Recommendation Atascadero A3A will improve aesthetic quality of the area, shade the Creek to keep the water cool and support steelhead, lessen algae blooms, and enhance the Creek's riparian ecosystem.

Figure 31. This section of Atascadero Creek near Puente Drive is exposed to sunlight, which heats the water and harms fish and wildlife. Planting trees to shade this section of the Creek would greatly enhance the Creek and riparian habitat.

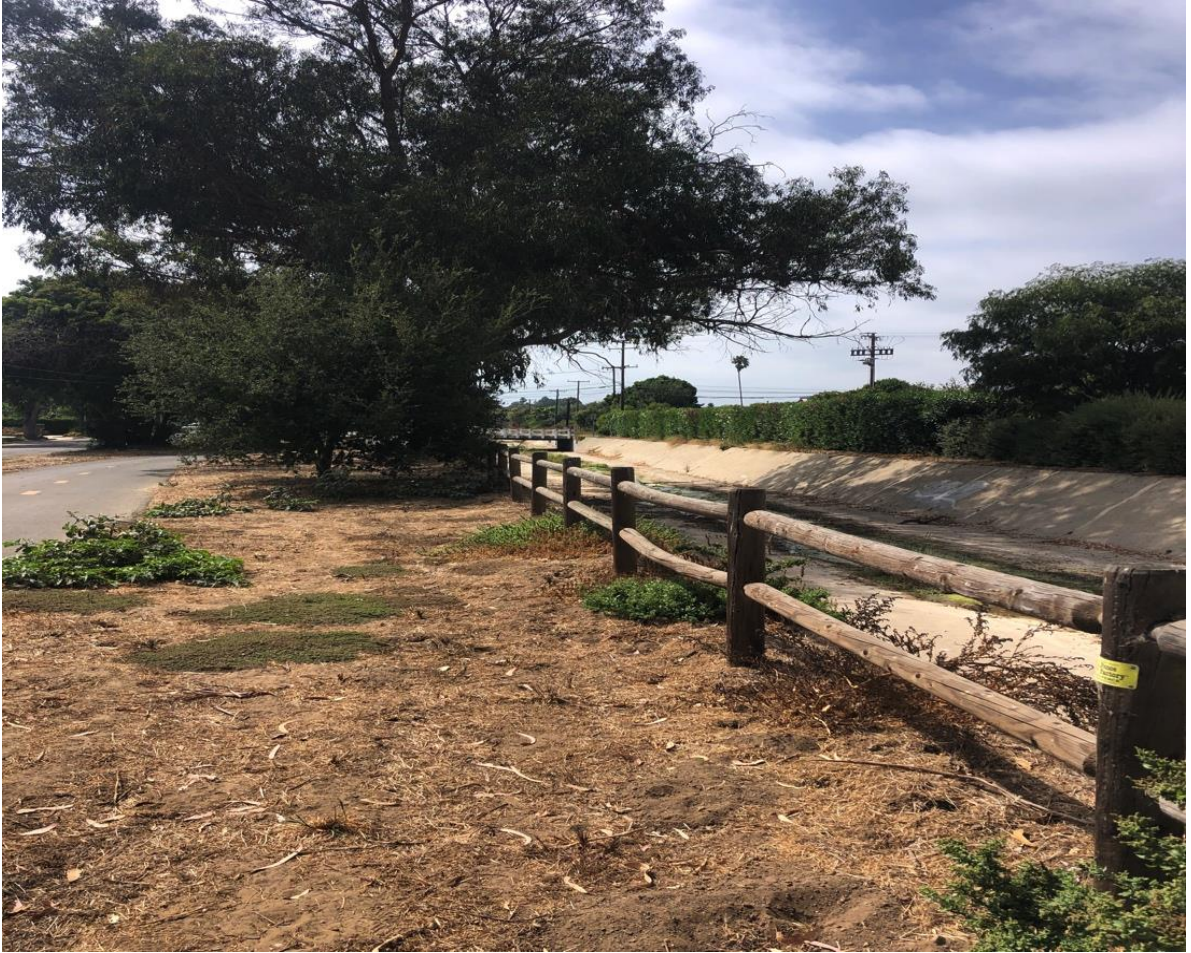
Figure 32. There are already several oak trees providing shade along Atascadero Creek near Puente Avenue.

- **Next Steps:** Contact the Goleta Sanitary District to discuss the feasibility of planting additional trees given the nearby sewer line. If planting trees is feasible, identify the property owner to discuss restoring riparian habitat in this area.

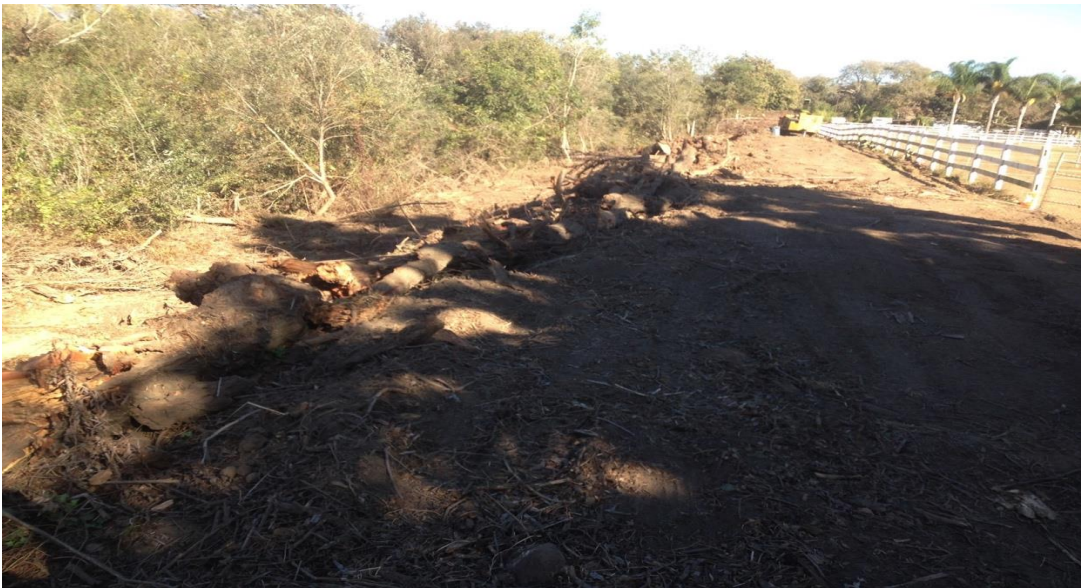
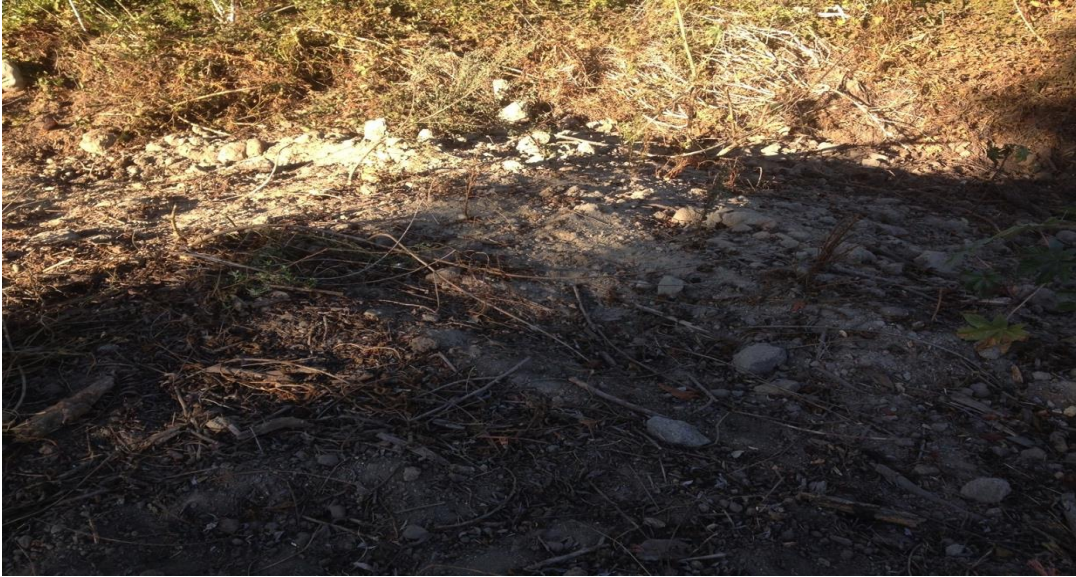
Figure 33. Riparian habitat destroyed along Atascadero Creek. November 4, 2019.

Figure 34. Cement or other material dumped over the bank of Atascadero Creek.

- **Recommendation Atascadero A5A:** EDC reported the clear-cut riparian habitat to the California Coastal Commission (“CCC”) enforcement staff and CDFW as a violation of the Santa Barbara County Local Coastal Plan and the Fish and Game Code. These agencies’ enforcement actions should be monitored to ensure that the area is restored with local native plants, the compensatory habitat mitigation ratio is at least 3:1, and the illegal dump is cleaned up. To be most effective, habitat restoration should occur onsite. Additional restoration that may be required should occur along Atascadero creek in the vicinity of this clearing. EDC recommends that the cleared habitat area and the area between the cleared habitat and the equestrian facility, and other onsite areas as needed, be restored to mitigate the impacts and achieve a minimum 3:1 ratio. All mitigation sites should be placed in a permanent conservation easement or otherwise subject to permanent preservation.

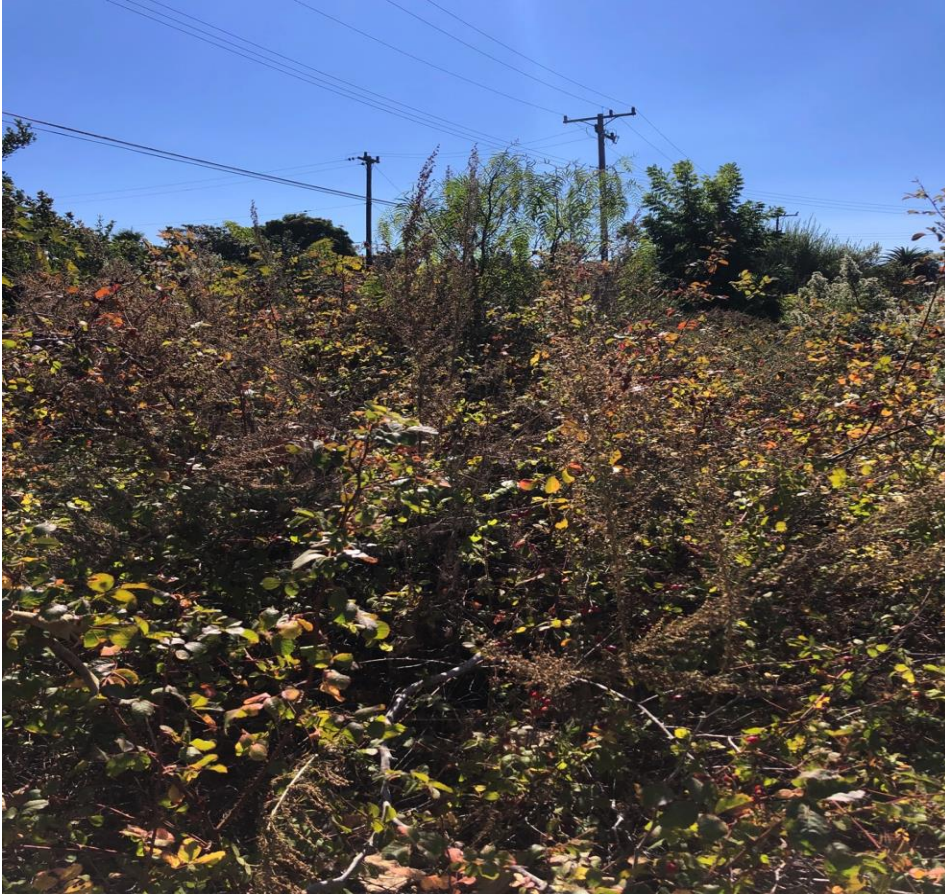
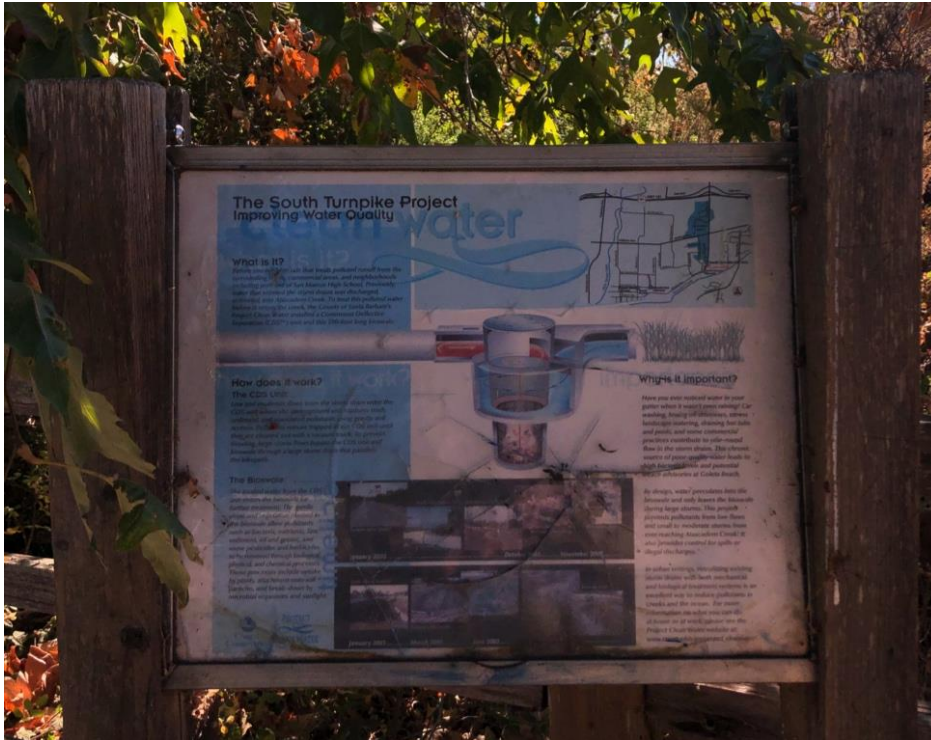
- South Turnpike Project Bioswale Restoration
  - **Problem Atascadero 6:** Santa Barbara County's South Turnpike Bioswale contains invasive non-native plants. The informational sign is compromised, rendering it difficult to read.

Figure 35. The Atascadero Creek Bioswale on South Turnpike Road contains non-native plants such as the Peruvian pepper tree sapling pictured above silhouetted against the blue sky between the telephone poles.

Figure 36. The Plexiglas on South Turnpike Bioswale Project's informational sign is cracked.

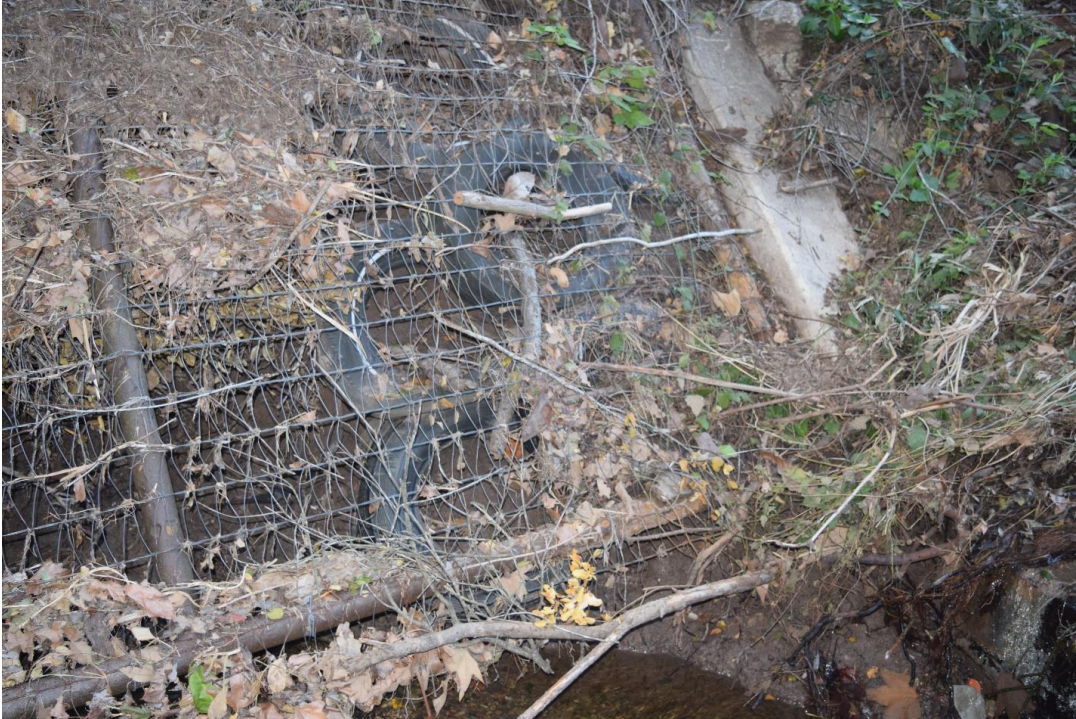
Figure 39. Pipe and wire revetment undercut by erosion in San Pedro Creek.

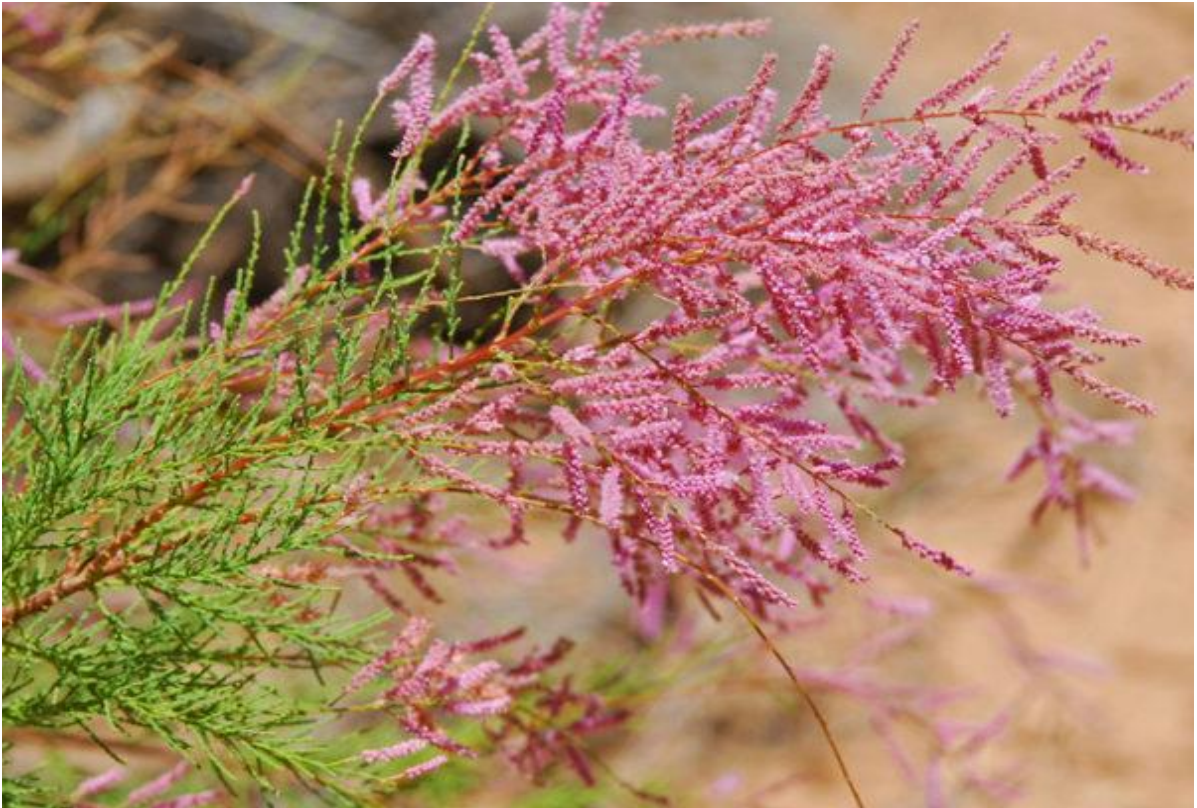
- **Problem Global A4:** Invasive exotic aquatic species, including the bullfrog, green sunfish, and crayfish inhabit some of Goleta's creeks. They prey on native fish and wildlife species and compete with native fish and wildlife species for resources, which contributes to the decline of native species. Invasive exotic plant species such as *Arundo donax* and castor bean outcompete native plants, displacing wildlife habitat, and degrading the environmental values of our watersheds.

Figure 41. A photo of invasive tamarisk. Tamarisk is spreading along Goleta's creeks, displacing native riparian vegetation. Sourced from the California Invasive Plant Council. (<https://www.cal-ipc.org/plants/profile/tamarix-chinensis-profile/>)

- **Recommendation Global A4A:** Eradicate bullfrog, green sunfish, and crayfish from Goleta's creeks.
- **Recommendation Global A4B:** Remove, control, and/or eradicate exotic invasive plant species from the Goleta Watershed. Gradually replace these invasive non-native plant

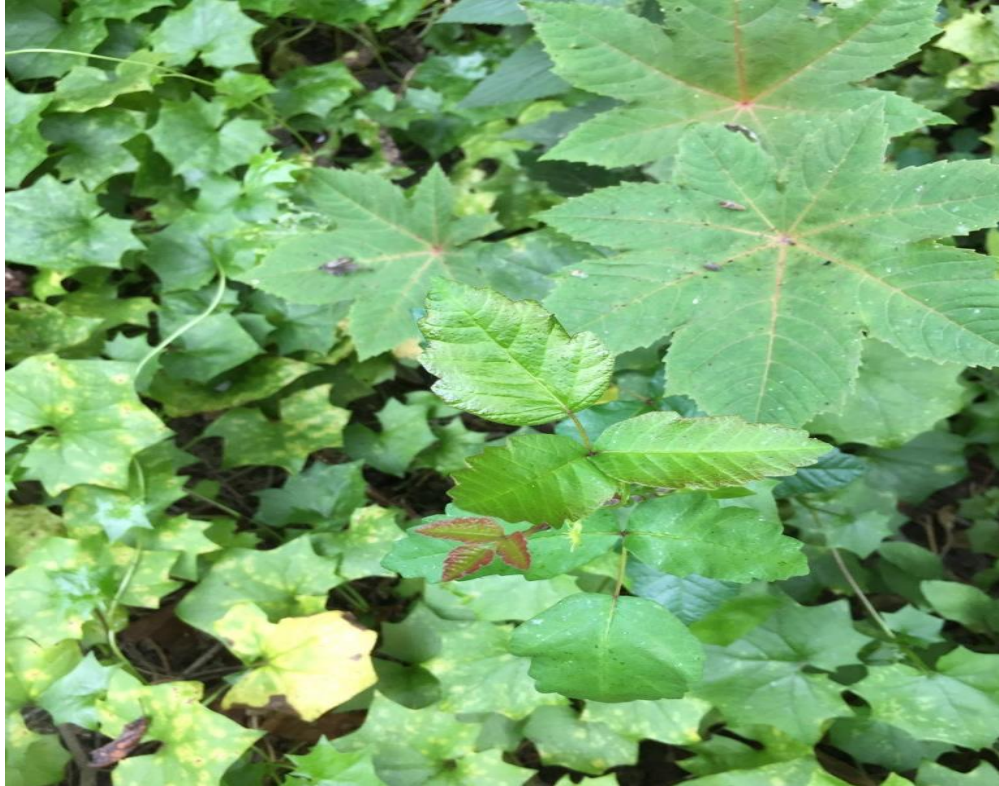
Figure 42. A photo of invasive castor bean and cape ivy. Sourced from Morro Bay National Estuary Program. (<https://www.mbnep.org/2017/09/08/poison-oak-natures-immune-response/>)

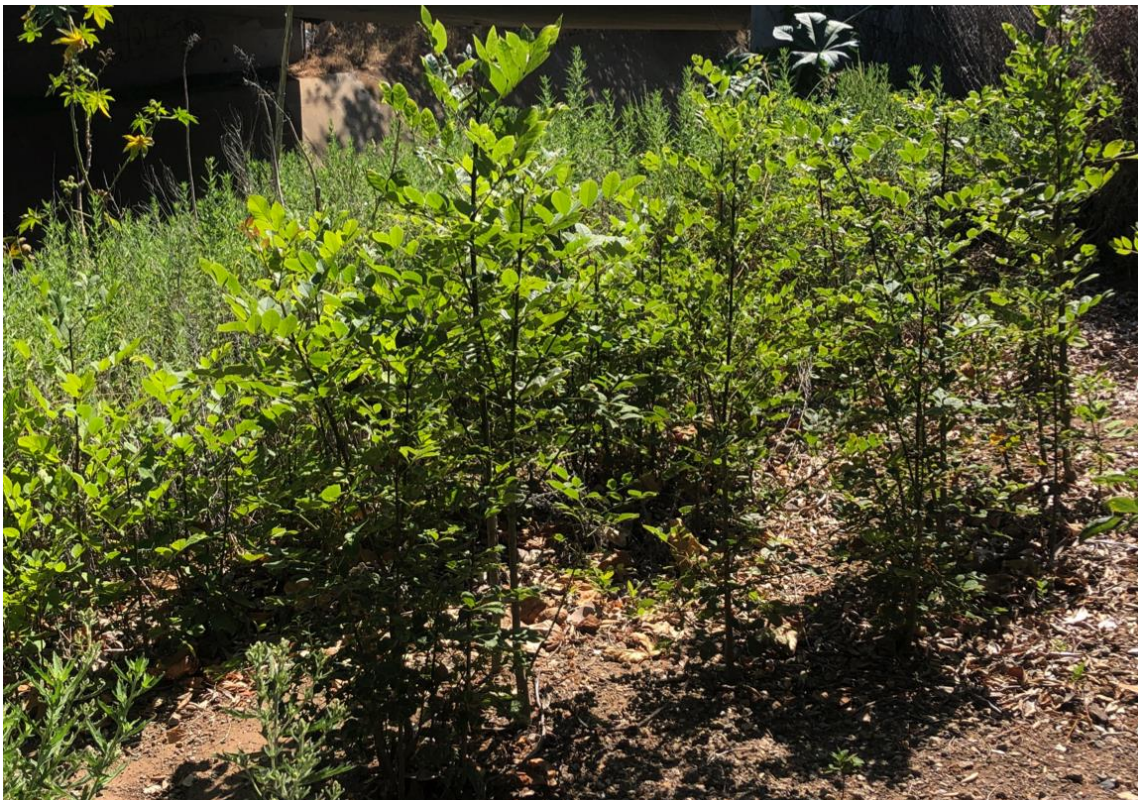
Figure 43. A photo of invasive ash tree saplings.

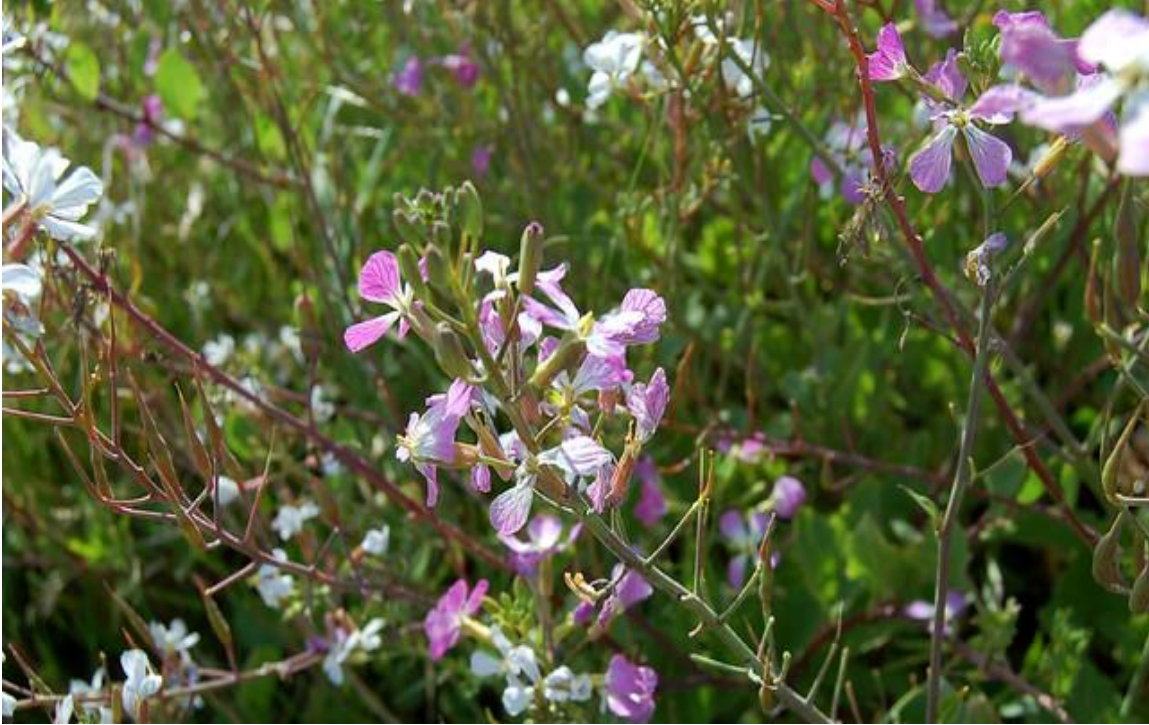
Figure 44. A photo of invasive wild radish. Sourced from KQED Quest. (<https://ww2.kqed.org/quest/exploration/view/319>)

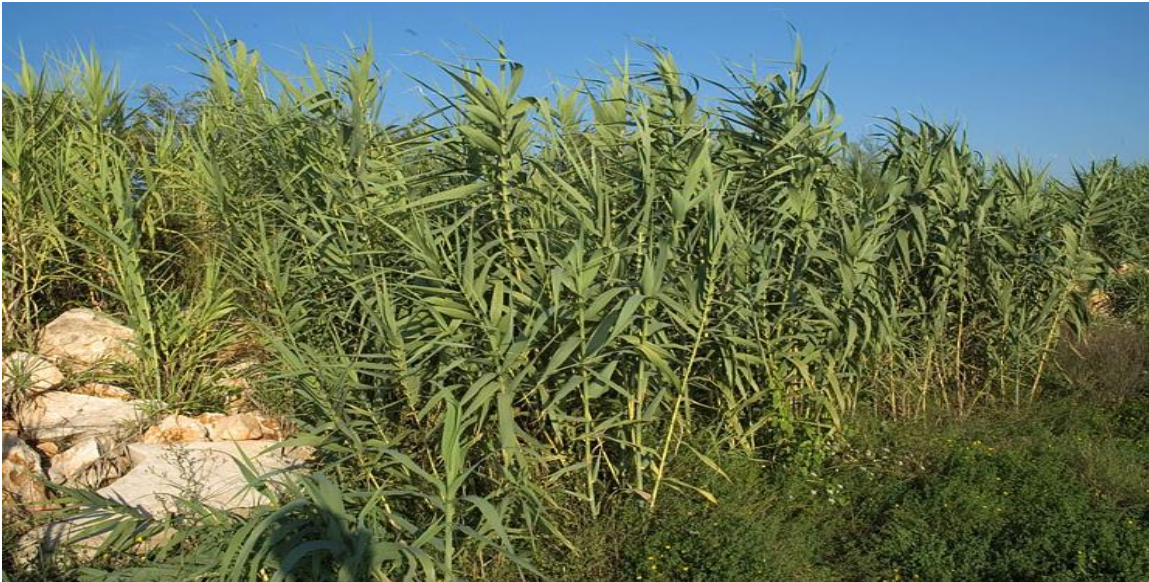
Figure 45. Invasive giant reed. (*Arundo donax*) From California Invasive Plant Council. (<https://www.cal-ipc.org/solutions/wmas/san-luis-obispo-wma/>)

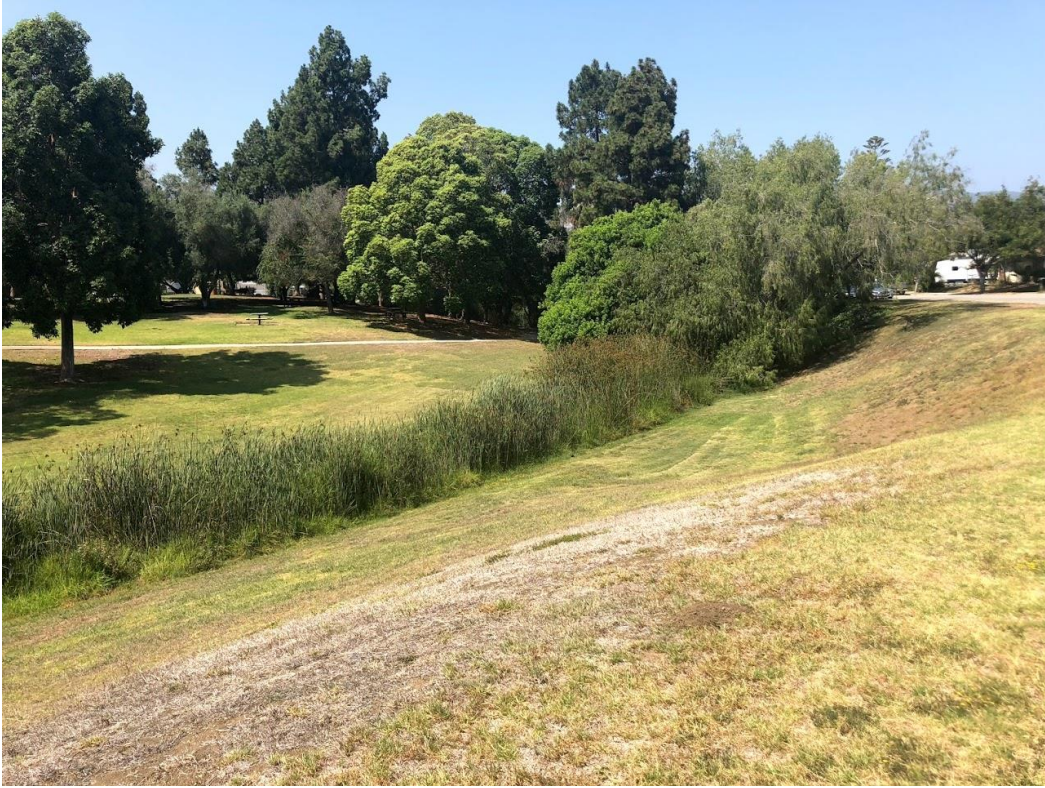
Figure 47. Exotic trees planted along and near Bella Vista Creek's SPA in the Devereux Watershed.
