San Jose Creek Flood Control Revegetation Sites **And Los Carneros Mitigation Bank** **Review and Recommendations**

ENVIRONMENTAL DEFENSE CENTER
October 24, 2022

Natalie Blackwelder, EDC Watershed Program Intern
Brian Trautwein, Senior Analyst / Watershed Program Director

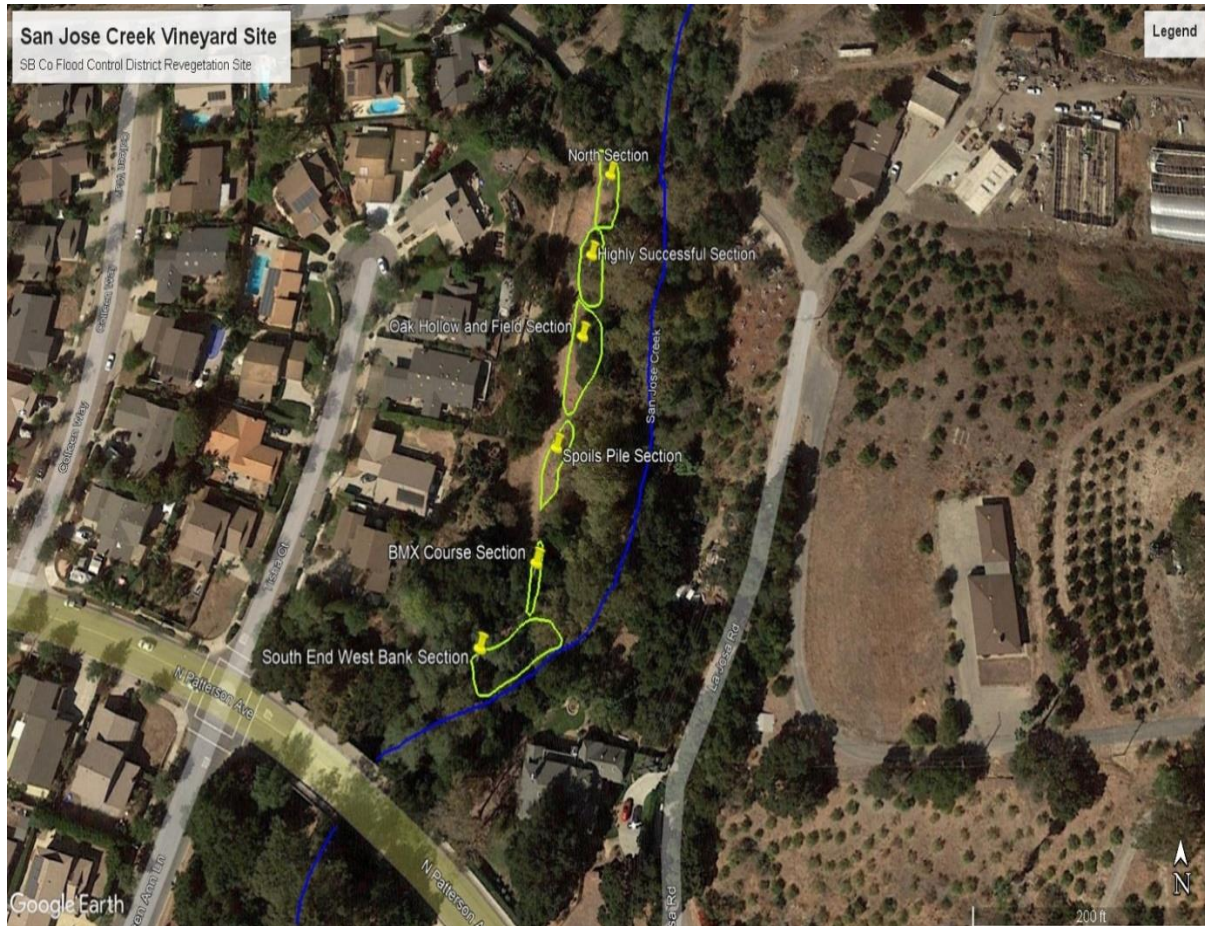
Figure 1. EDC divided the Vineyard Road revegetation site into six sections for evaluation. Google Earth. 2021.

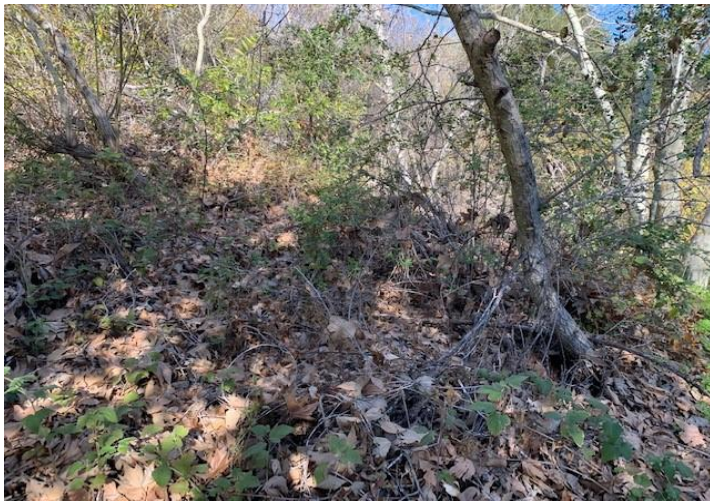
Figure 2. North End of Vineyard Site. Successful establishment of blackberry understory with gooseberry in center of photo. Trautwein. January 25, 2022.

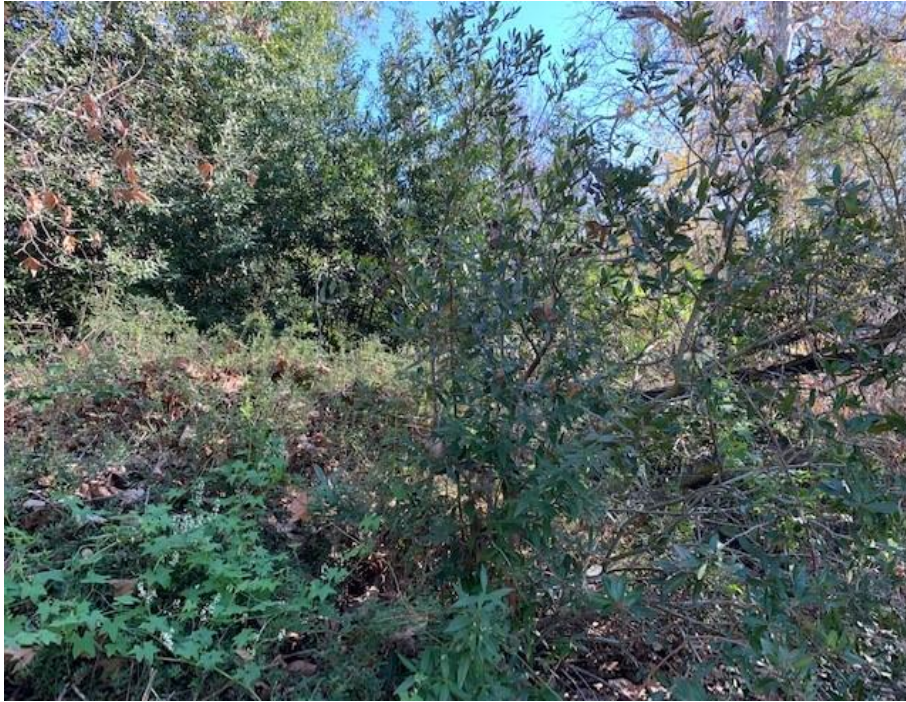
Figure 4. North end of Vineyard Site looking southeast. Successful establishment of toyon and Santa Barbara honeysuckle. Trautwein. January 25, 2022.

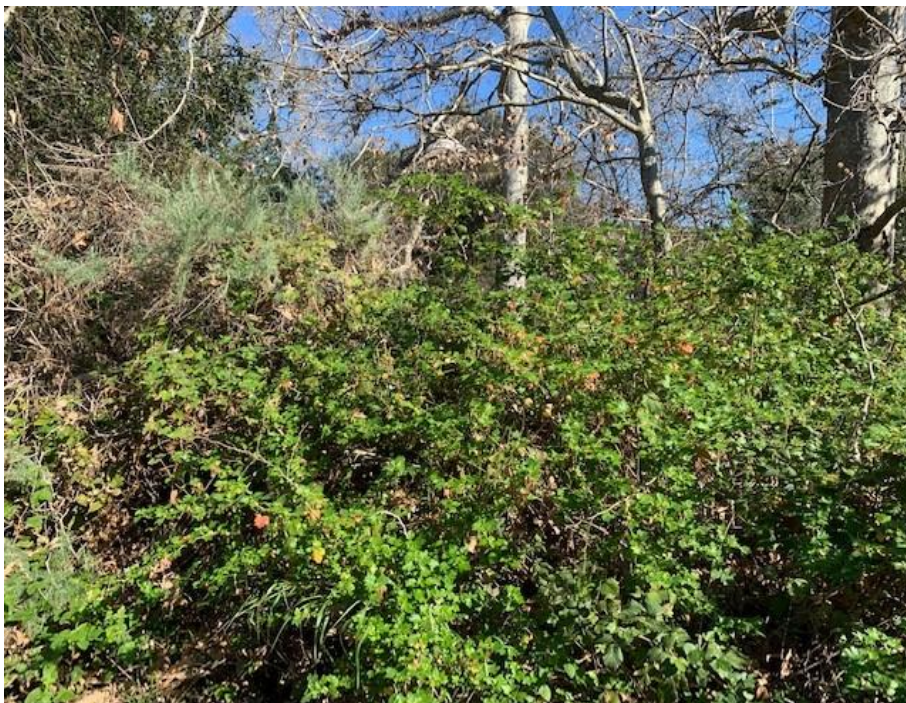
Figure 5. Highly Successful Section of Vineyard Site with estimated 95% cover (estimated 2,850 square feet out of 3,000 square feet). Gooseberry and California sage. Trautwein. January 25, 2022.

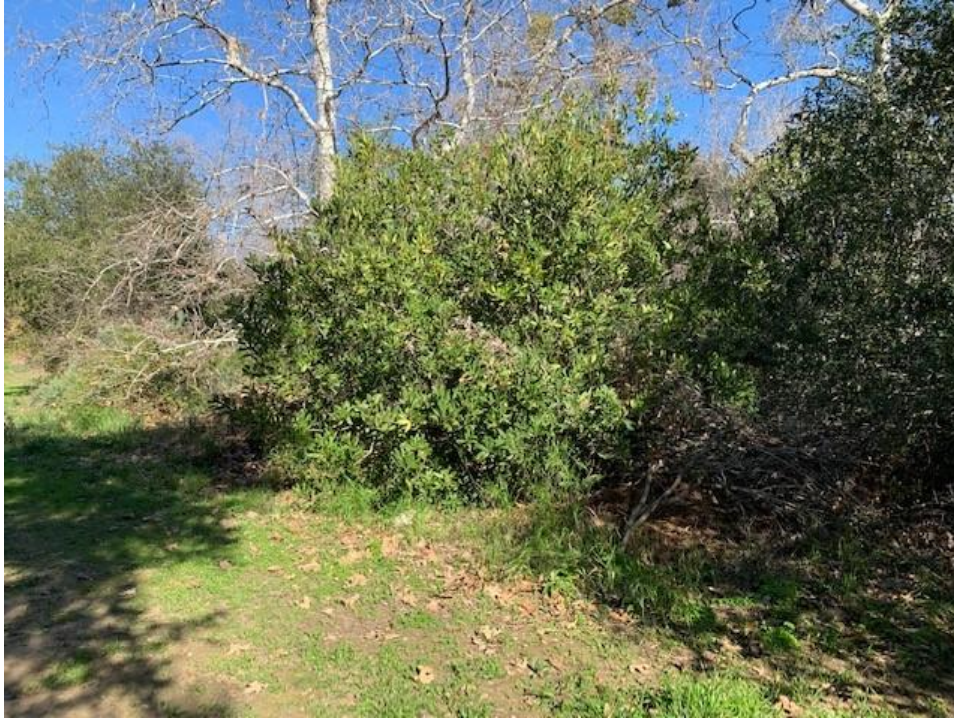
Figure 6. Southwest edge of Highly Successful Section of Vineyard Site looking north by northeast. Large toyon in center of image. Note lack of native vegetation between toyon and trail in lower left and bottom portions of photo. Trautwein. January 25, 2022.

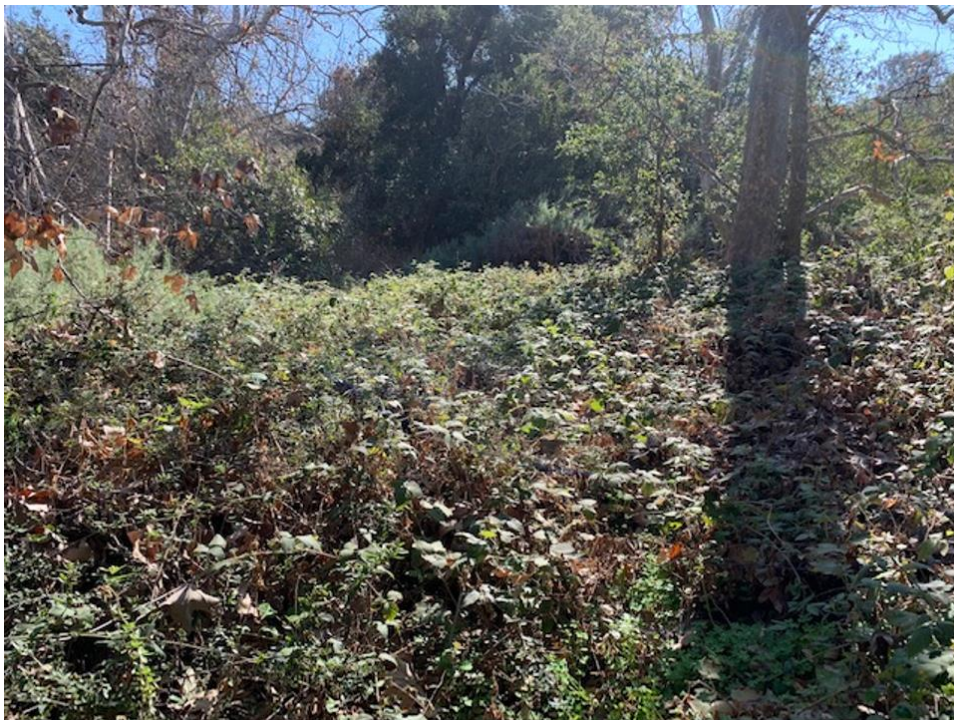
Figure 7. Highly Successful Section of Vineyard Site looking south across area with nearly 100% native cover of blackberries and California sage. Trautwein. January 25, 2022.

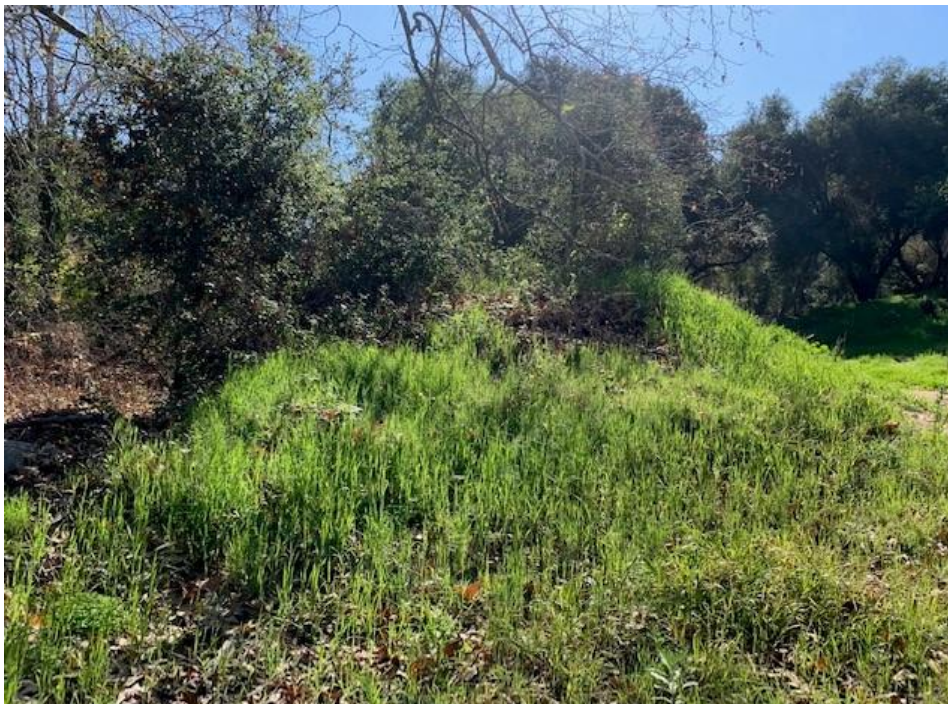
Figure 9. Spoil Pile Area Section with oaks established on spoil pile. Herbaceous layer is dominated by nonnative grasses. Scattered wild blackberry and mugwort also present. Trautwein. January 25, 2022.

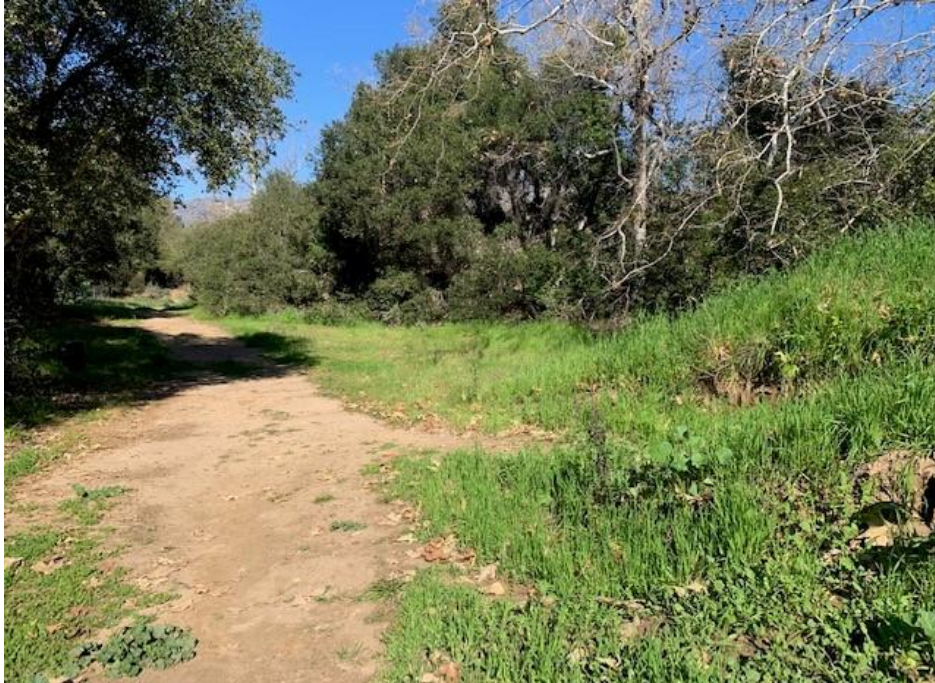
Figure 10. Spoil Pile Area Section (right side) looking north along trail to Field Section containing nonnative grasses and Oak Hollow Section (upper center). Trautwein. January 25, 2022.

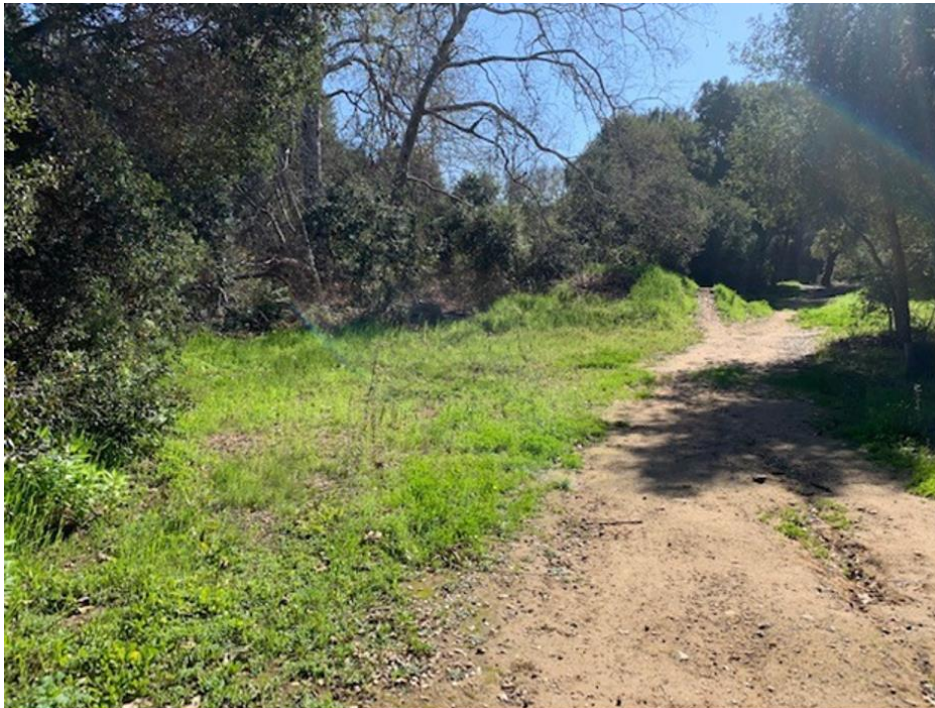
Figure 11. Field Section containing mostly nonnative weeds between Highly Successful Section (to left of picture), Spoil Pile Section (center right), east of trail, and west of San Jose Creek bank. Trautwein. January 25, 2022.

- Oak Hollow / Field
 - Plant fifty to eighty blackberries under the large oak tree's dripline. Cage plants using chicken wire to prevent vandalism.
 - Remove all grasses and weeds from field by removing for three consecutive years prior to seed set or solarize these invasives. Plant with fifty blackberries, three to five gooseberries, and four to six Santa Barbara honeysuckle plants. Cage to prevent vandalism.
 - Remove cages after five to ten years or once blackberries reach fifty percent cover. Remove cages using wire cutters to avoid damaging vines.

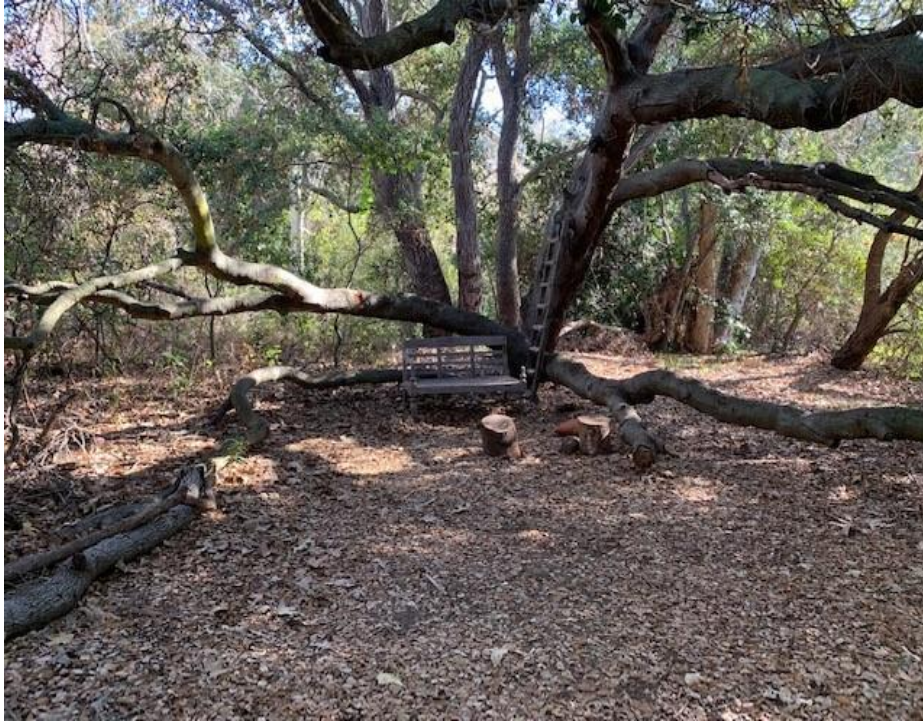
Figure 12. Oak Hollow Section. Scattered wild blackberry in understory. Lack of wild blackberry understory may be the result of vandalism. Trautwein. January 25, 2022.

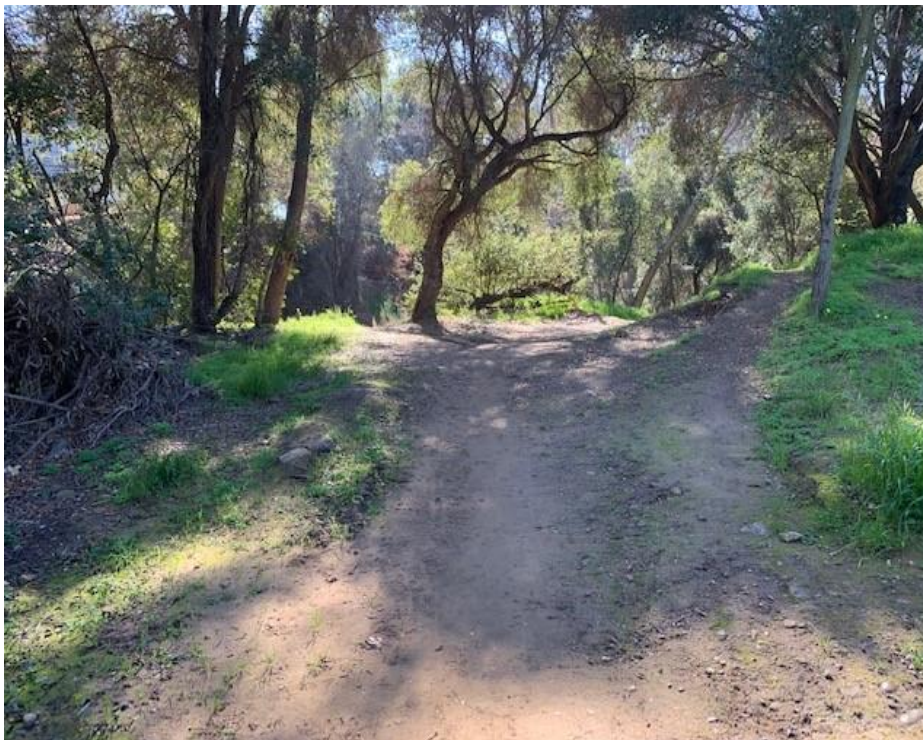
Figure 13. BMX Section. No native understory plants established likely due to BMX course established in this location and associated removal of native understory. Trautwein. January 25, 2022.

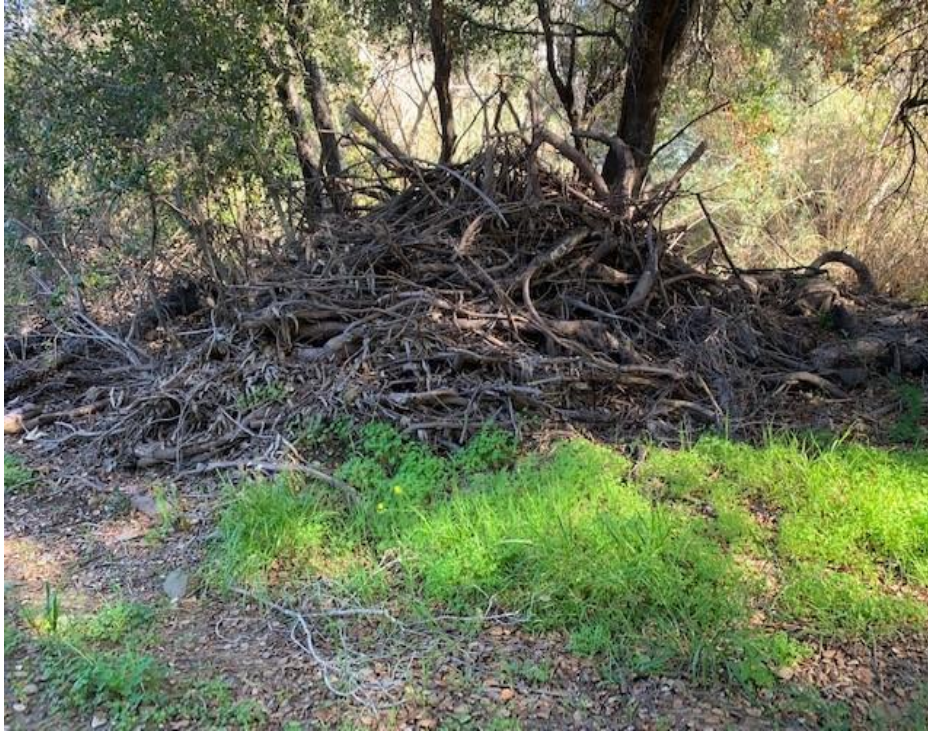
Figure 14. Pile of deadwood likely created during clearing of area to construct BMX course. Trautwein. January 25, 2022.

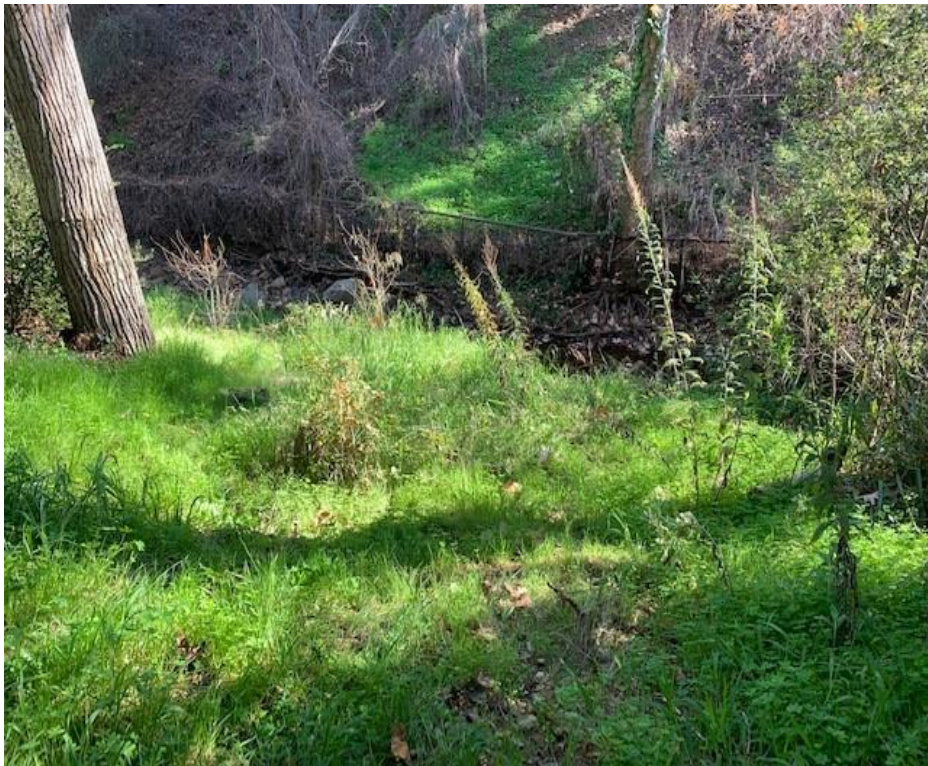
Figure 15. South End West Bank Section dominated by nonnative grasses. Note mugwort plants (tall thin plants center and right), and coast live oak and cottonwood saplings (orange flagging tape center left). Trautwein. January 25, 2022.

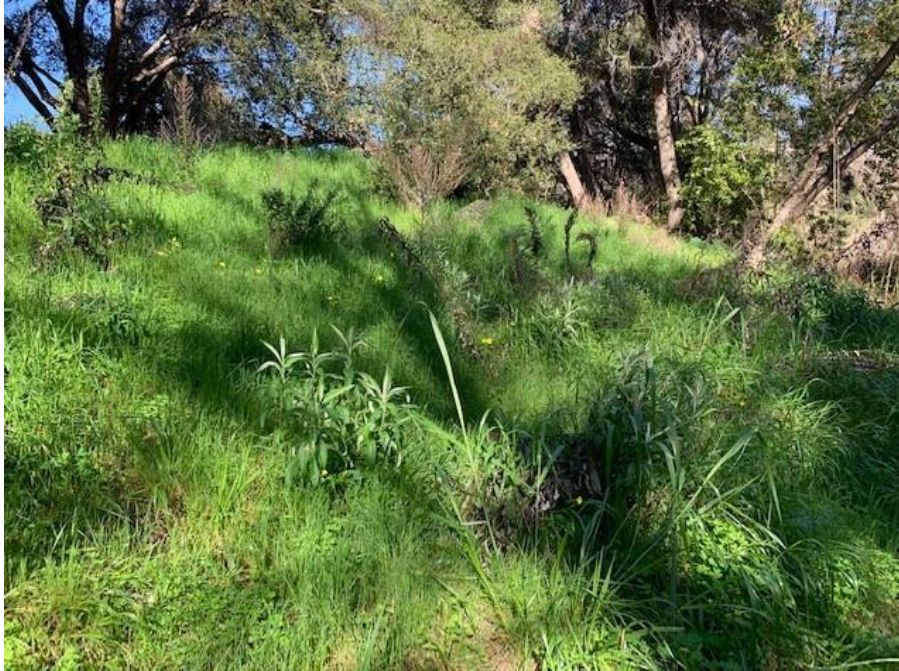
Figure 16. South End West Bank Section. Mugwort plants amidst dense nonnative grasses dominating this section of Vineyard Revegetation Site near North Patterson Avenue. Trautwein. January 25, 2022.

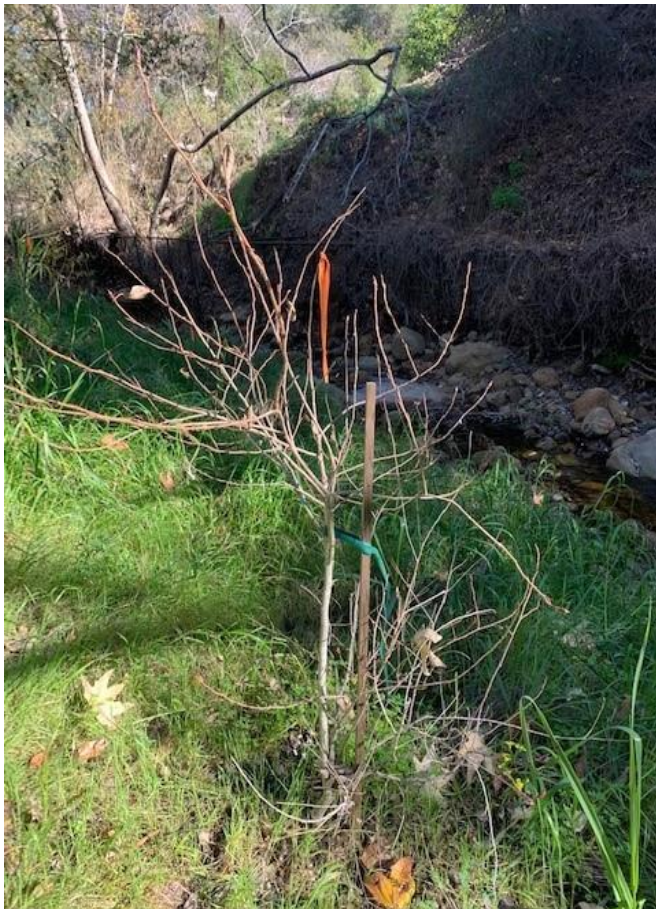
Figure 17. Small, four-foot tall, healthy black cottonwood sapling. South End West Bank Section. Trautwein. January 25, 2022.

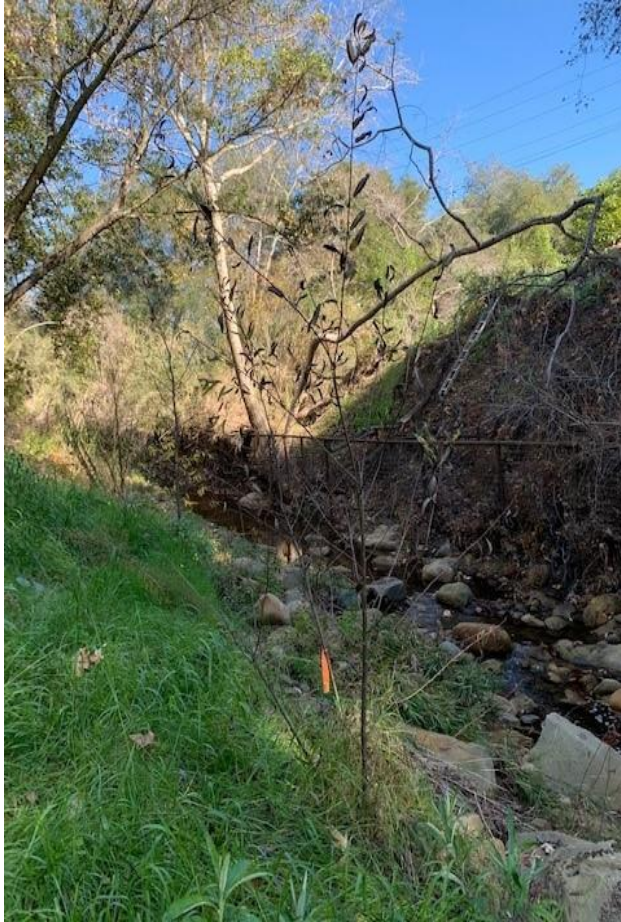
Figure 18. Successful willow saplings near toe of west bank at South End West Bank Section, near North Patterson Avenue. Note extensive nonnative grass understory. Trautwein. January 25, 2022.

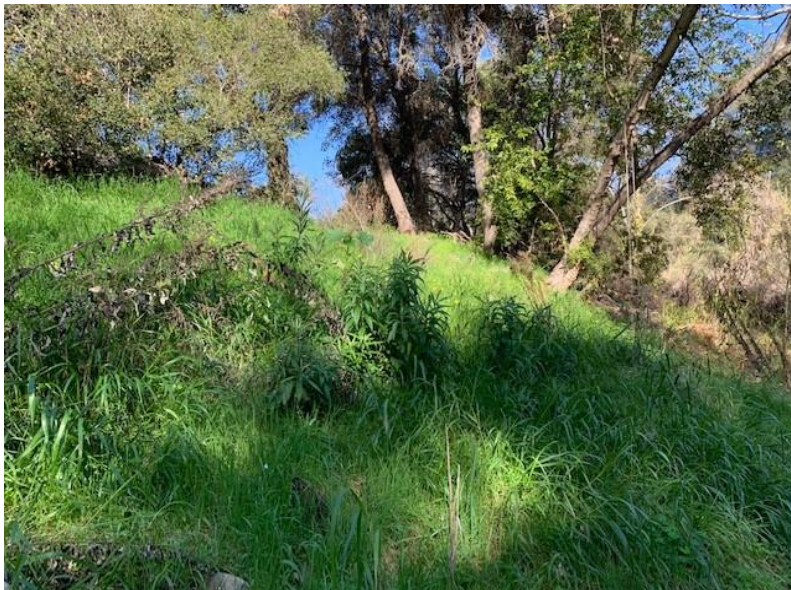
Figure 19. Scattered mugwort plants surrounded by dense nonnative grasses. South End West Bank Section near North Patterson Avenue. Trautwein. January 25, 2022.

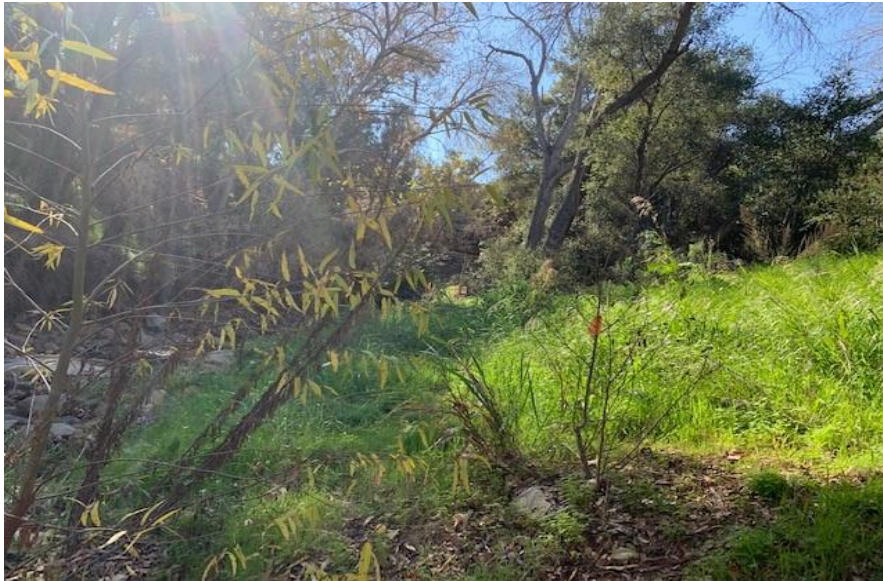
Figure 20. Successful willow sapling (left side of image) established on South End West Bank Section near North Patterson. Smaller cottonwood sapling to right of willow. Note extensive nonnative grasses. Trautwein. January 25, 2022.

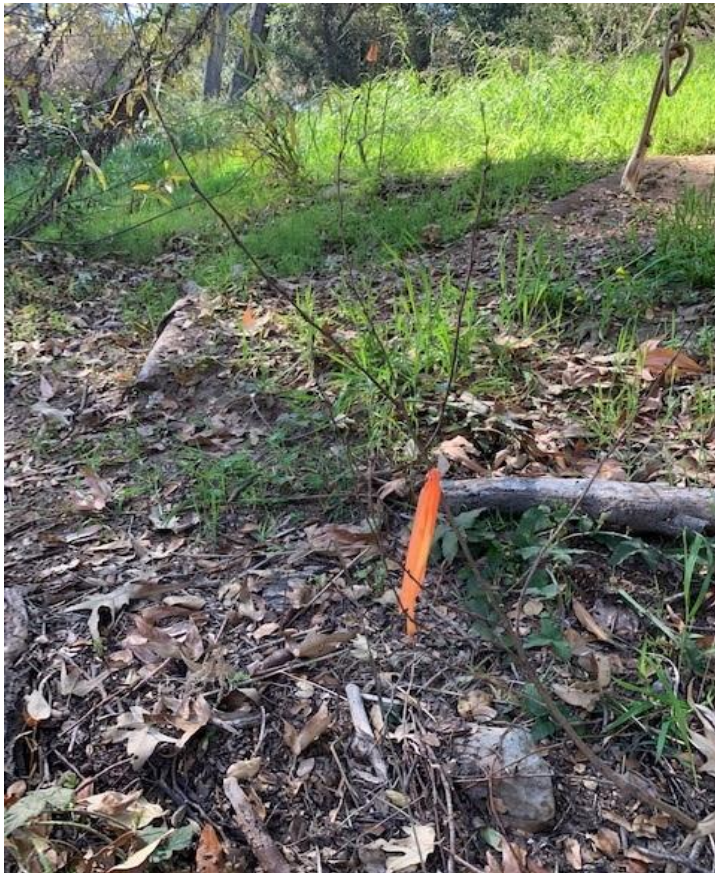
Figure 21. Small thirty-inch-tall black cottonwood sapling at South End West Bank Section of Vineyard Site. Note extensive nonnative grasses. Trautwein. January 25, 2022.

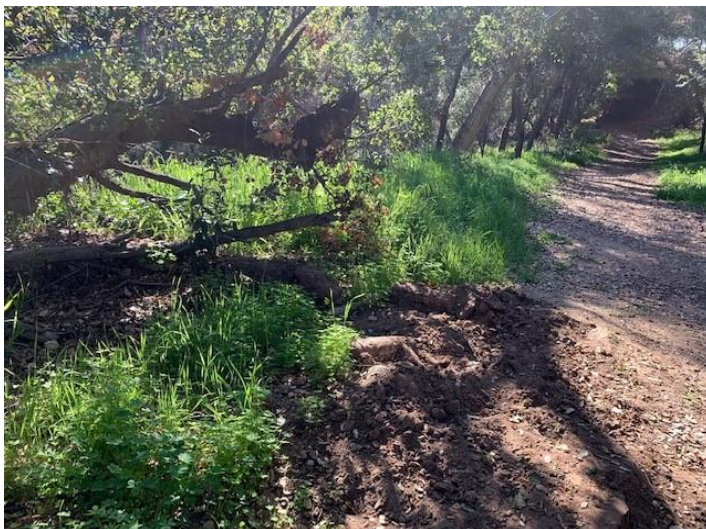
Figure 23. Trail at South End West bank Section of Vineyard Site. Note Patterson Avenue Bridge in background. Nonnative oxalis and grasses dominate strip along trail's edge. Trautwein. January 25, 2022.

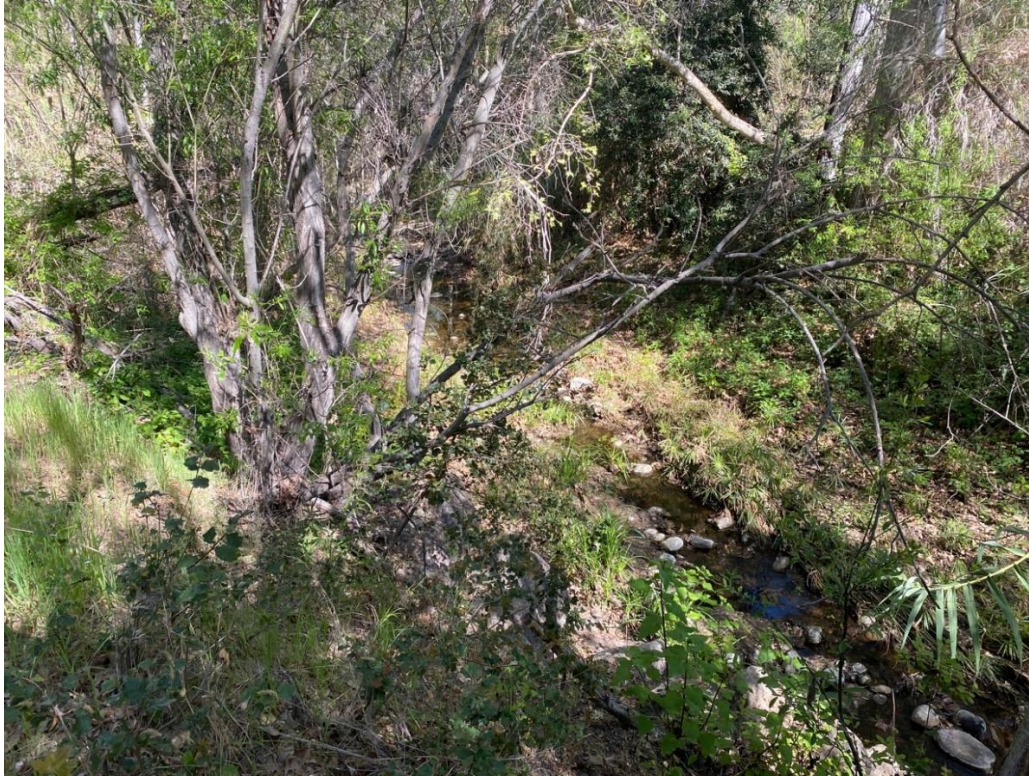
Figure 26. Looking down the west bank of San Jose Creek at the Norma Site. Note the understory is primarily nonnative grasses, and poison oak, however in the lower foreground are young black cottonwoods and a coast live oak sapling about 3' tall. These appear to be from natural recruitment. Blackwelder. March 7, 2022.

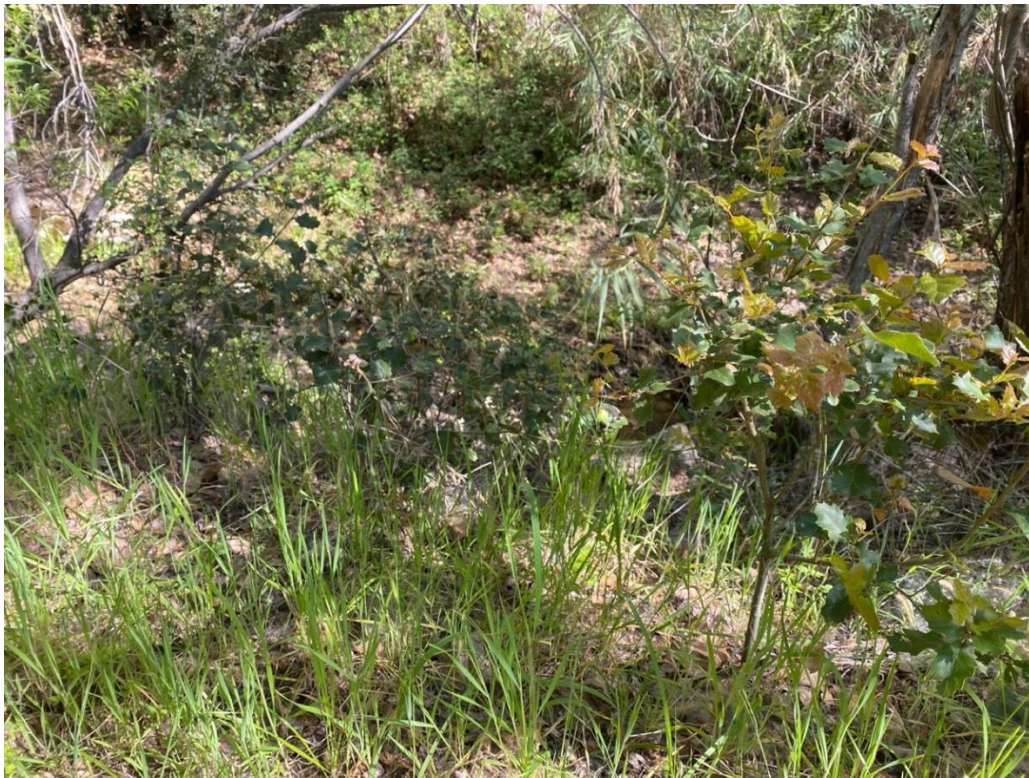
Figure 27. West bank of San Jose Creek at Norma Site above the installed rip rap. The understory is primarily nonnative grasses. Coast live oak sapling about four feet tall in the right third of the photo. There is nonnative, invasive Arundo in the background along the upper mid-right edge. Blackwelder. March 7, 2022.

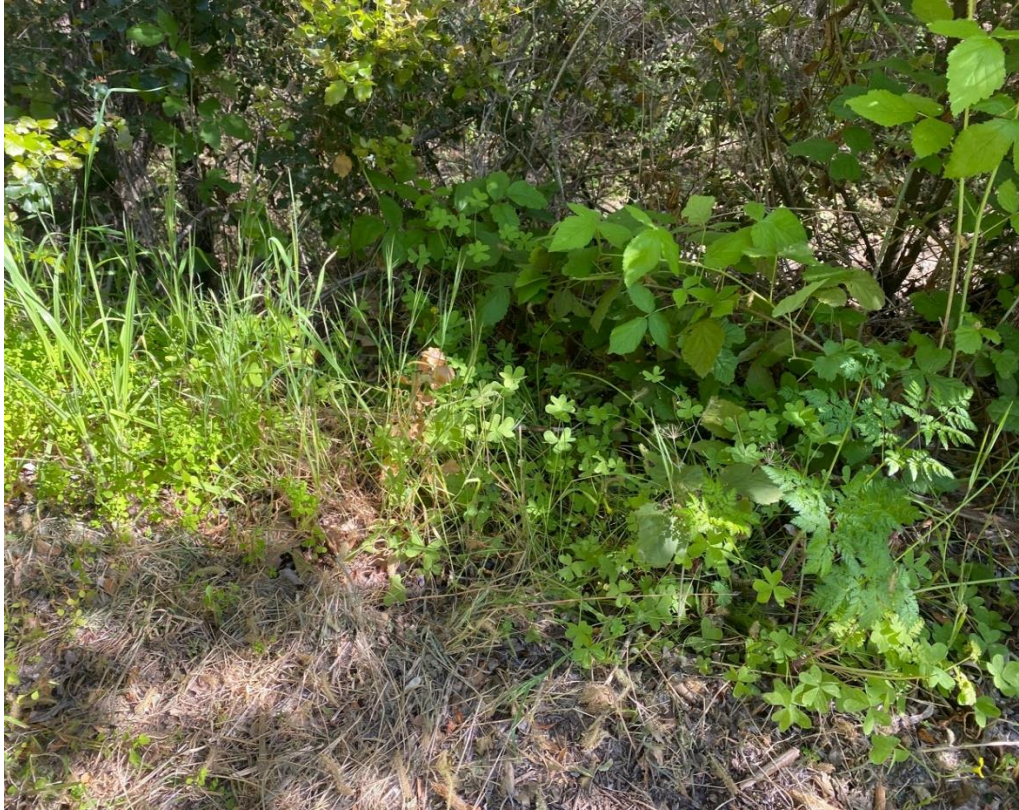
Figure 28. Nonnative grasses and oxalis on west bank San Jose Creek at the of Norma Site. There are also oaks and willows in the background near the top of the image. Blackwelder. March 7, 2022.

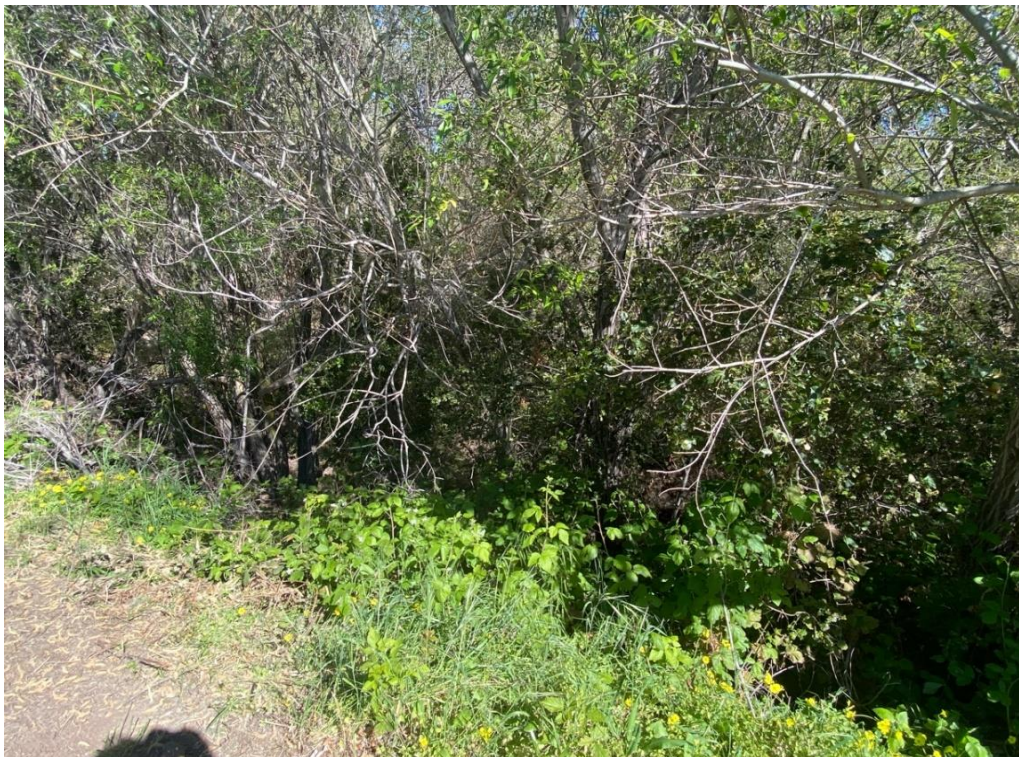
Figure 29. Along the trail west of the Norma Site on San Jose Creek. Understory is primarily nonnative grasses and poison oak. The upper half of this image shows the thick cover of willow trees planted on the west bank, with coast live oak saplings appearing through natural recruitment. Blackwelder. March 7, 2022.

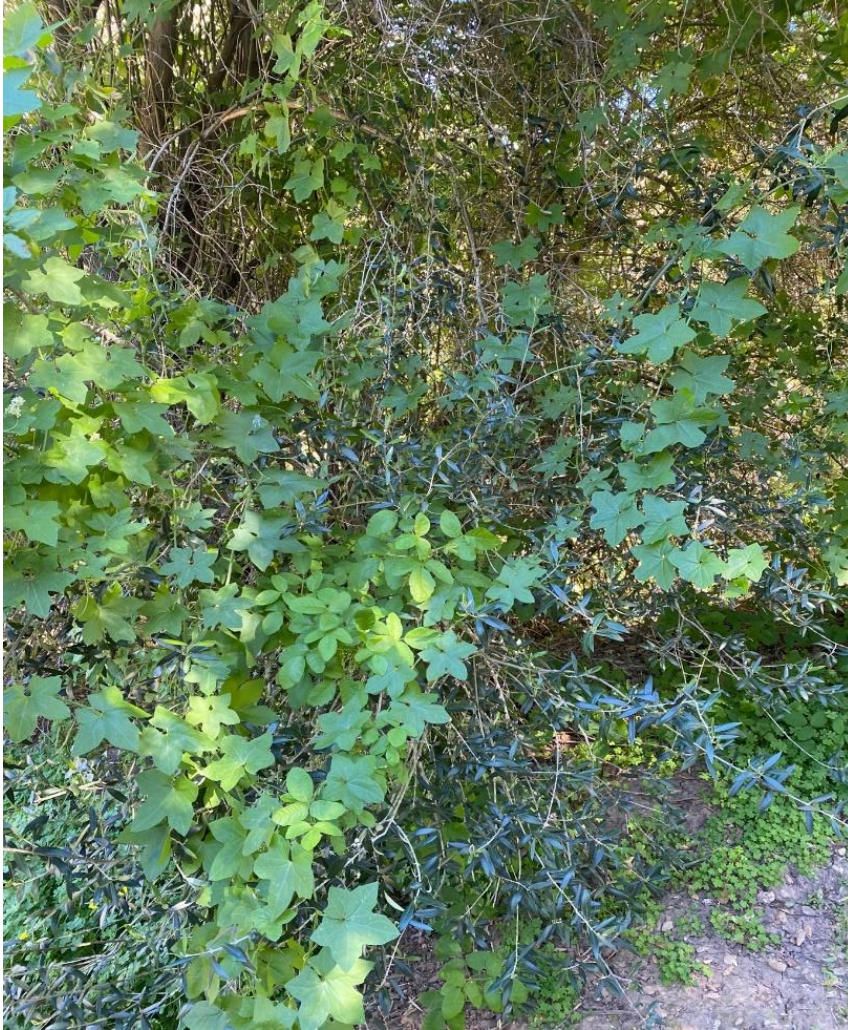
Figure 30. Naturalized olive tree (dark waxy lanceolate leaves), poison oak and native wild cucumber. Ground covered includes nonnative oxalis. Blackwelder. March 7, 2022.

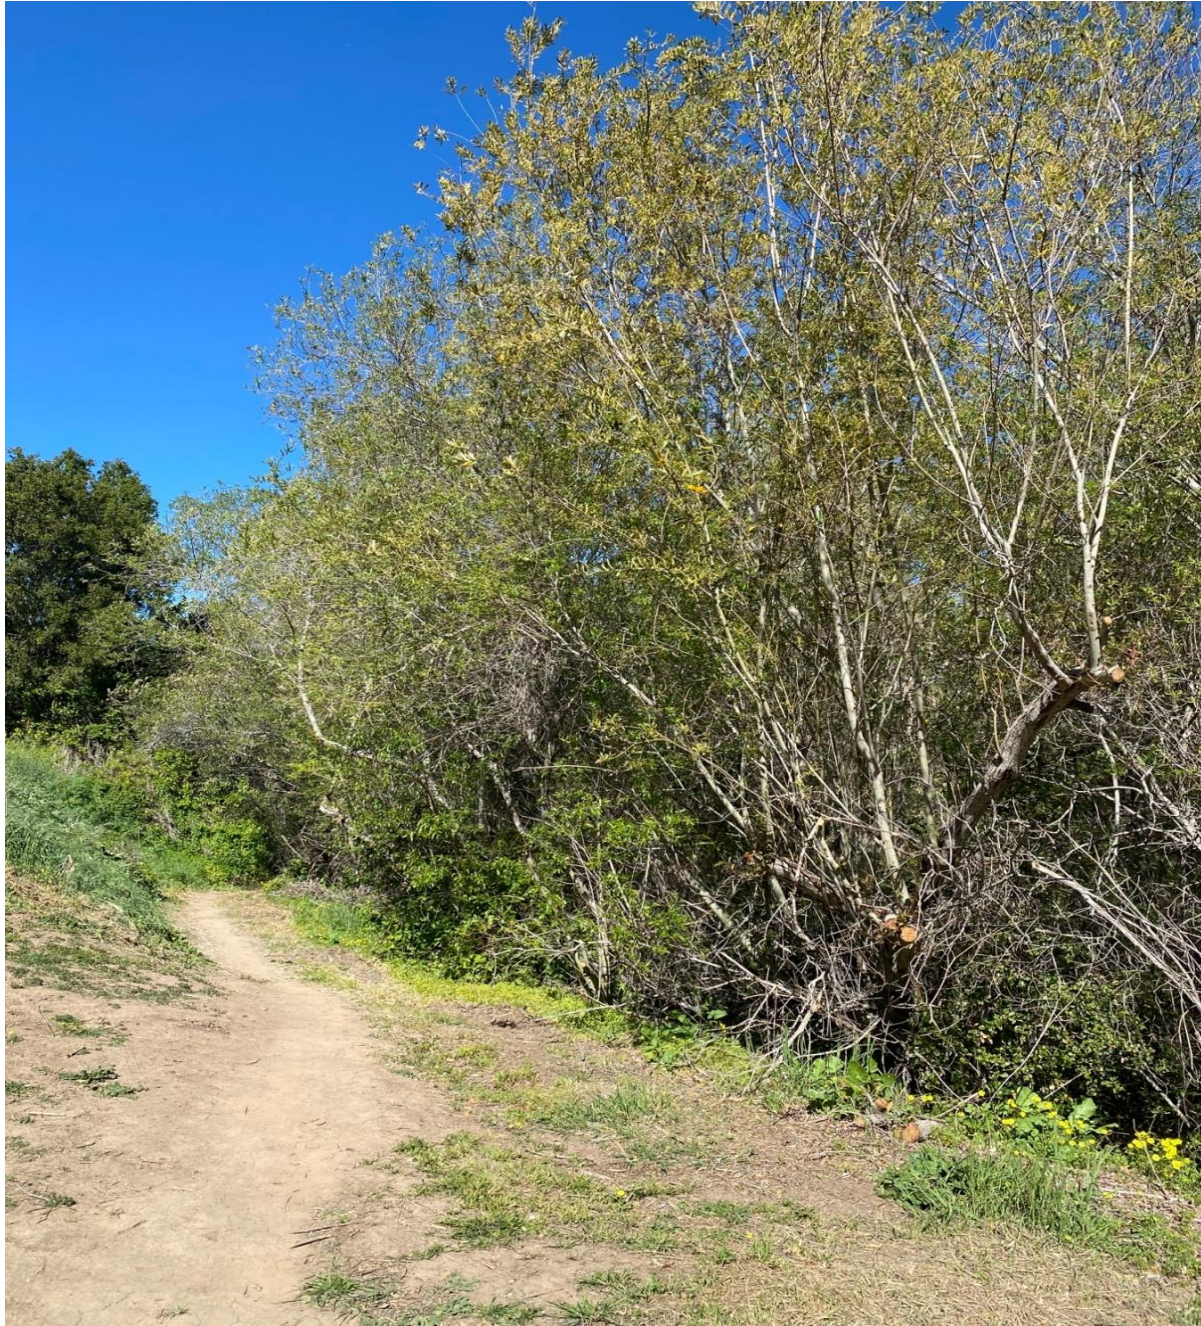
Figure 31. Looking north along the trail at the Norma Revegetation Site on the west bank of San Jose Creek. The trail runs parallel to the Creek. Note the dense willow woodland along the right side of the trail. These trees contribute to a healthy native riparian habitat. Ideally there would be more plant species diversity in the overstory and groundcover along this section of the Creek. Blackwelder. March 7,

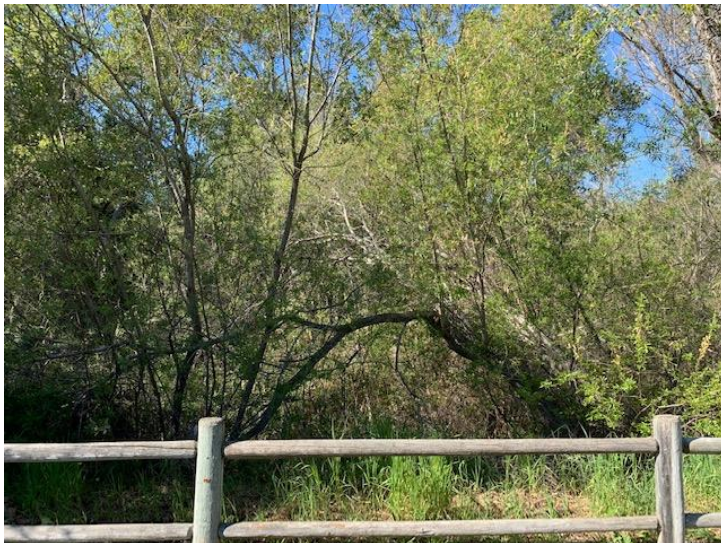
Figure 33. Paseo Cameo. Willow trees as tall as forty feet comprise the riparian canopy but the understory is mostly devoid of vegetation and contains nonnative species. Trautwein. March 7, 2022.

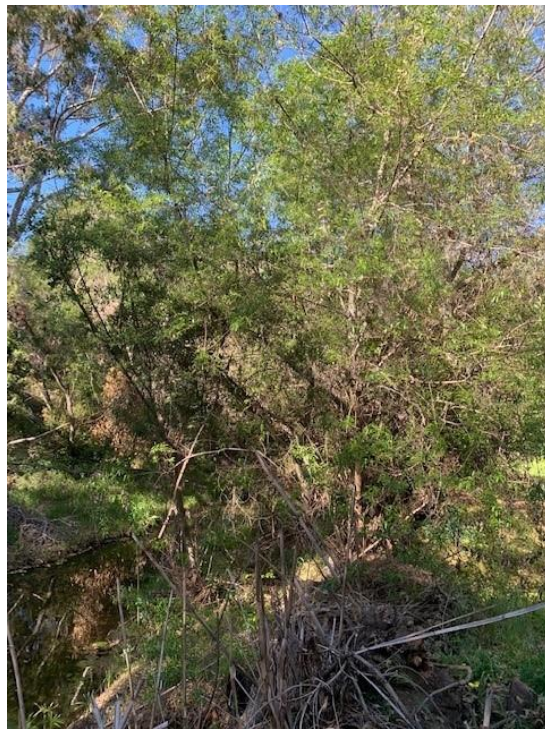
Figure 36. Willow on east bank and dead *Arundo donax* stalks in foreground likely remaining after SBCFCWCD eradication efforts. Trautwein. March 22, 2022.

- Eradicate cape ivy in area north of Cathedral Oaks and along access road.
- Remove Arundo patch on east bank near Cathedral Oaks Road.
- Eradicate patches of Arundo on west bank near access ramp.
- Eradicate periwinkle, oxalis, and nasturtium on east Creek bank and along the access road and ramp. Control nonnative grasses.
- Plant cottonwood trees on top of rock revetment on west bank near access ramp.⁹⁸
- Plant willow poles within rock revetment on west bank near access ramp.
- Extend plantings east from narrow strip of plantings atop east bank near Cathedral Oaks Bridge to widen riparian habitat and enhance Creek buffer.

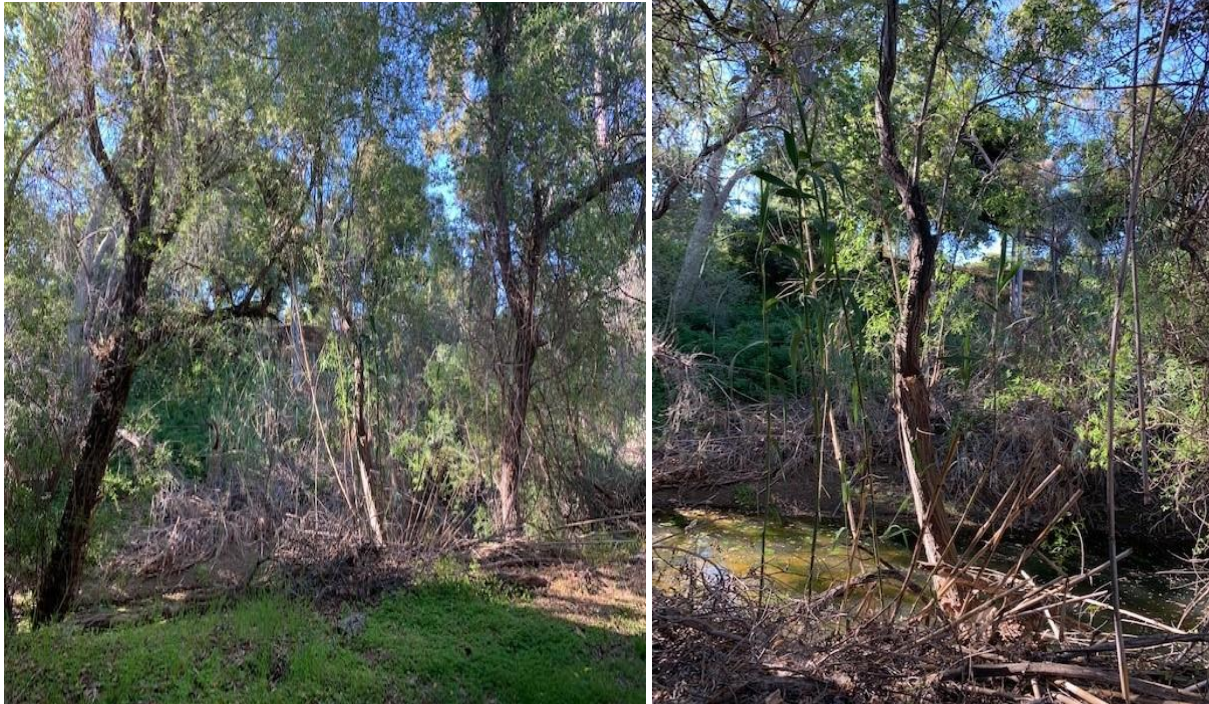
Figure 37. Willows on east bank of San Jose Creek and Arundo recovering between trees.

Figure 38. Arundo not fully eradicated is surviving around base of willow tree. Trautwein. March 22, 2022.

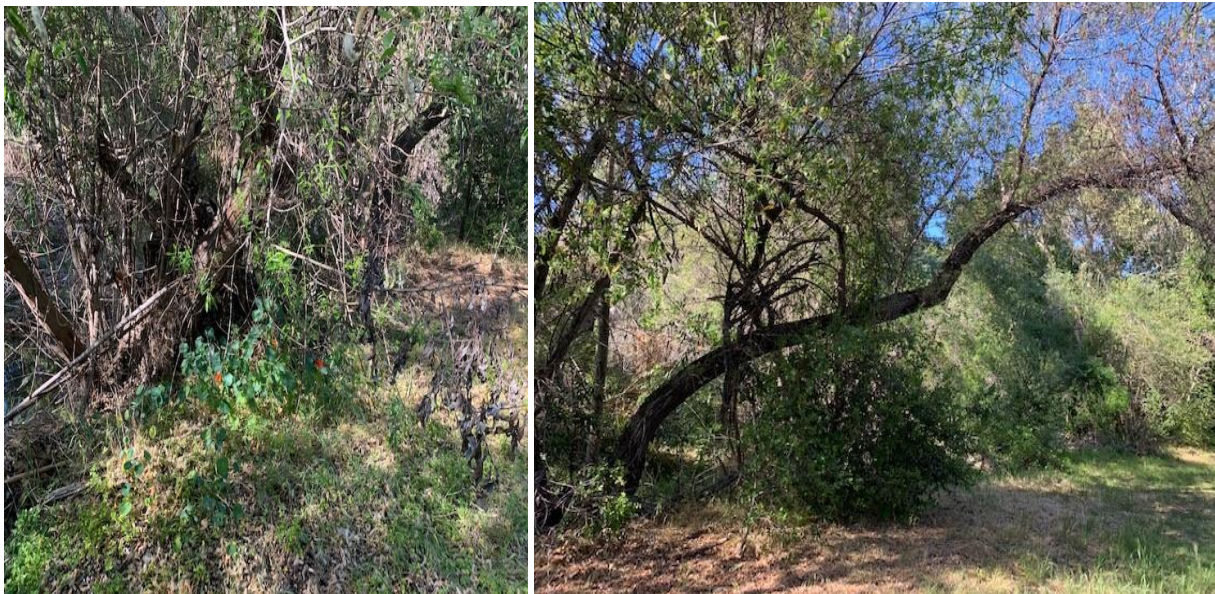
Figure 39. Nasturtium in riparian understory below willow tree on east bank upstream from Cathedral Oaks.
