San Jose Creek Flood Control Revegetation Sites **And Los Carneros Mitigation Bank** **Review and Recommendations**

ENVIRONMENTAL DEFENSE CENTER
October 24, 2022

Natalie Blackwelder, EDC Watershed Program Intern
Brian Trautwein, Senior Analyst / Watershed Program Director

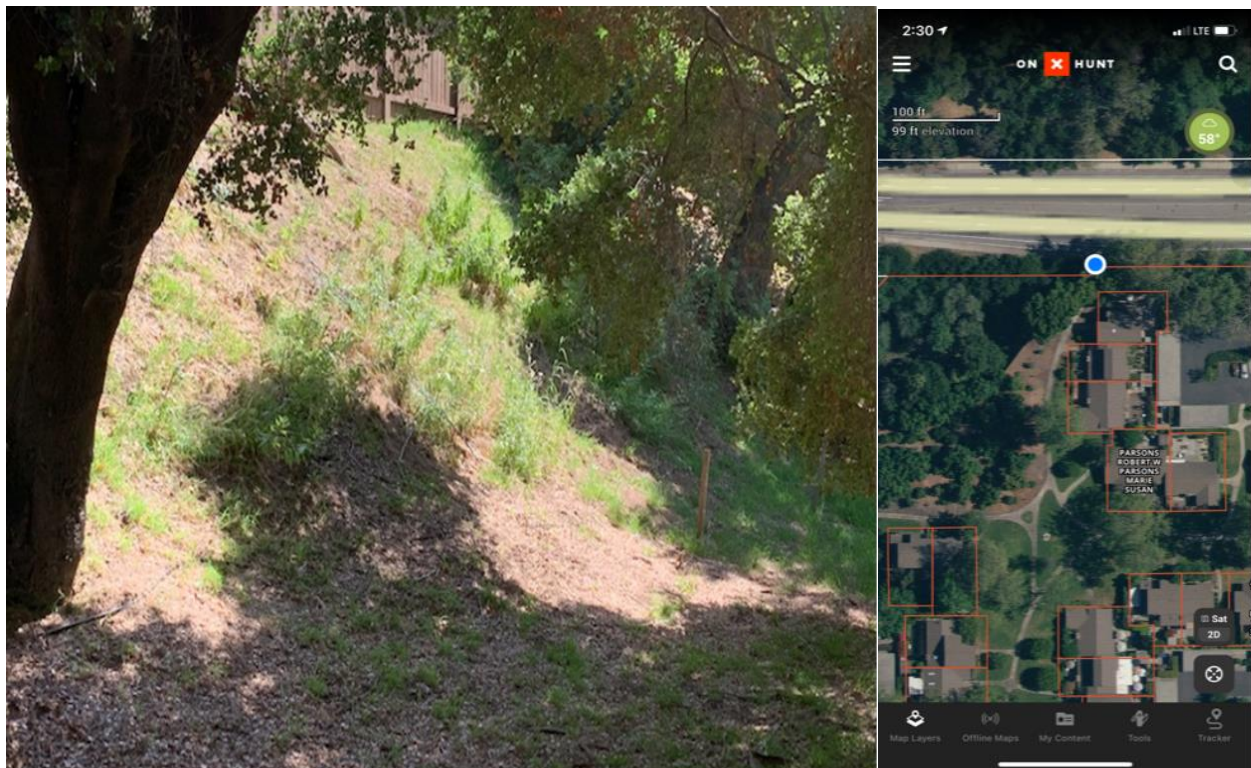
Figure 44. COVA Site #1. This site was one of the sites COVA was supposed to plant as mitigation for COVA's clearing of riparian habitat, but it was planted by SBCFCWCD as part of its Annual Maintenance Program, therefore COVA must still implement revegetation to mitigate the effects of COVA's riparian vegetation removal. This site is dominated by nonnative weeds, including oxalis, kikuyu grass, dandelion, and cape ivy which are visible using binoculars from the Cathedral Oaks Road Right of Way. (Figure 44b) Yucca trees and a Shamel ash are also present. Four hundred native deergrass, willow trees, elderberry, toyon blackberry, and wildrye plants were reportedly installed by SBCFCWCD at COVA Site #1 and #2 in 2016, however only one giant wild ryegrass, and one to two elderberries including one which has been knocked down by a fallen limb are present at COVA Site #1. Two other elderberries are located outside COVA Site #1 and it is unclear if they were planted by SBCFCWCD or as part of UCC's San Jose Creek Restoration Project or are naturally-occurring. COVA Site #1 is largely dominated (over 50% cover) by invasive nonnative herbaceous vegetation including oxalis and kikuyu grass. Mugwort is also common but is not one of the species planted. CDFW SAA success criteria require <5% cover by herbaceous invasive plants but this criterion is not being met. Irrigation lines are still present but appear to be in disuse. Trautwein. January 30, 2022. Figure 44b. Photographer location. On-X.

- Increase plant diversity by planting additional shrub and understory species such as toyon, coffeeberry, hummingbird sage, gooseberry, and wild rose propagated from plant materials collected along San Jose Creek near COVA.

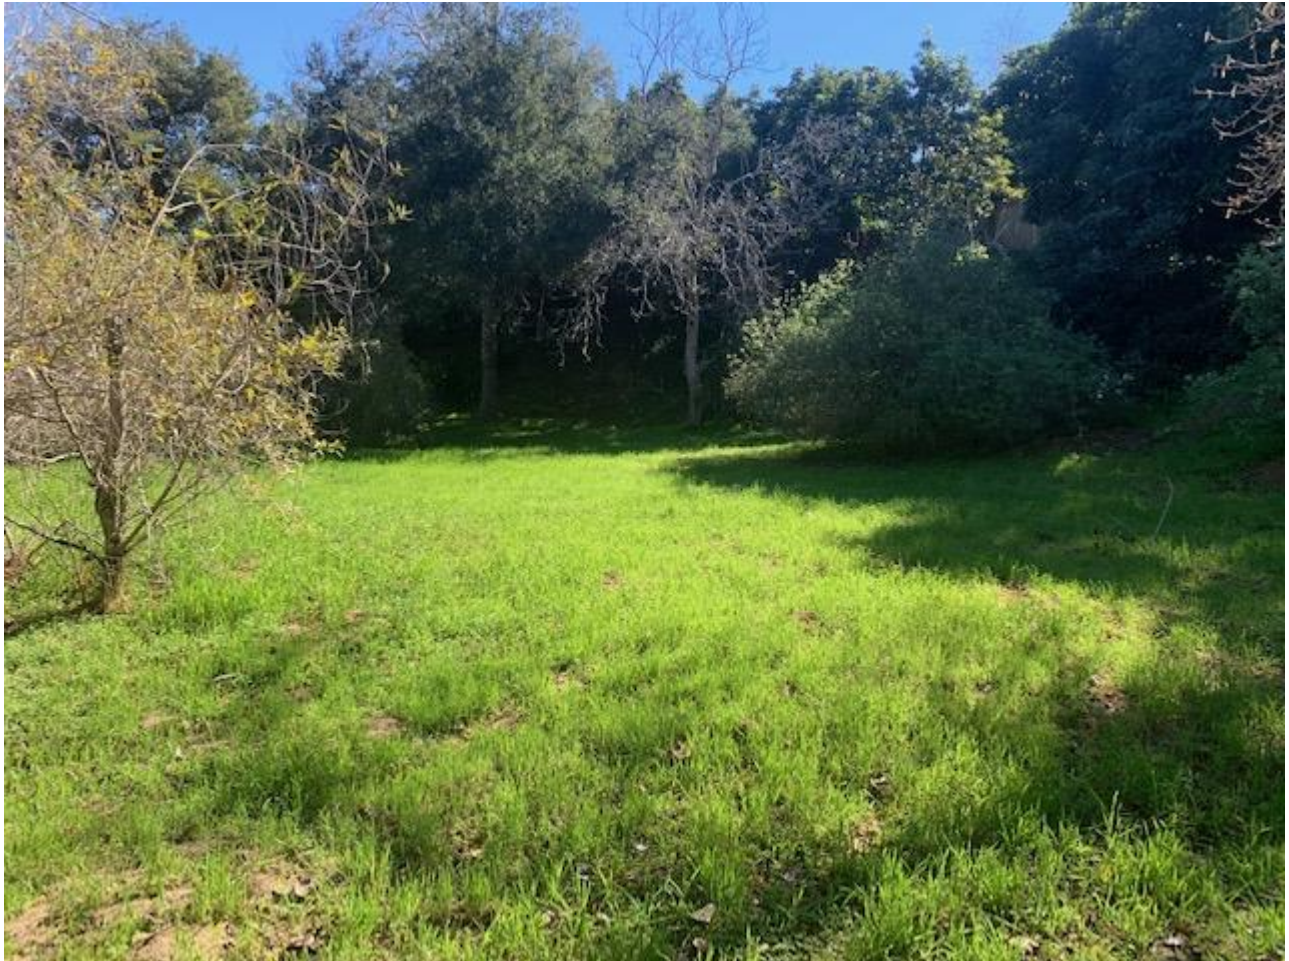
Figure 45. COVA Site #1 is located on the slope behind and under trees in the background of this image. The center of this image is a portion of UCC's San Jose Creek Restoration Project Site #1 which was cleared incrementally by COVA between 2007 and 2018. Note one of two healthy elderberries naturally occurring or planted near COVA Site #1 (upper right quadrant right of image). Trautwein. January 2022.

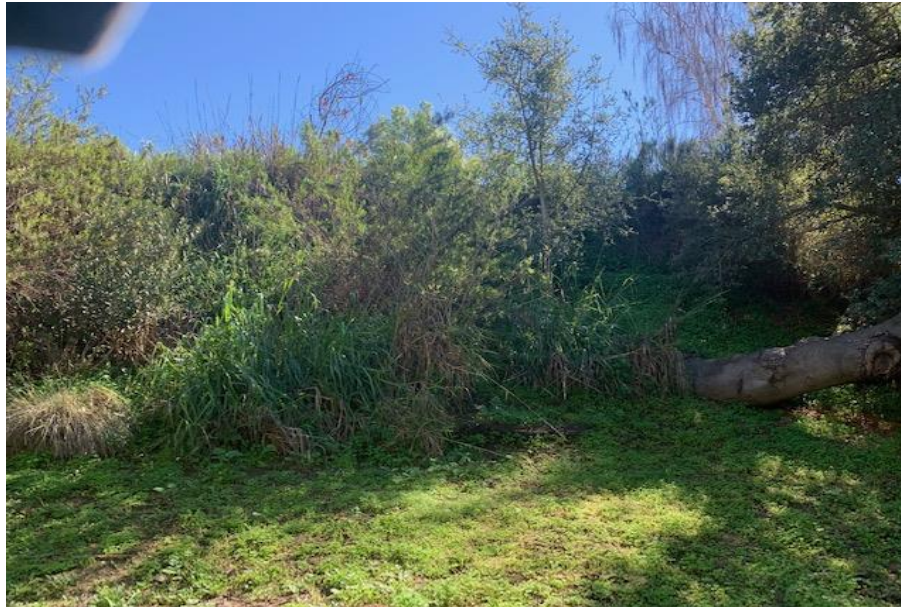
Figure 47. COVA Site #2 with giant wild ryegrass (center left), deergrass (lower left), coast live oak sapling (upper center-right), and mule fat (left side). Note area in foreground was cleared of riparian vegetation and consists of one hundred percent nonnative species. Trautwein. January 30, 2022.

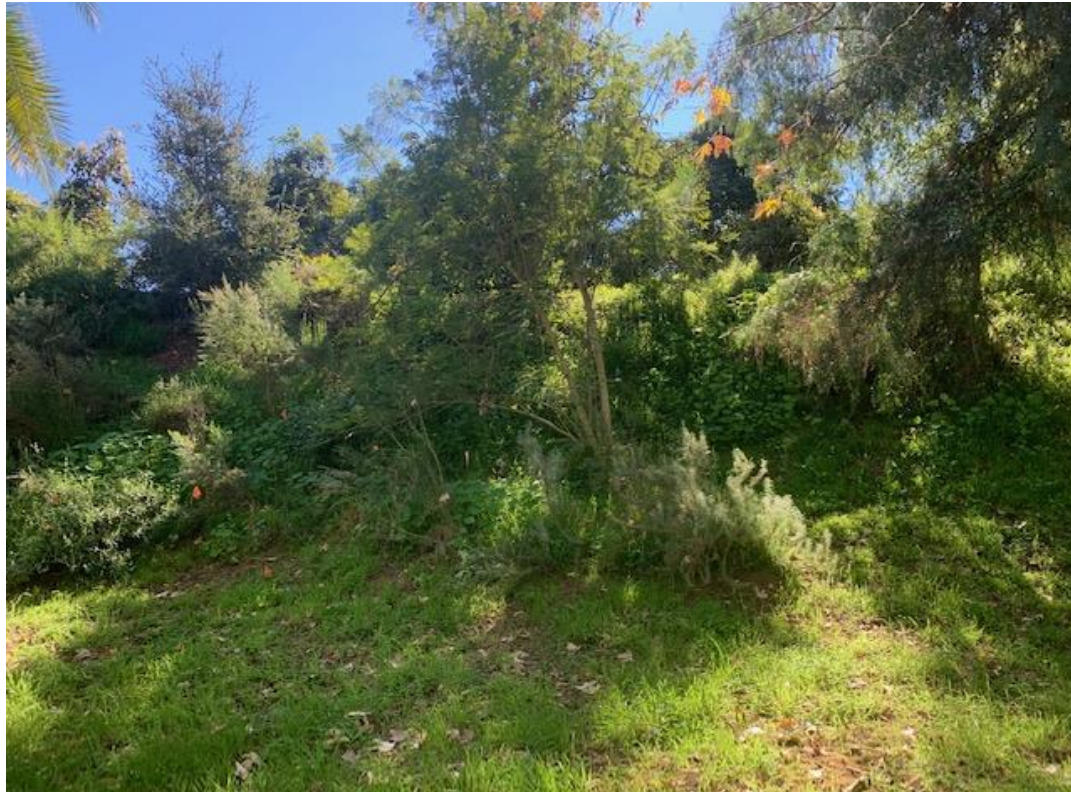
Figure 49. COVA Site #3. Nonnative jacaranda tree retained within revegetation site is shading native upland species such as California shade which prefer full sunlight. COVA requested SBCFCWCD to retain nonnative trees in revegetation areas. Understory is comprised of aggressive nonnative herbaceous species including nasturtium. Weedy area in foreground is where riparian habitat was cleared. Trautwein. January 30, 2022.

- Remove all Kikuyu grass by rhizomes for three consecutive years or by solarization.
- Remove medium-sized multi-trunked *eucalyptus citriodora* tree west of Site. This tree was retained when native willows and riparian habitat was removed during 2013-2015 in violation of CDFW SAA No. 1600-2012-0132-R5.

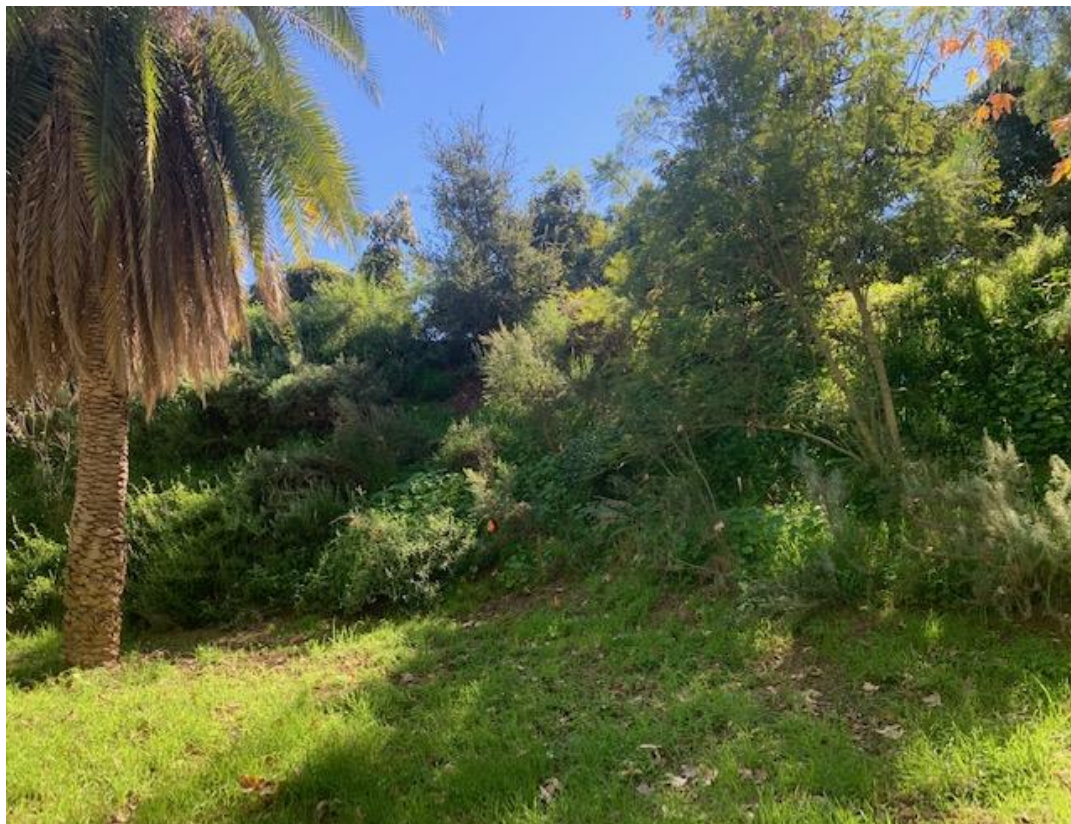
Figure 50. COVA Site #3. Note healthy coast live oak sapling in upper middle portion of image. Weedy area in lower portion of image is where riparian habitat was cleared. Trautwein. January 30, 2022.

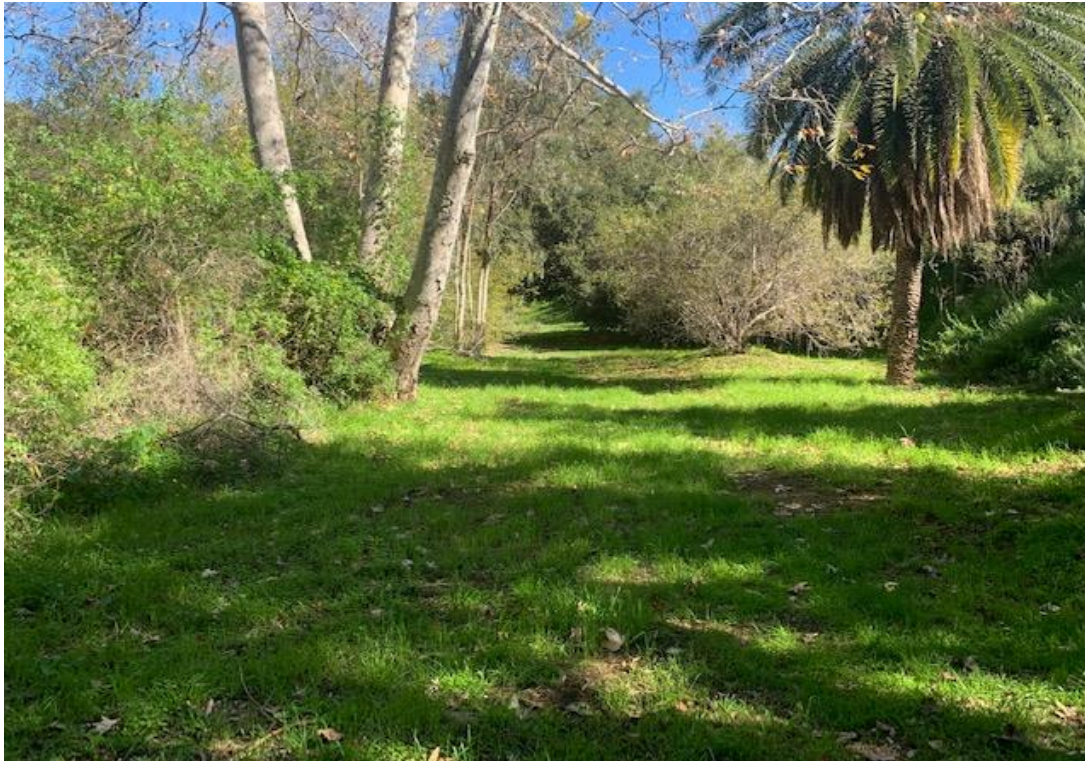
Figure 51. COVA Site #3 (upper right quadrant of image). Lower half of image is where COVA cleared dense willow-riparian woodland with nearly impenetrable understory of blackberries. Area is now comprised of invasive nonnative grasses. Note multi-trunked *Eucalyptus citriodora* tree behind tri-trunked sycamore (left of middle, upper portion of image). Trautwein. January 30, 2022

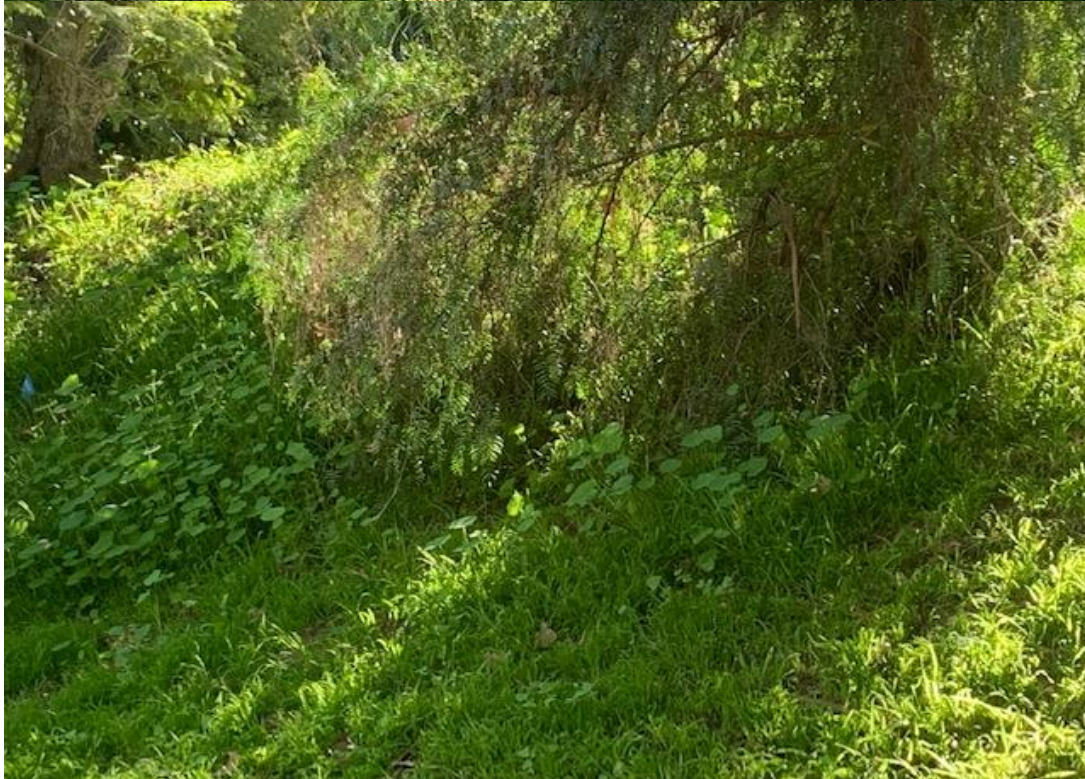
Figure 52. COVA Site #3. Understory in southern portion of site comprised of nasturtium and other aggressive nonnative herbaceous species such as exotic grasses. Trautwein. January 30, 2022.

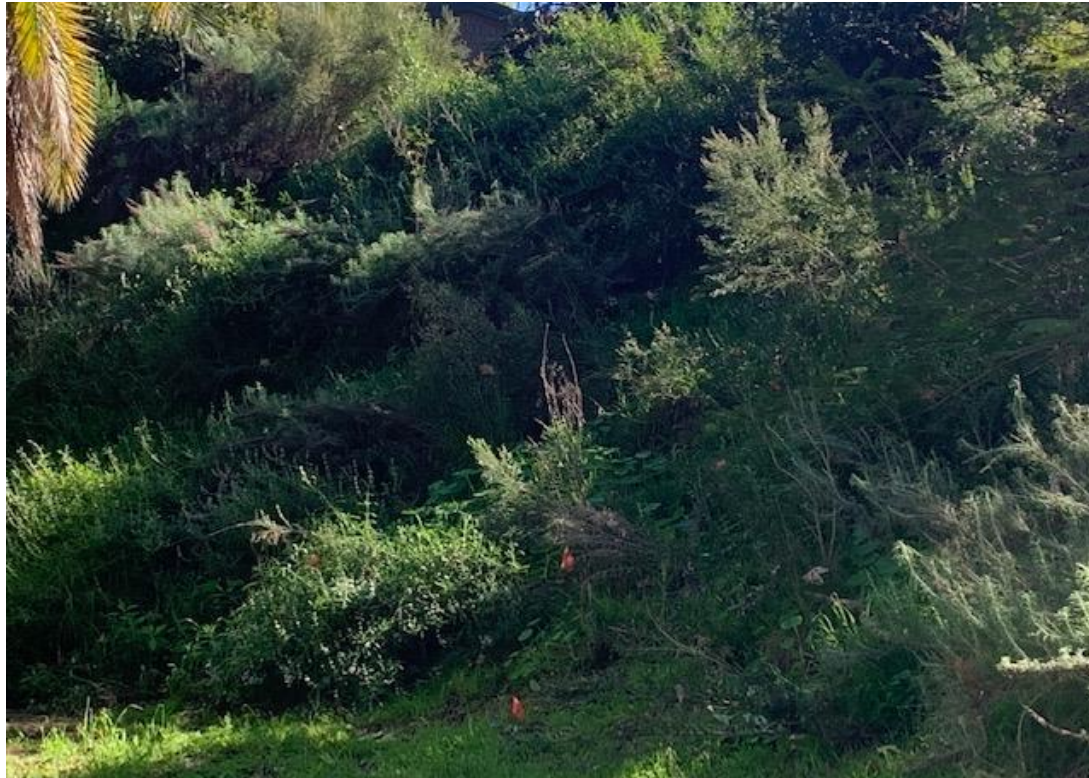
Figure 53. COVA Site #3. Site is upland plant community which is not in-kind mitigation for loss of riparian vegetation. Trautwein. January 30, 2022.

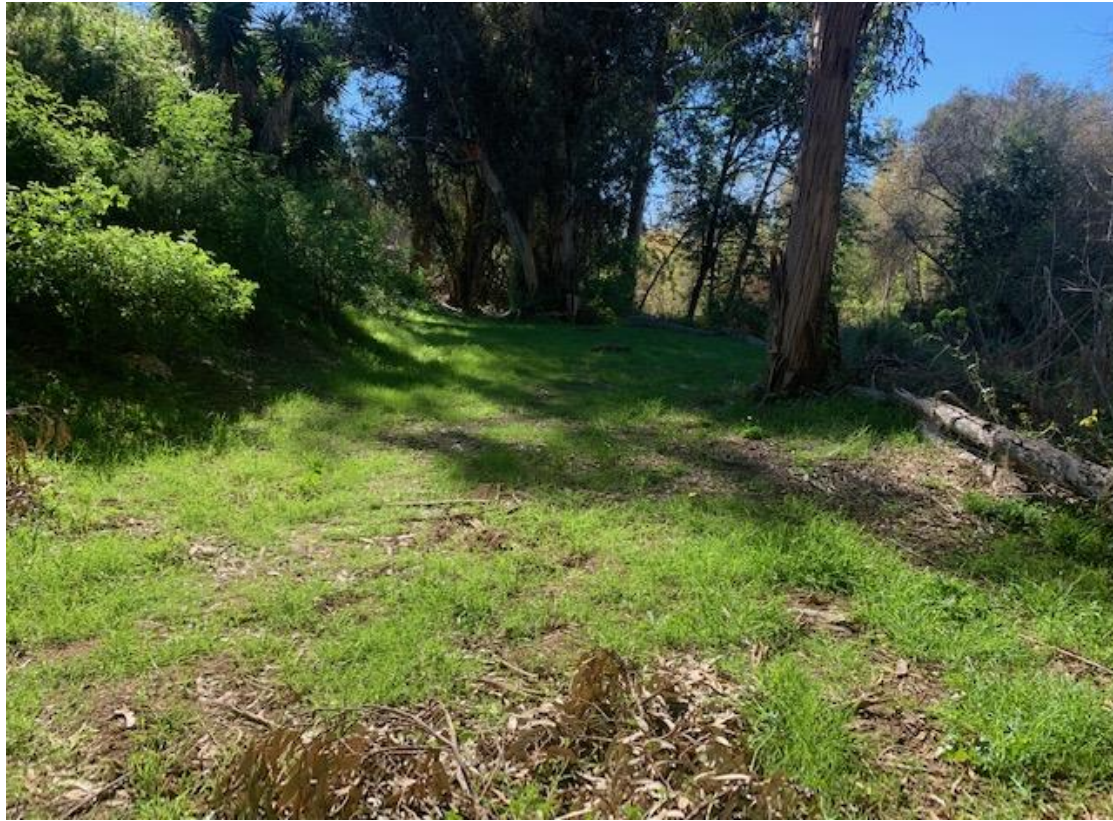
Figure 55. COVA Site #4 (Upper left quadrant of image) Note large, cleared area approximately 90' by 30' covered by exotic grasses. This area was a dense riparian woodland prior to clearing by COVA in 2015. This revegetation site supports ten healthy elderberry plants and an established stand of blackberries mixed with native wild cucumber and nonnative nasturtium at the south end of the Site. COVA Site #4 has achieved an estimated cover of 75-80% of native species. Trautwein. January 30, 2022.

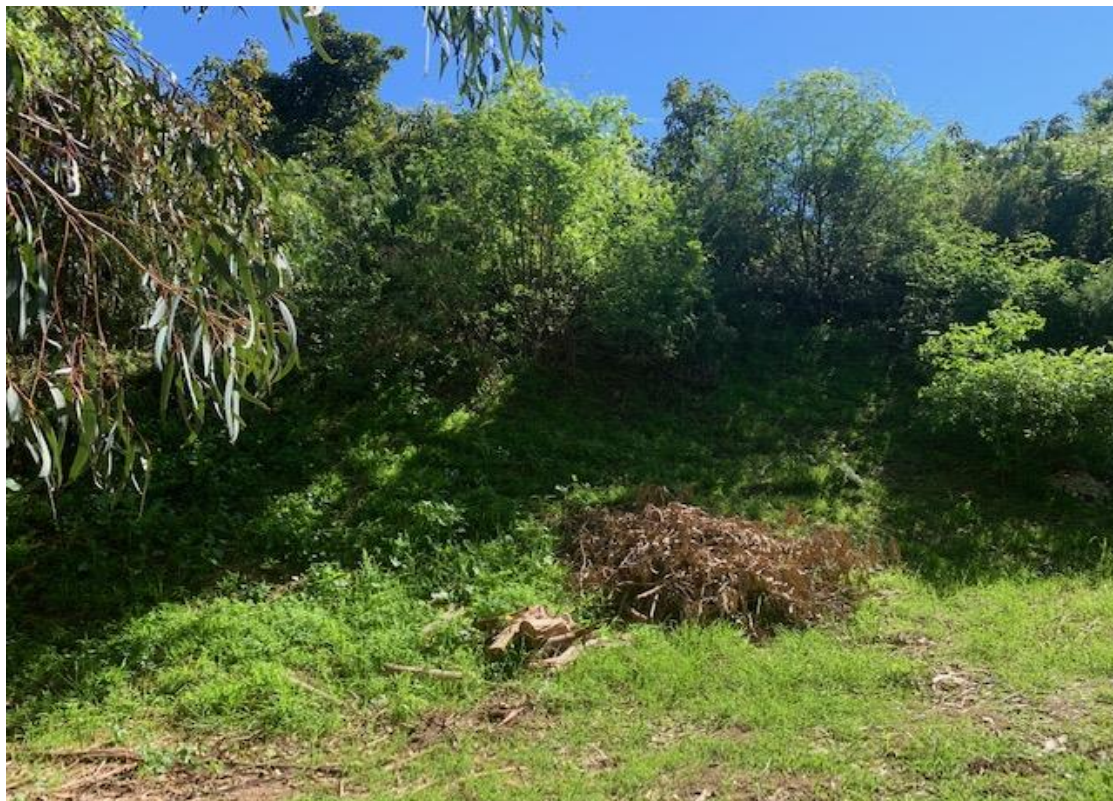
Figure 56. COVA Site #4 with healthy elderberries at north end of site. Note exotic invasive herbaceous species on slope below elderberries. Italian thistle, nasturtium, mallow, and oxalis dominate site's understory. The area in the foreground / lower portion of image was cleared of high-quality riparian habitat. Trautwein. January 30, 2022.

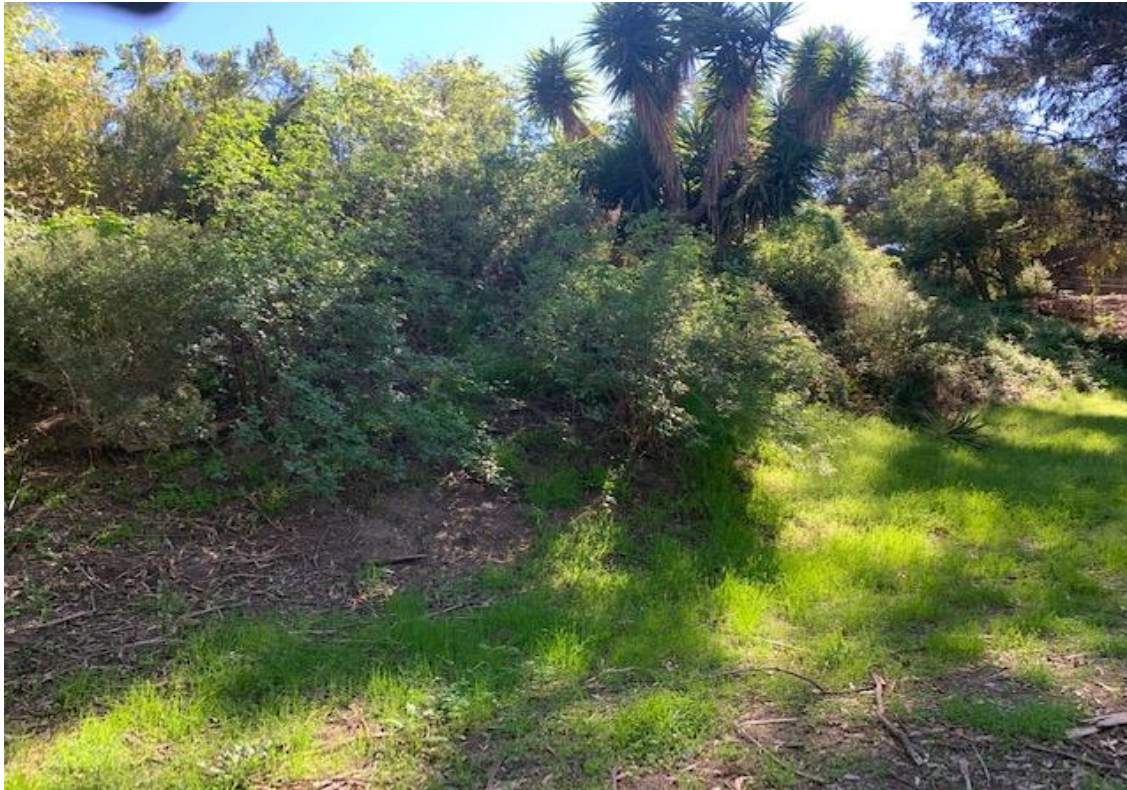
Figure 57.
COVA Site #4.
A large yucca
was retained
within this
revegetation
site detracting
from its
success. COVA
cleared riparian
habitat in lower
right half of
this image.
Trautwein.
January 30,
2022.

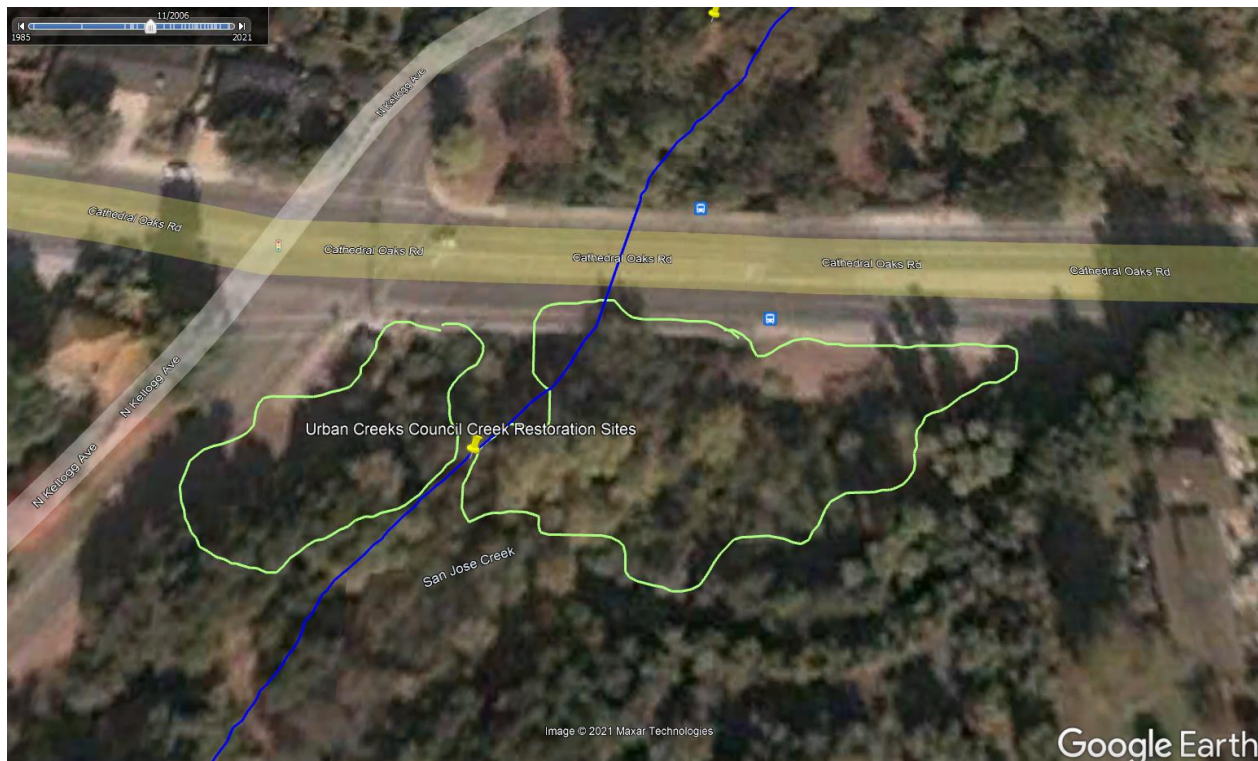
and western sycamores) and understory plants (wild blackberry, etc.) in 2006. (Figure 59) However, much of this native riparian vegetation was sequentially removed between 2007 and 2018 by COVA which was issued SAA No. 1600-2012-0132-R5 in 2012 after COVA's clearing project was reported to CDFW. COVA never implemented revegetation required by that SAA.¹³³ (Figures 59 - 63)

Figure 59. UCC San Jose Creek Restoration Project Site #1 (green polygon in middle and right side of image) covered with native riparian vegetation installed by UCC and established through natural recolonization processes. Google Earth. 2006.

- CDFW should require COVA to replant all areas COVA cleared of riparian habitat and achieve one hundred percent (100%) cover of native overstory and understory species to replace habitat removed between 2007 and 2018.¹⁴⁰ (Figures 59 – 66)

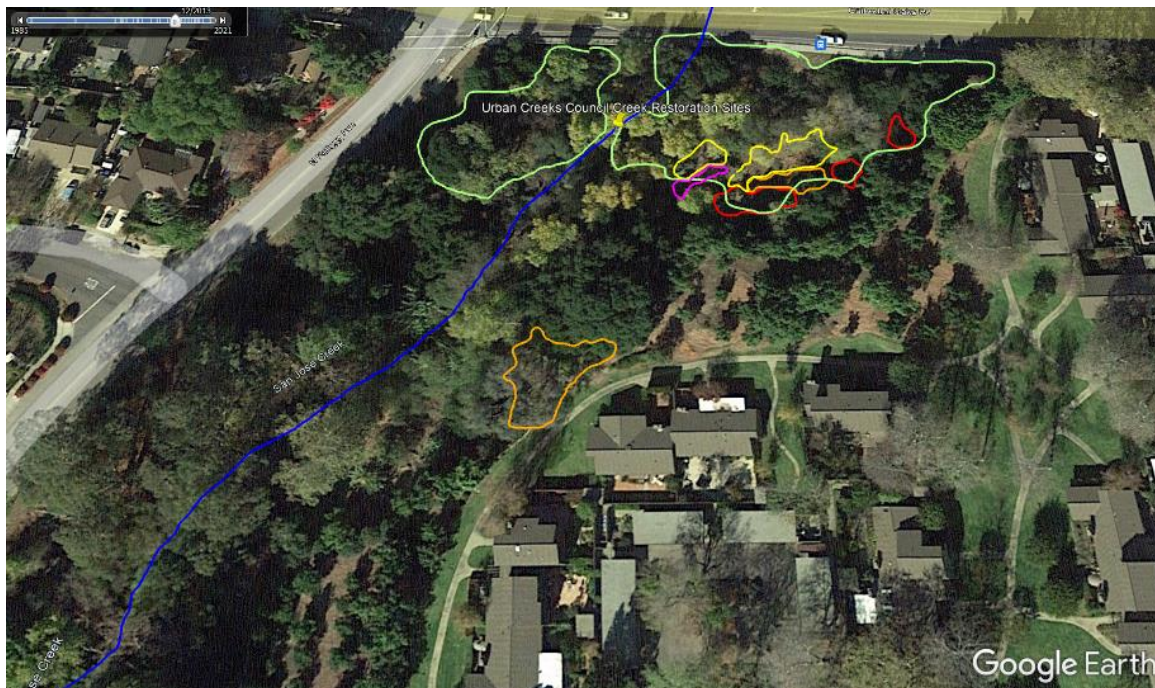
Figure 65. Prior to COVA clearing of riparian habitat in 2014. Note lower orange polygon in center of image contained dense riparian vegetation including willow trees in December 2013, which were removed in 2014 as shown in Figure 64 above. Google Earth. December 2013.

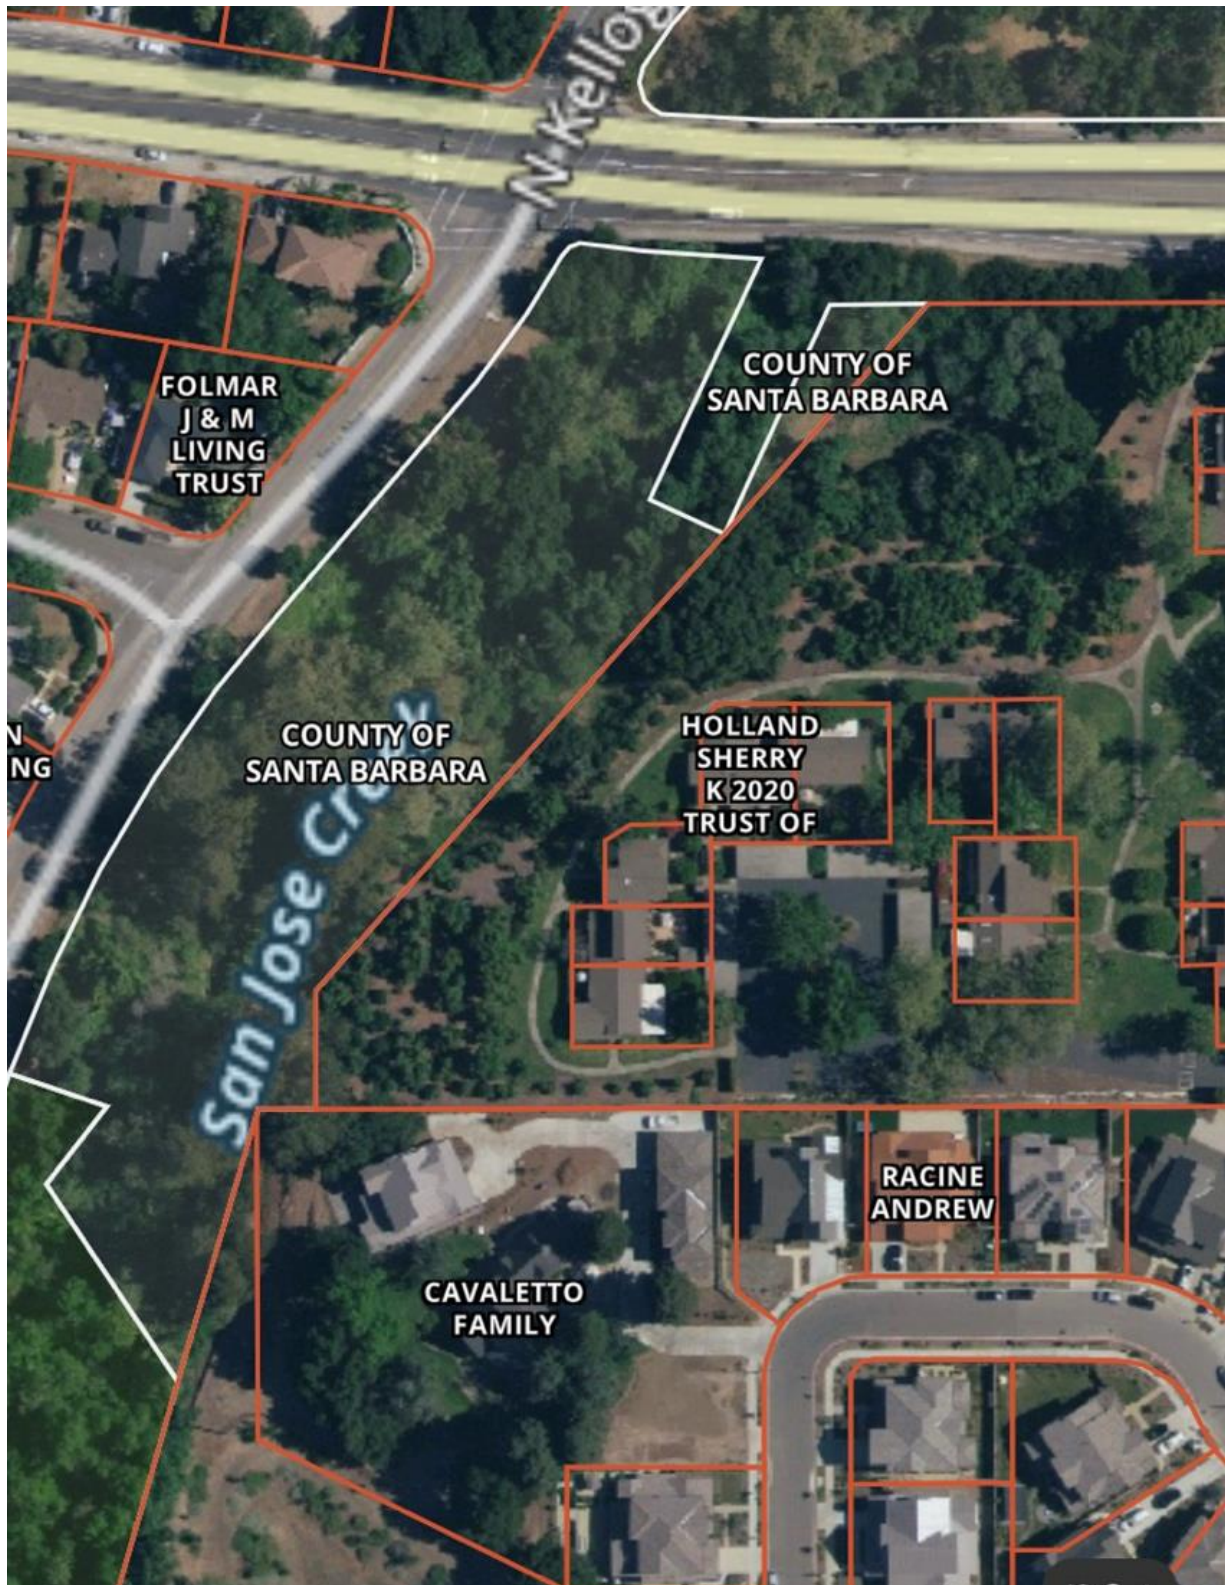
Figure 67. Parcel Map showing a portion of the cleared habitat was located on County property. On-X. January 29, 2022.

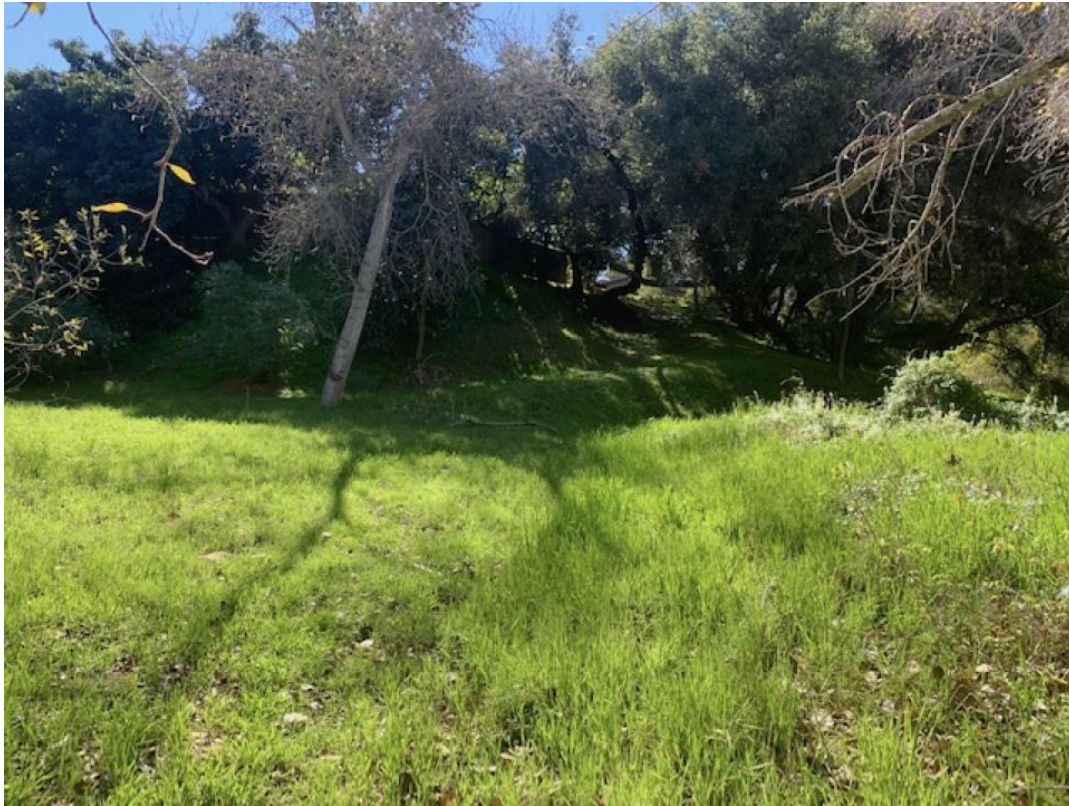
Figure 68. The western portion of Urban Creeks Council's San Jose Creek Restoration Project Site #1 located on County property was cleared by COVA. CDFW directed COVA to undertake revegetation to mitigate the impacts of the unpermitted removal of riparian habitat but this revegetation never occurred. Trautwein. January 2022.

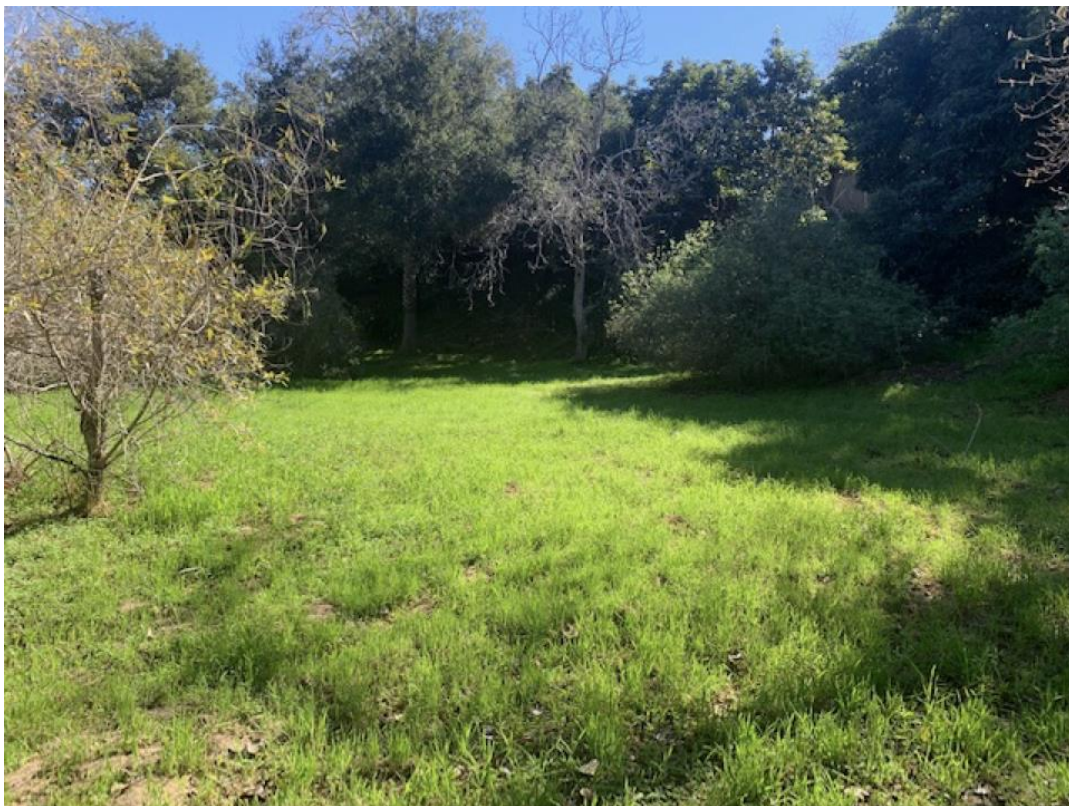
Figure 69. Southern portion of Urban Creeks Council's County-approved San Jose Creek Restoration Site #1 was cleared by COVA. CDFW subsequently required COVA to revegetate COVA Sites #1 and #2 as mitigation for the unpermitted habitat removal, but these sites were revegetated by SBCFCWCD as part of its Annual Maintenance Plan. Trautwein. January 30, 2022.

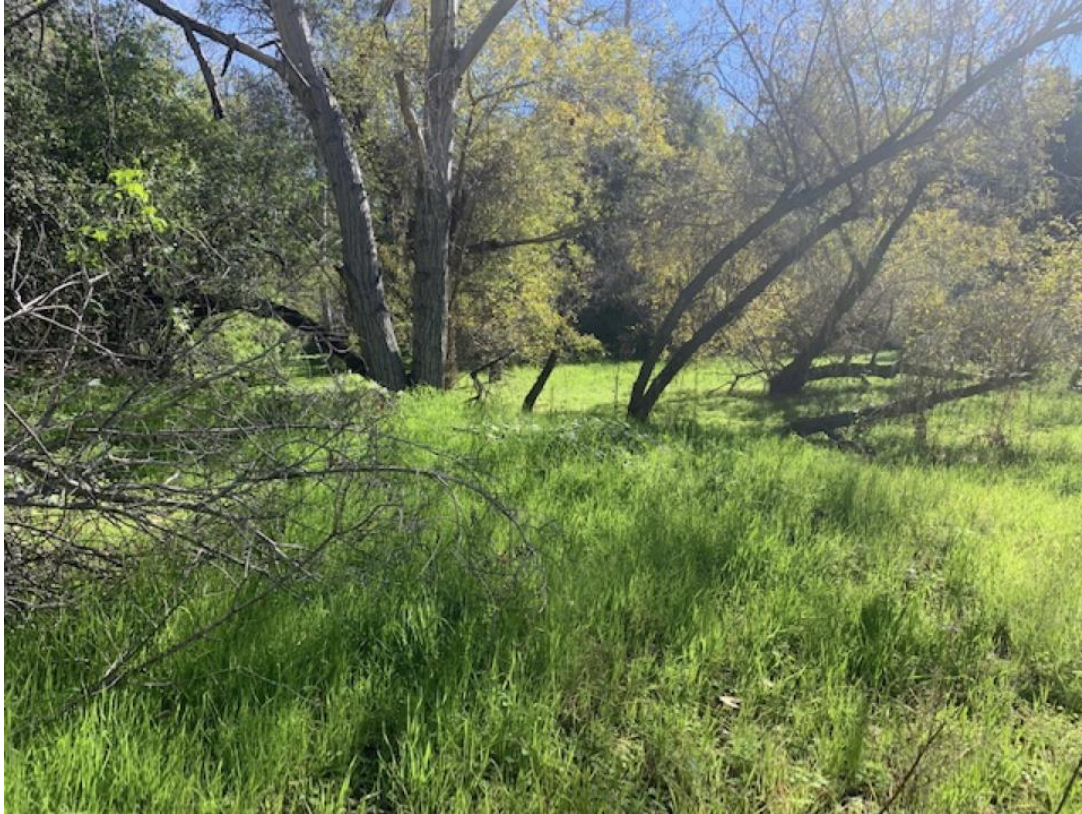
Figure 70. COVA also cleared the native understory from the entirety of Urban Creeks Council's San Jose Creek Restoration Project Site #1. Note the black cottonwood and arroyo willow trees in Urban Creek's Council's County-approved San Jose Creek Restoration Project Site #1 are underlain by a 100% nonnative understory. The understory was 100% native cover consisting primarily of wild blackberries prior to COVA's clearing of the Site. Trautwein. January 30, 2022.

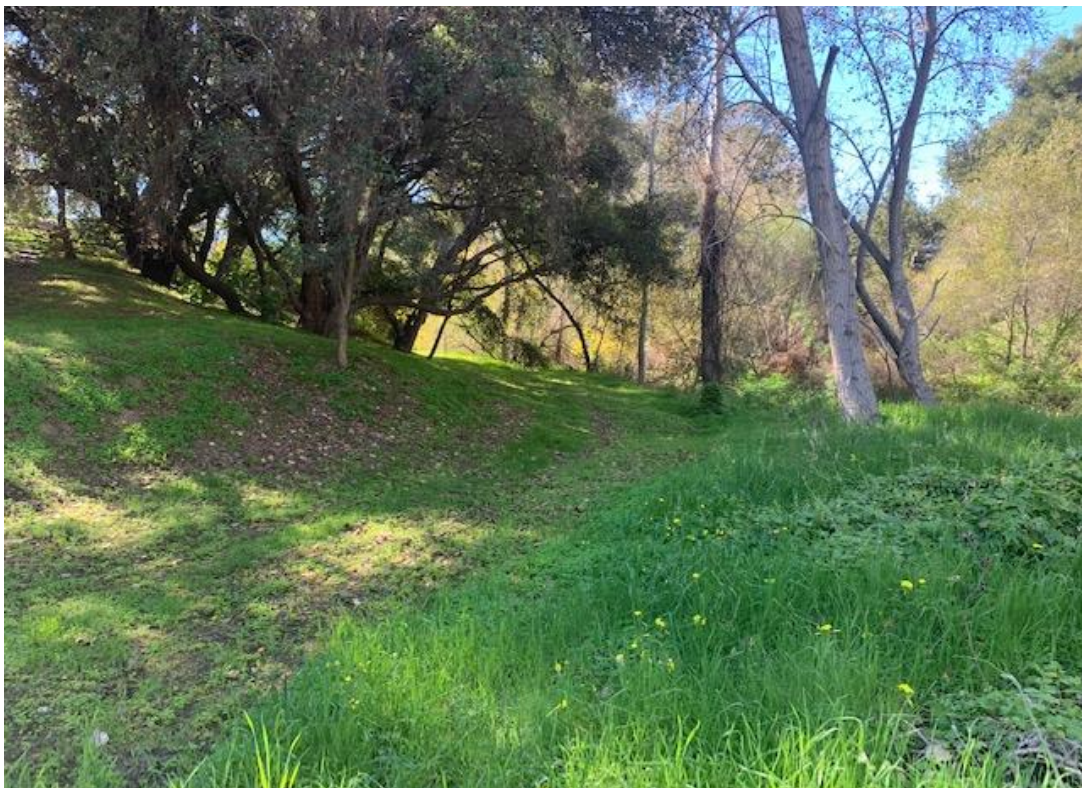
Figure 71. COVA cleared oak riparian woodland understory on City property south of the Cathedral Oaks Road Bridge over San Jose Creek. Trautwein. January 30, 2022.

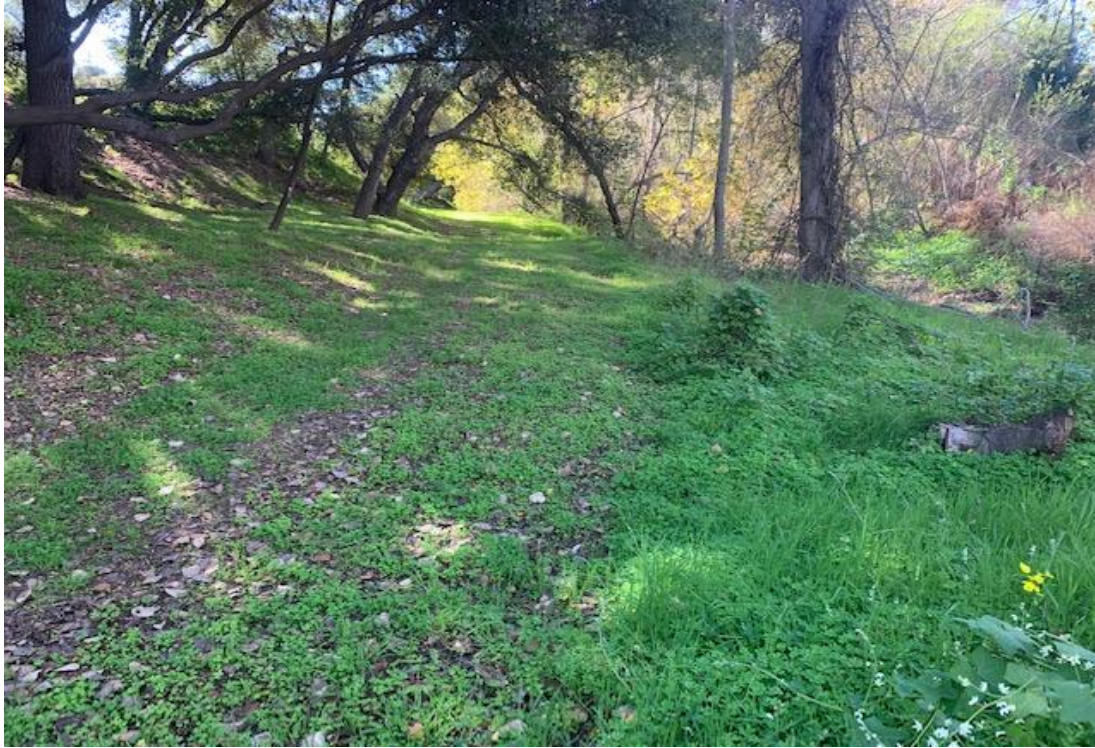
Figure 72. Oak riparian woodland understory was cleared and oak trees were pruned along east side of San Jose Creek west of COVA between 2009 and 2015 providing vehicle access along the Creek bank. Trautwein. January 23, 2022.

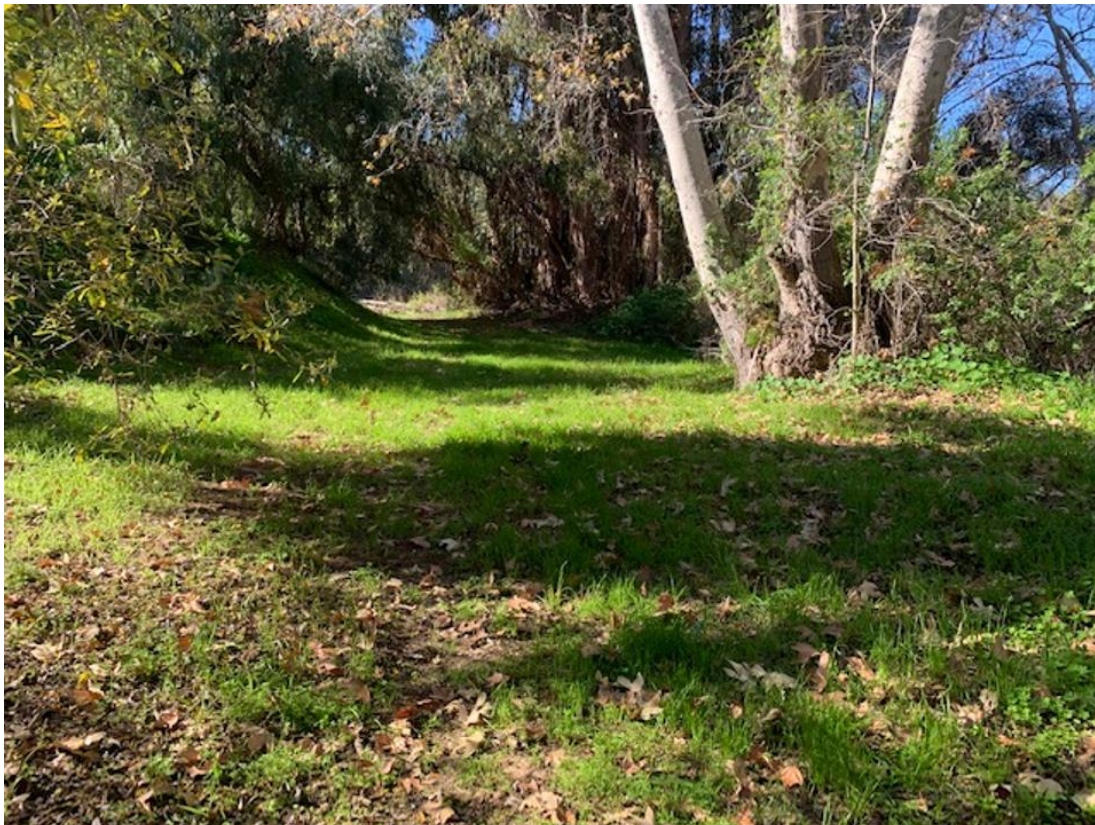
Figure 73. Cleared riparian habitat now provides vehicle access along Creek bank near COVA Sites #2 and #3. Trautwein. January 23, 2022.

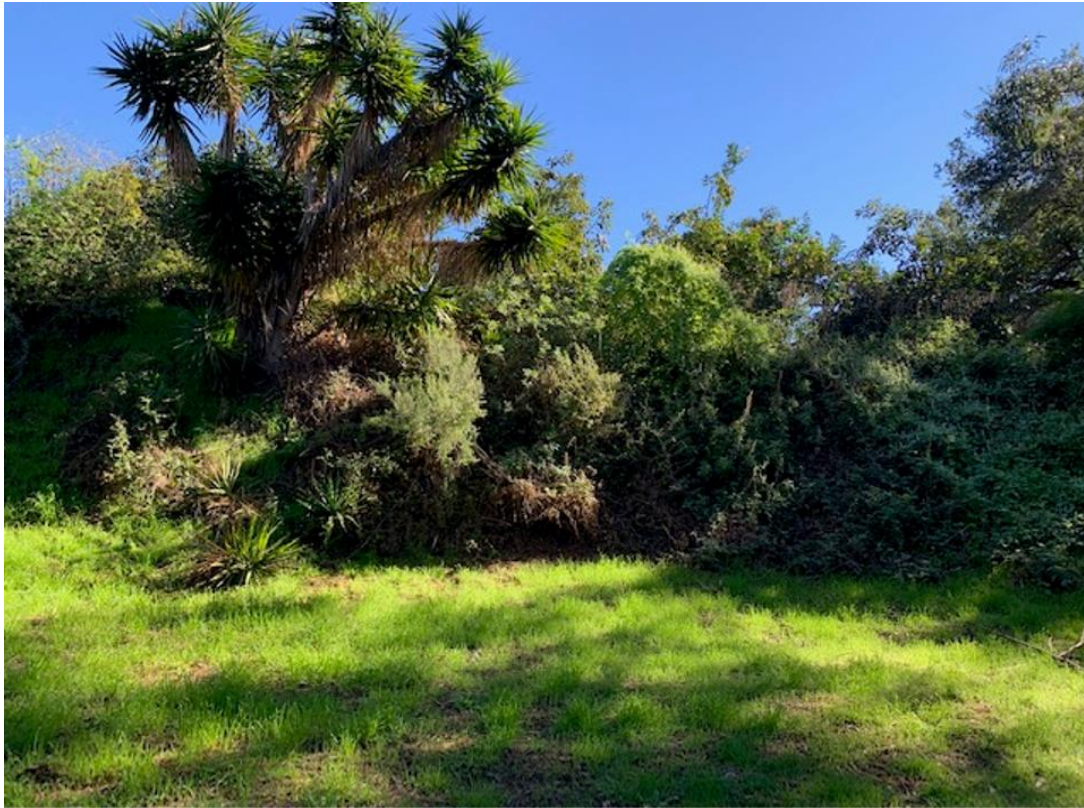
Figure 74. COVA Site #2 with cleared riparian habitat in foreground. Wild blackberry (right side) and California sage (center) present. COVA required SBCFCWD to retain nonnative trees in the revegetation sites. Large yucca tree (upper left) was retained in revegetation site. Trautwein. January 23, 2022.

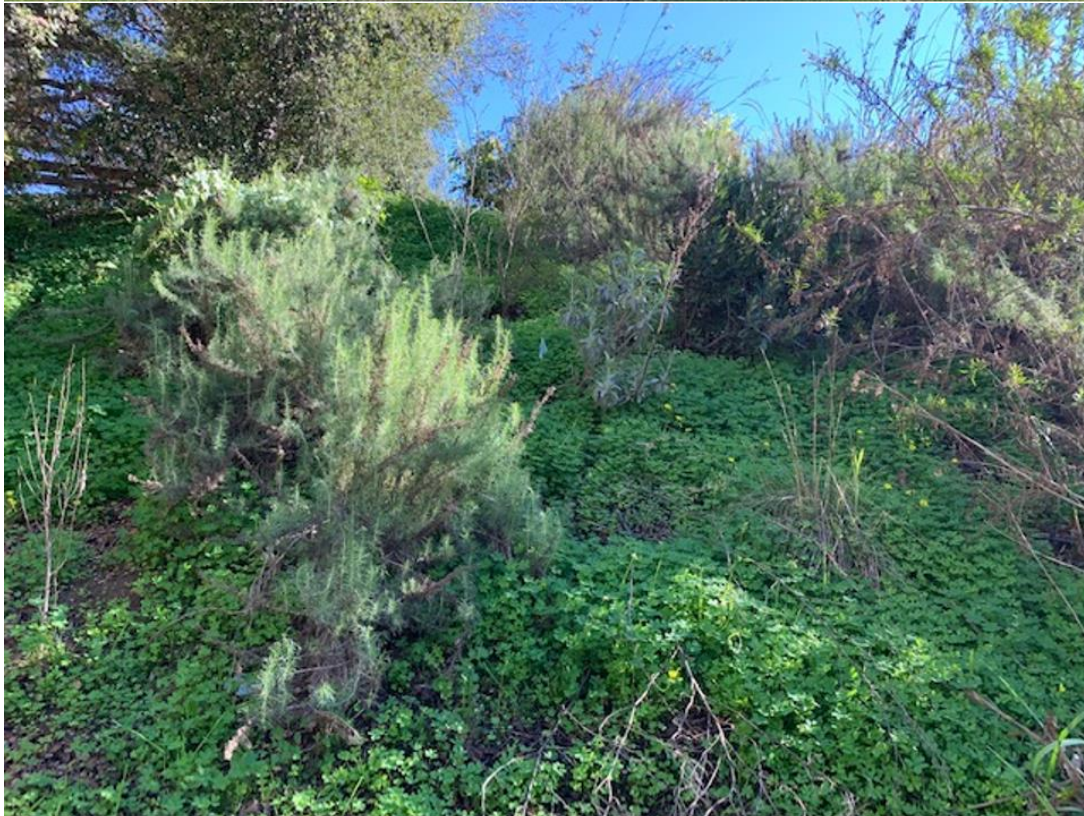
Figure 75. COVA Site #2 showing California sage on left, small white sage in center, and mulefat on right. Understory is dominated by invasive nonnative oxalis. Trautwein. January 23, 2022.
