San Jose Creek Flood Control Revegetation Sites **And Los Carneros Mitigation Bank** **Review and Recommendations**

ENVIRONMENTAL DEFENSE CENTER
October 24, 2022

Natalie Blackwelder, EDC Watershed Program Intern
Brian Trautwein, Senior Analyst / Watershed Program Director

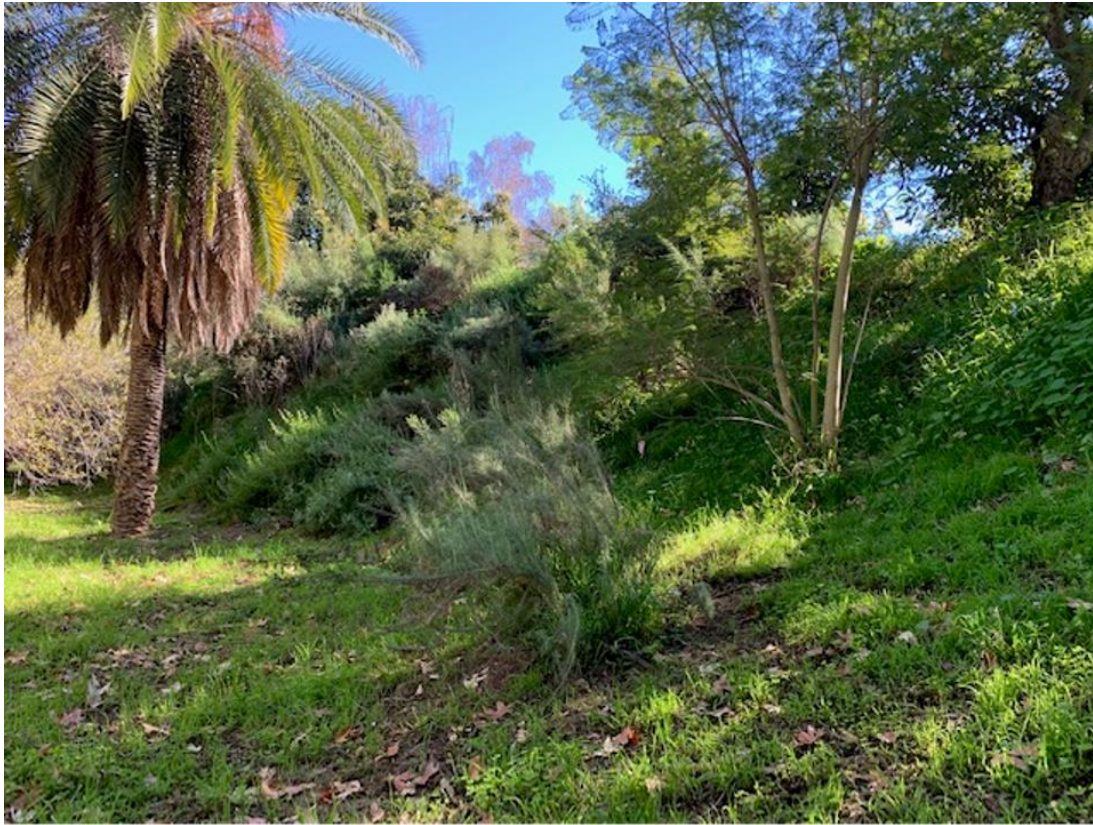
Figure 76. COVA Site #2 with California sage. COVA directed SBCFCWCD to retain nonnative trees in the revegetation sites. Note palm tree and jacaranda tree were inappropriately retained in and adjacent to restoration site. Trautwein. January 23, 2022.

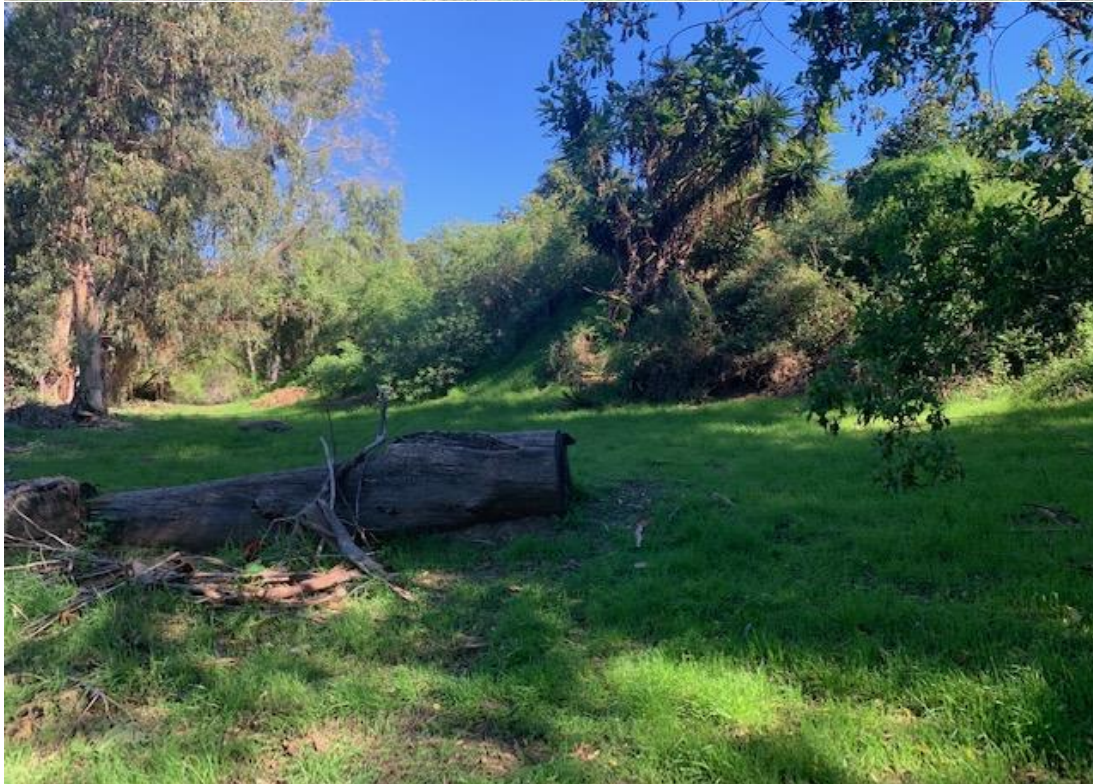
Figure 77. COVA cleared a dense willow riparian habitat including mature willow trees and native understory plants creating a large field of nonnative grasses and forbs approximately ninety feet by thirty feet immediately west of COVA Site #4. Trautwein. January 30, 2022.

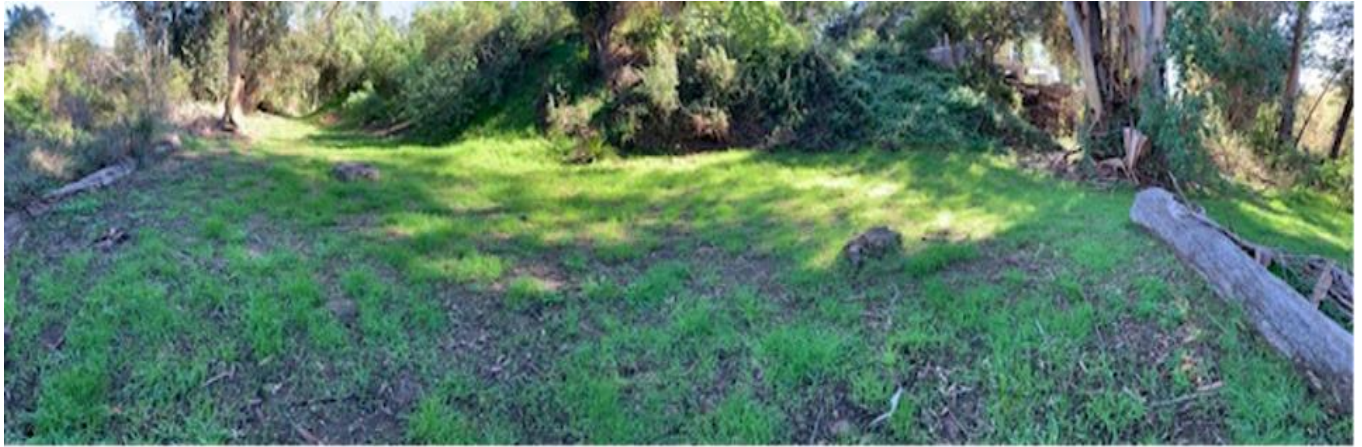
Figure 80. COVA cleared riparian habitat near COVA Site #4. Looking north by northeast to south by southeast. San Jose Creek is located on left side of image. Trautwein. January 30, 2022.

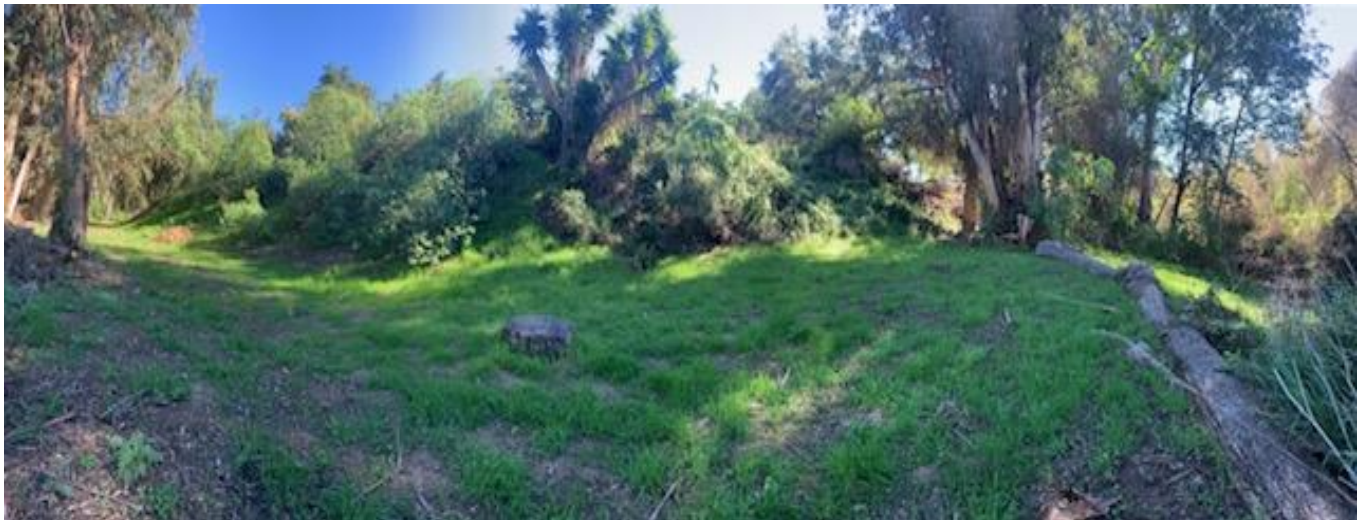
Figure 81. COVA's large riparian habitat removal site (grassy area) west of COVA #4 (upper center portion of image). Trautwein. January 30, 2022.

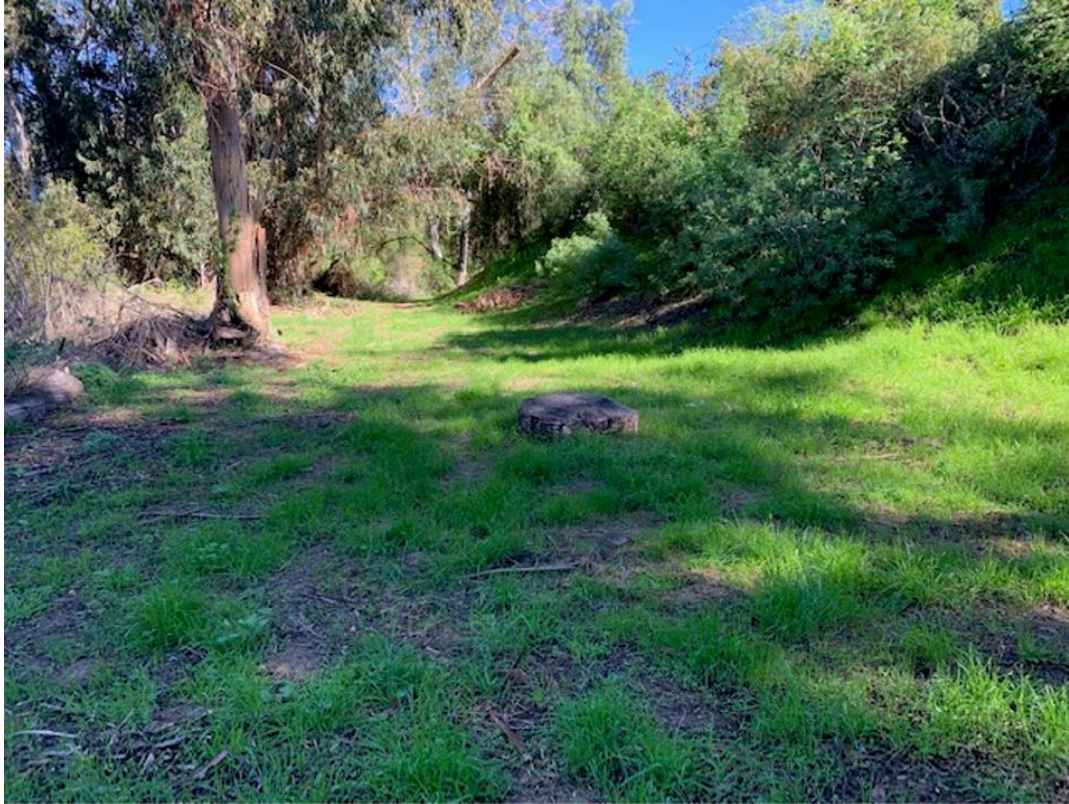
Figure 82. Dense, high-quality riparian habitat was cleared from County property near COVA Site #4. COVA Site #4 is visible in upper right portion of image. Trautwein. January 23, 2022.

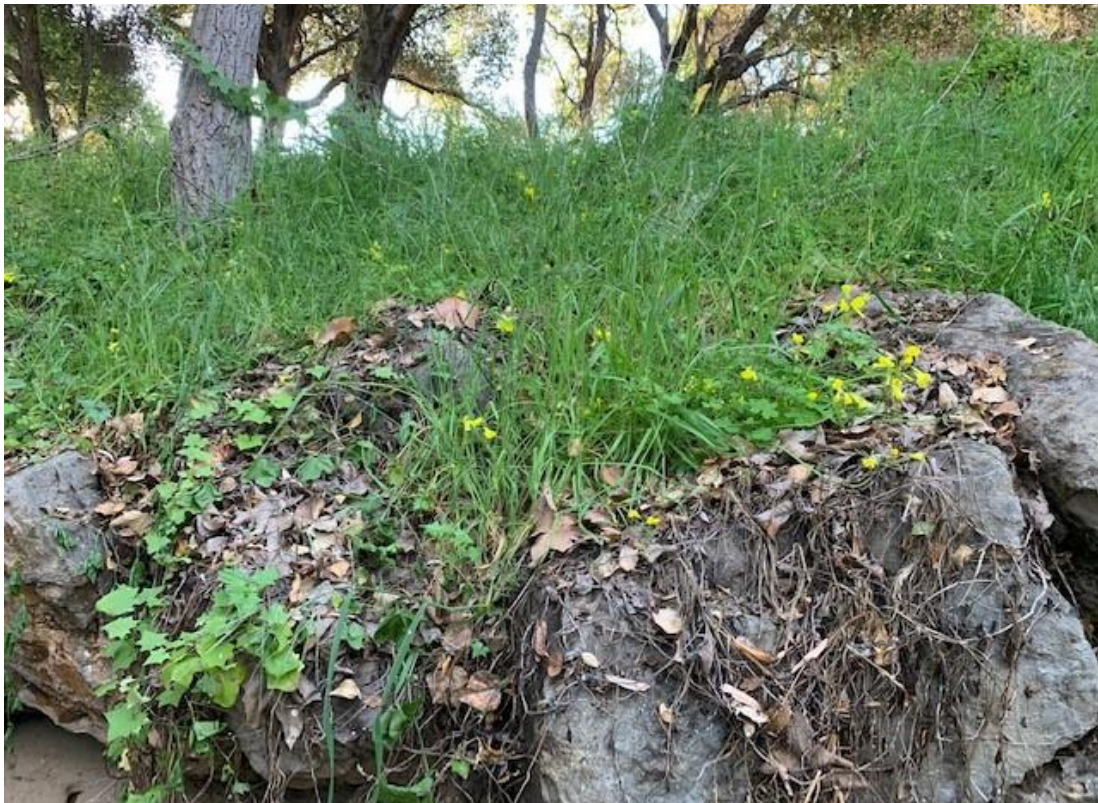
Figure 86. Nonnative, invasive grasses, oxalis, and cape ivy growing over rip rap that was installed as bank stabilization. Trautwein. February 25, 2022.

- Remove and replace nonnative understory, including Cape ivy, oxalis, and Kikuyu grass with natives, including mugwort, wild blackberry, giant wild ryegrass.
- Remove Shamel ash trees and Arundo donax on east bank opposite rip rap.
- Do not use concrete or asphalt in rip rap. Use naturally occurring rocks.
- Plant willow and black cottonwood trees around the rip rap.

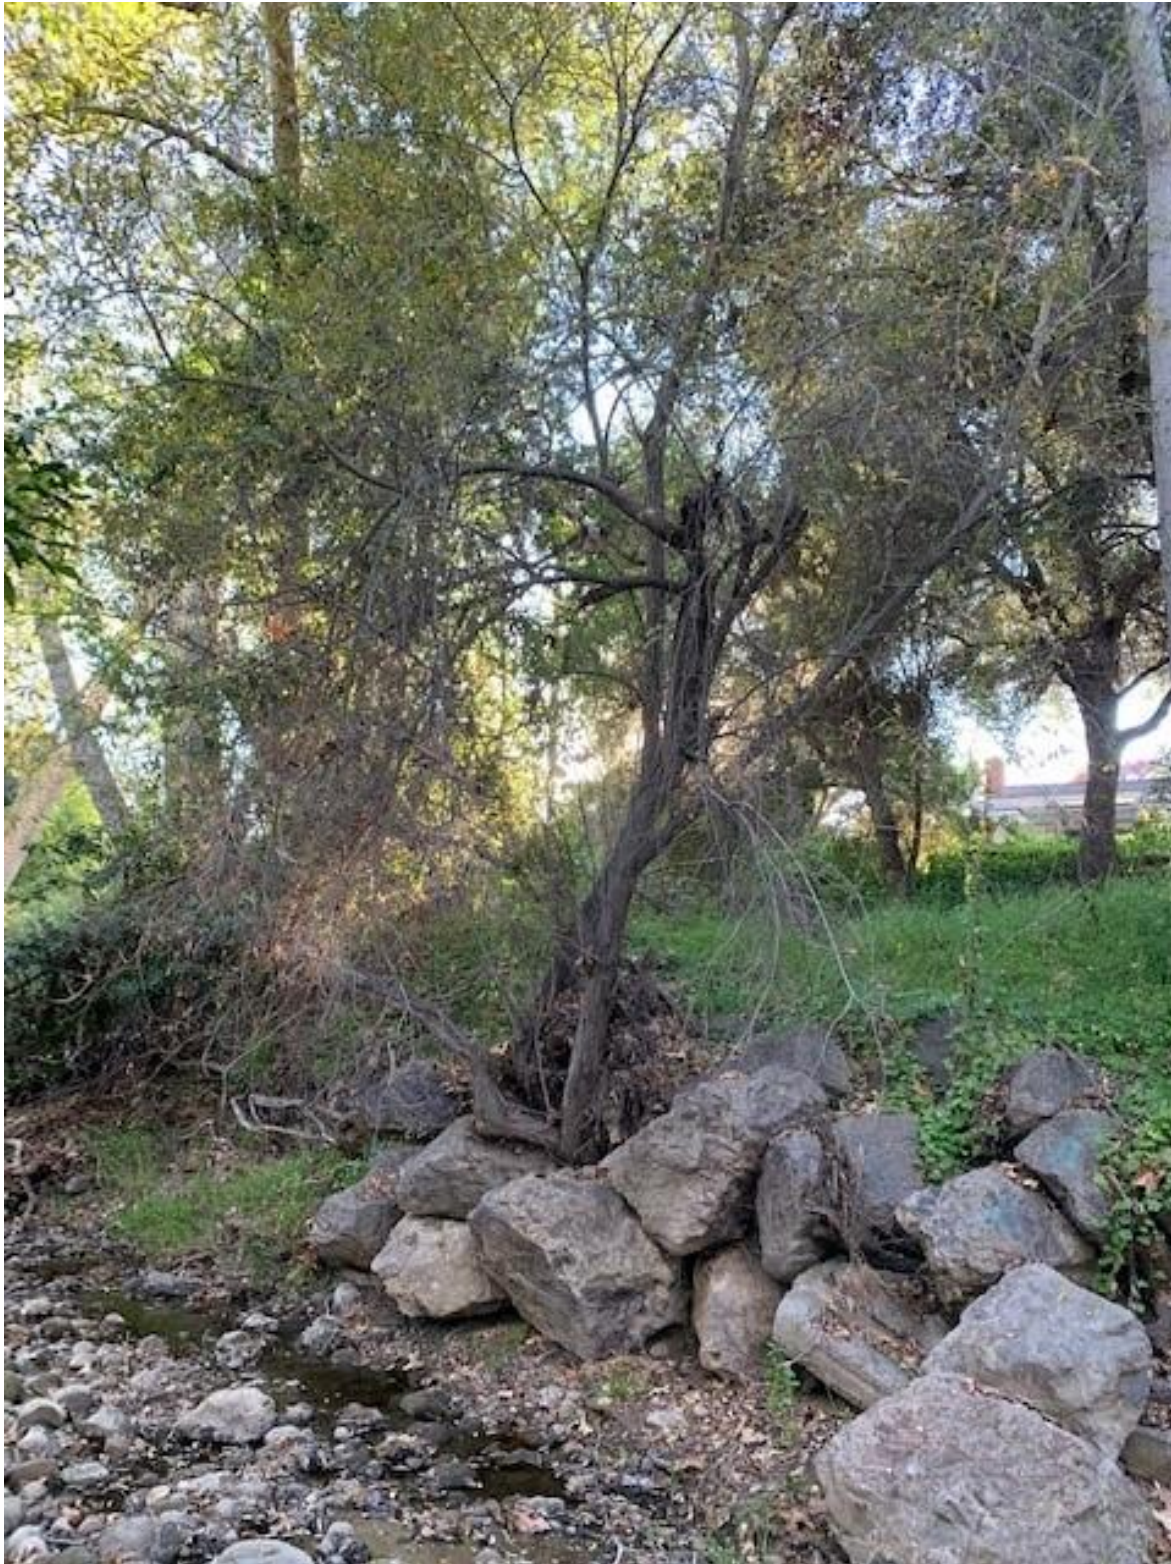
Figure 90. Rip rap with one of two surviving willow trees installed in 1995. February 25, 2022.

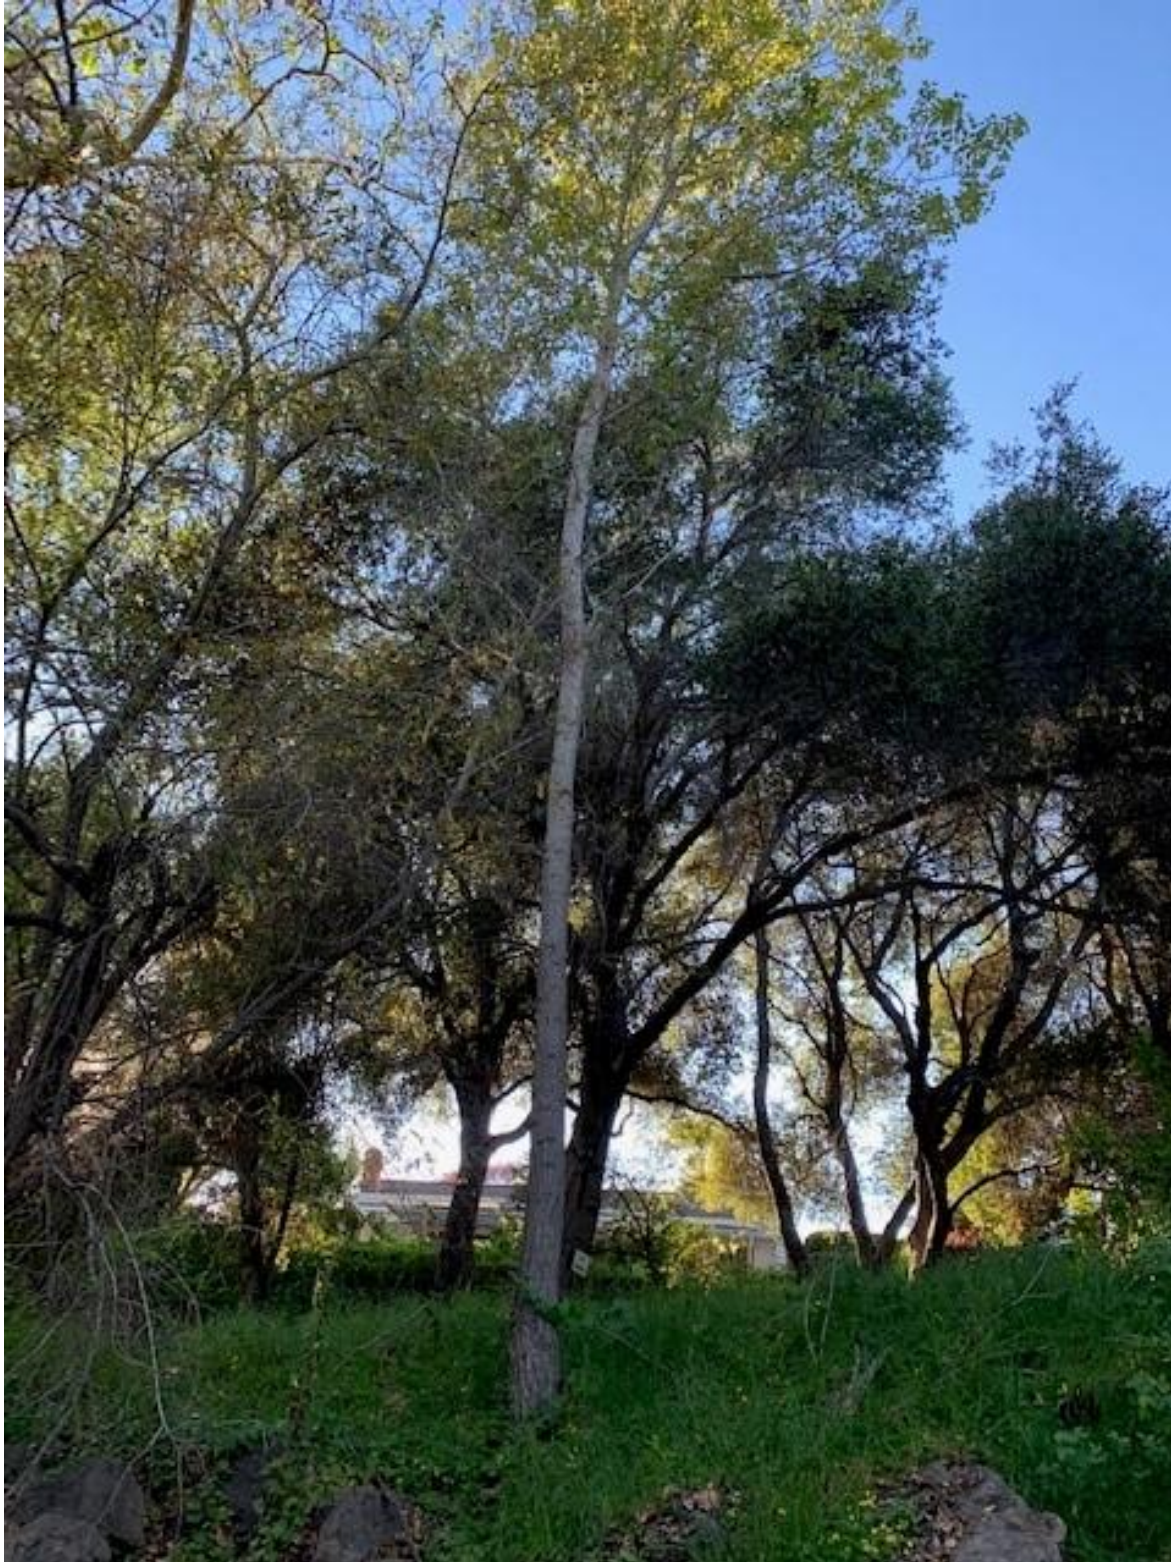
Figure 91. Black cottonwood on creek bank growing above rip rap at Old Footbridge Site. This is believed to be a naturally-occurring tree because only willows were planted in the rip rap. Trautwein. February 25, 2022.

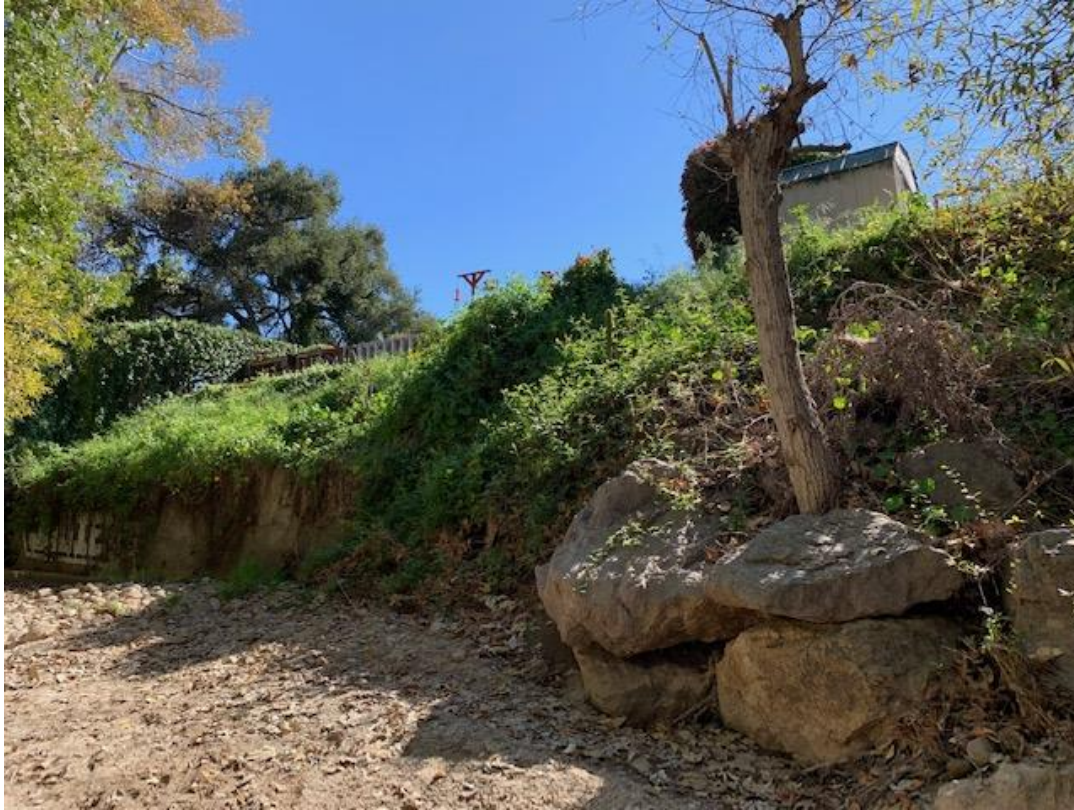
Figure 92. Site known as Seventy-five Feet Upstream from the Berkeley Footbridge. Installed rip rap is supporting native black cottonwood tree. Bank downstream from rip rap lacks native riparian vegetation. Trautwein. February 2022.

- Remove residential shed located on public property. (Figure 92)
- Plant native trees and understory around the rip rap to achieve a higher percent cover at this site.

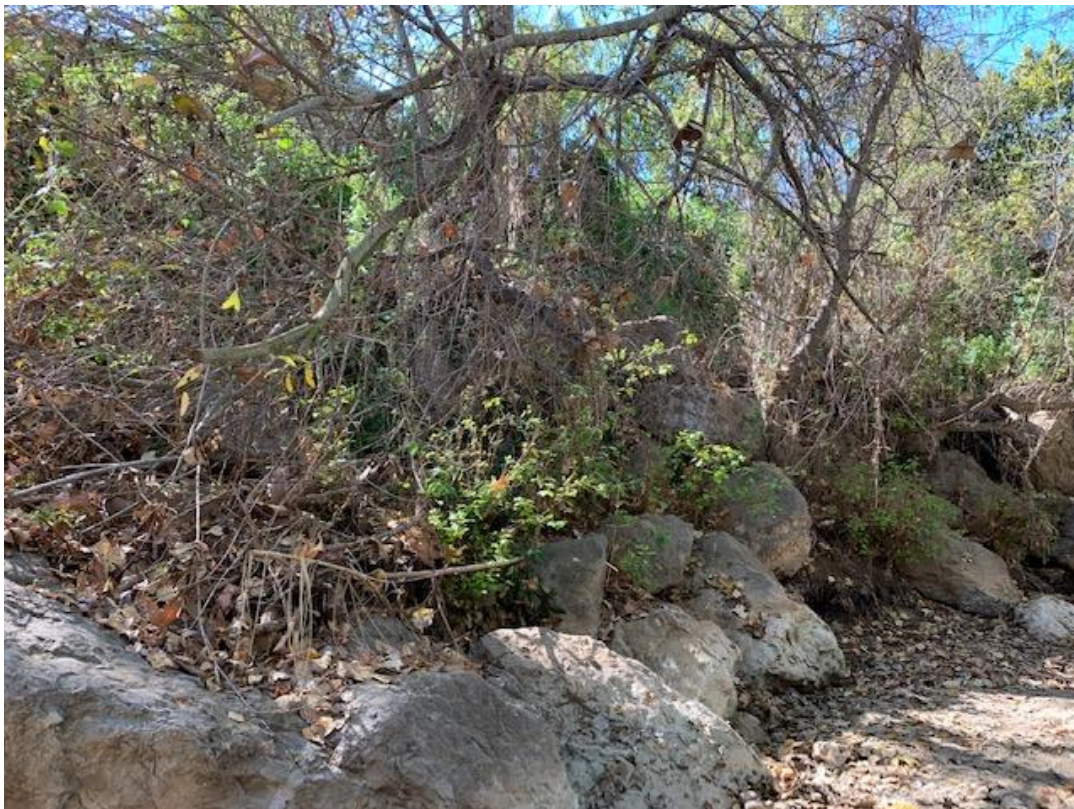
Figure 93. View of rip rap, looking upstream of San Jose Creek. Willows growing out of the rocks and bank. Trautwein. February 2022.

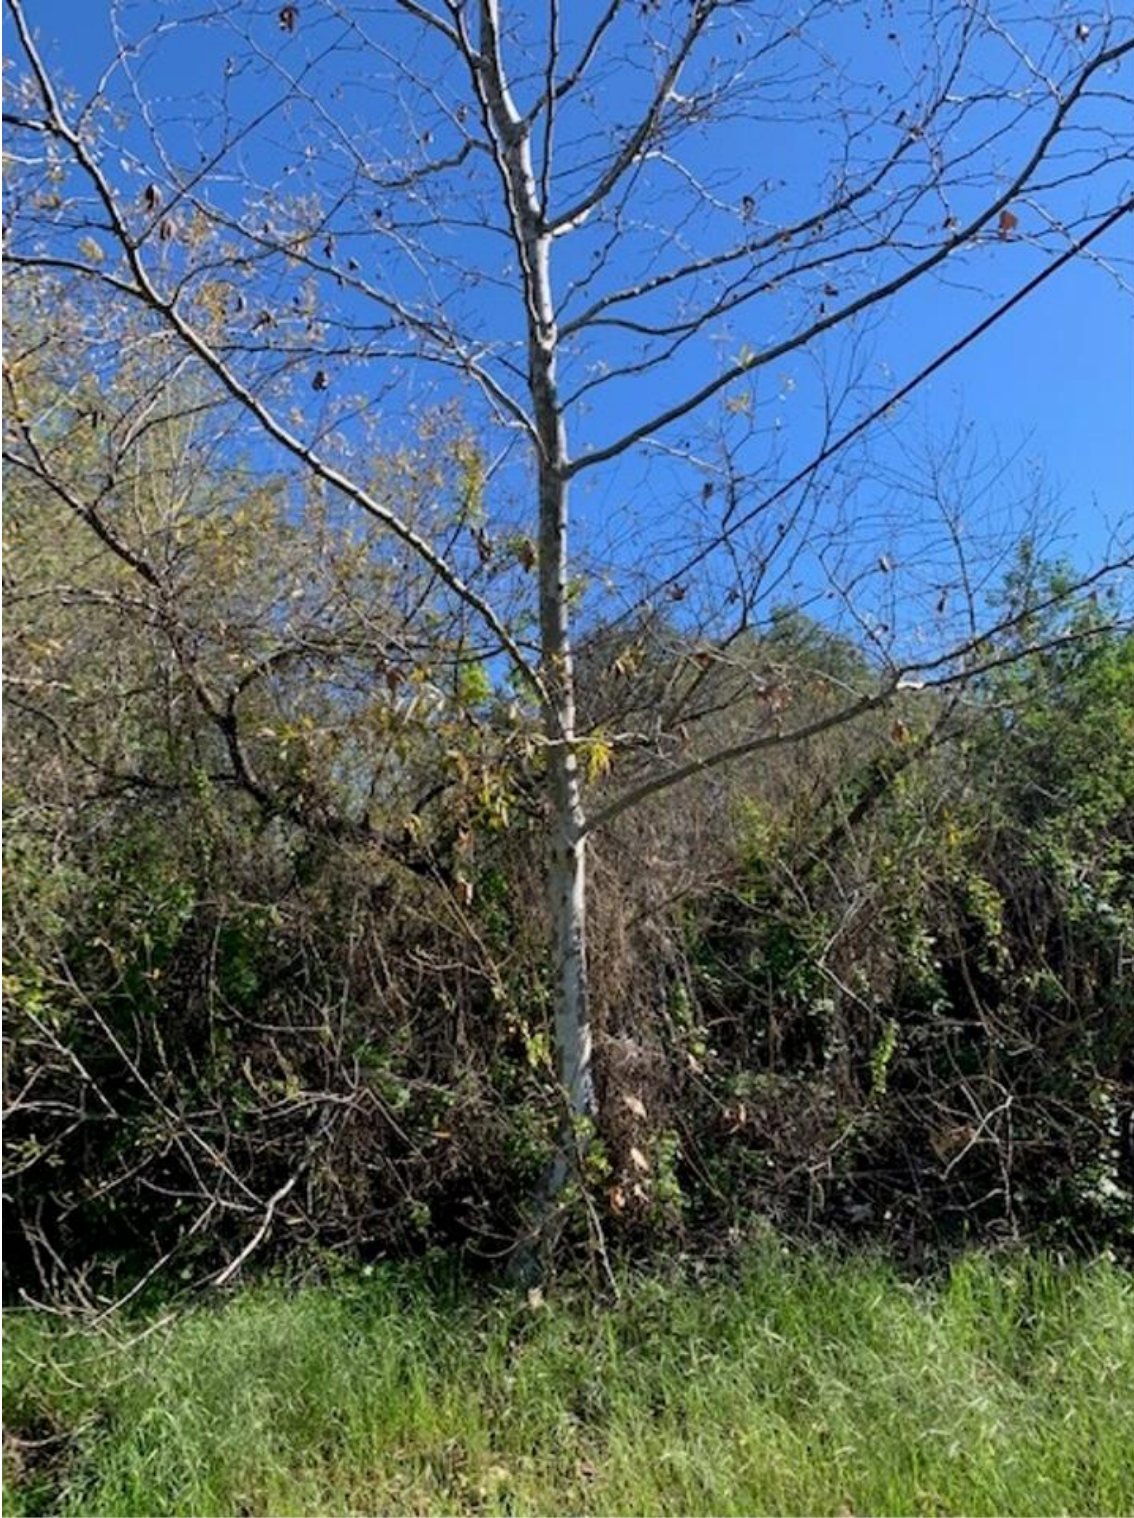
Figure 95. One of two healthy sycamore trees SBCFCWCD planted at the Berkeley Footbridge Site. Trautwein. January 23, 2022.

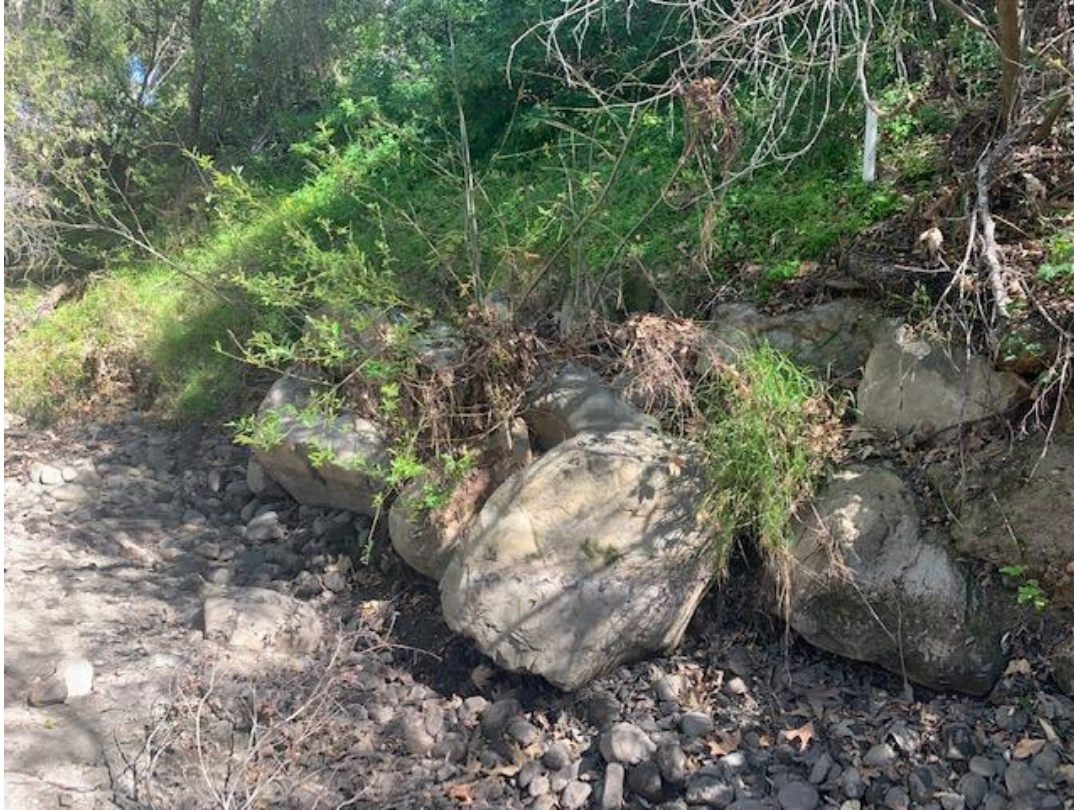
Figure 98. Riprap located on the east bank of Site 23. Young willows are growing out of the rocks are a result of willow brush layering at the time of mitigation. Understory is about 50% nonnative grasses. Trautwein. March 7, 2022.

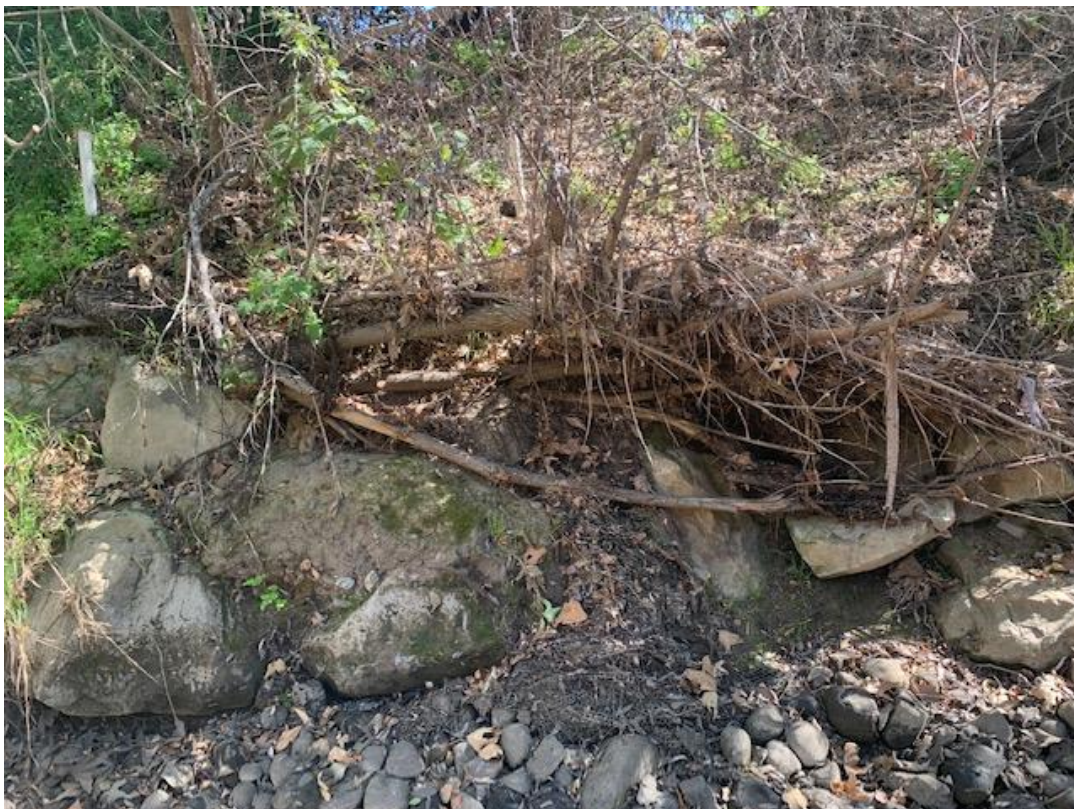
Figure 99. Rip rap and exposed willow layering. Note the upshoots of new willow growth. Trautwein. March 7, 2022.

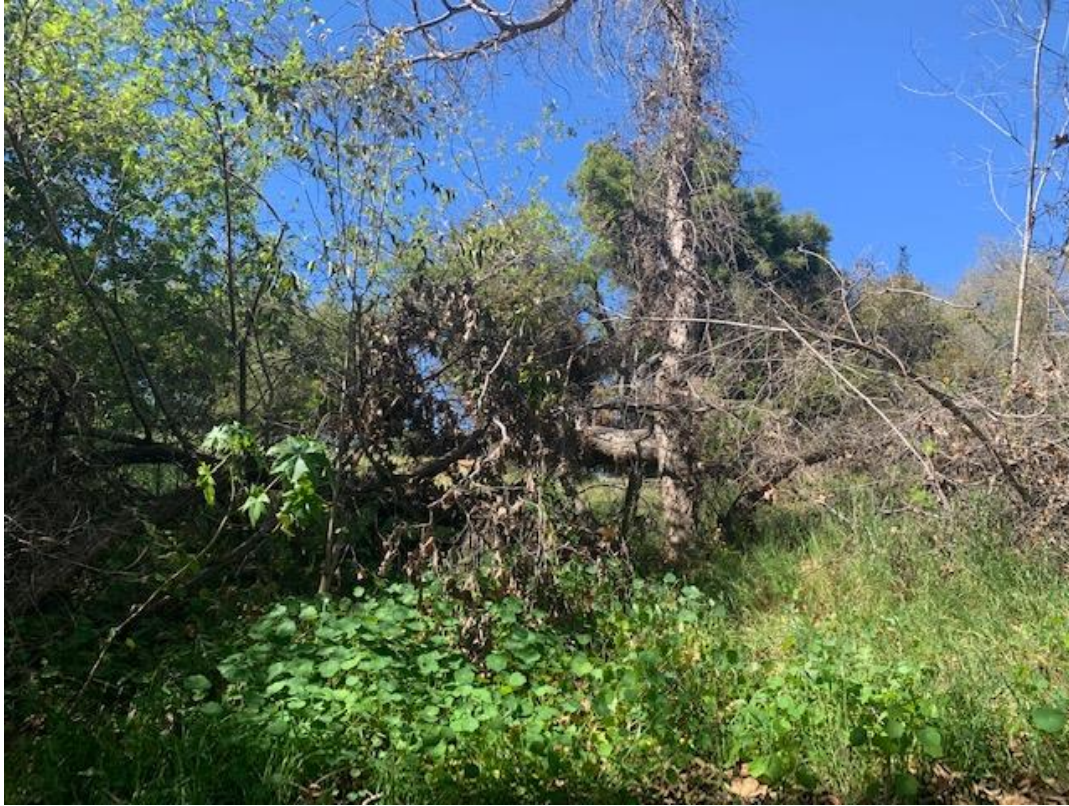
Figure 100. Site 23, about three hundred feet downstream of the Berkeley Footbridge, on the west bank. The understory is primarily nonnative grasses and nasturtium. The overstory is primarily willow, sycamore, and black cottonwood. Trautwein. March 7, 2022.

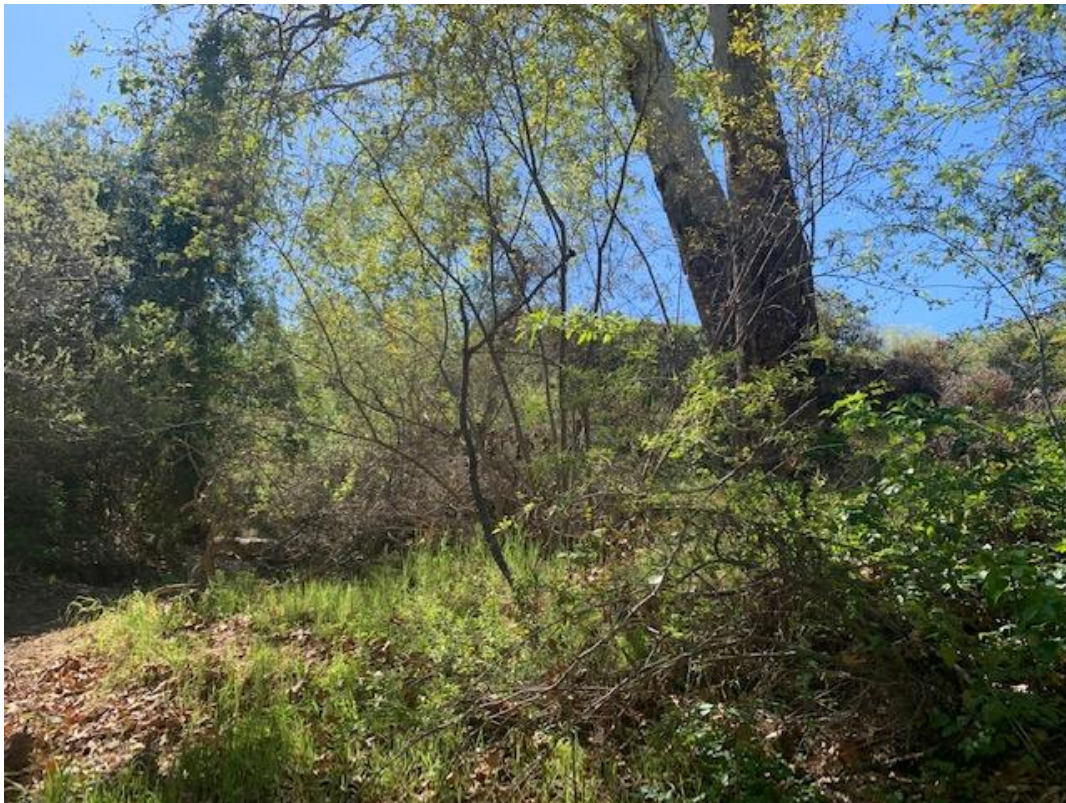
Figure 101. West bank of San Jose Creek at Site 23. Large sycamore in the background from natural recruitment. Understory is primarily nonnative grasses. Willow saplings present on lower bank of Creek. Trautwein. March 7, 2022.

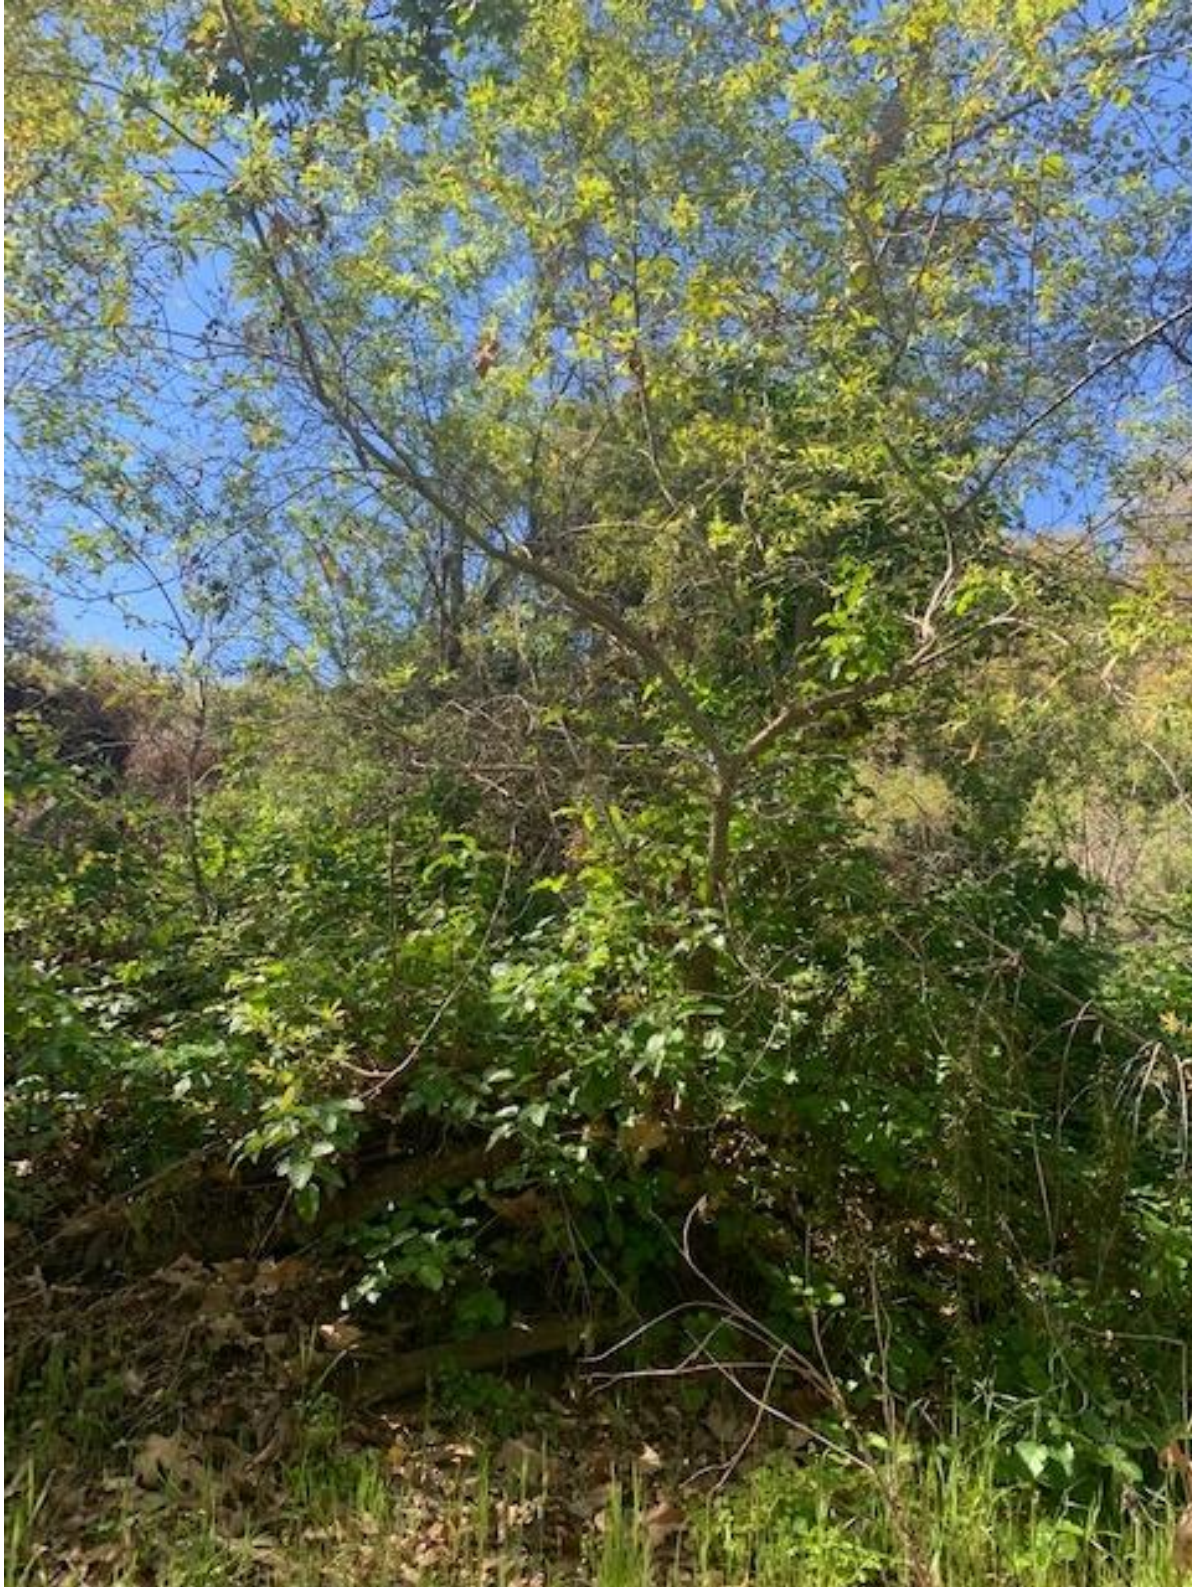
Figure 102. Young willow growing out of a poison oak. Note the nonnative grasses in the foreground. Trautwein. March 7, 2022.

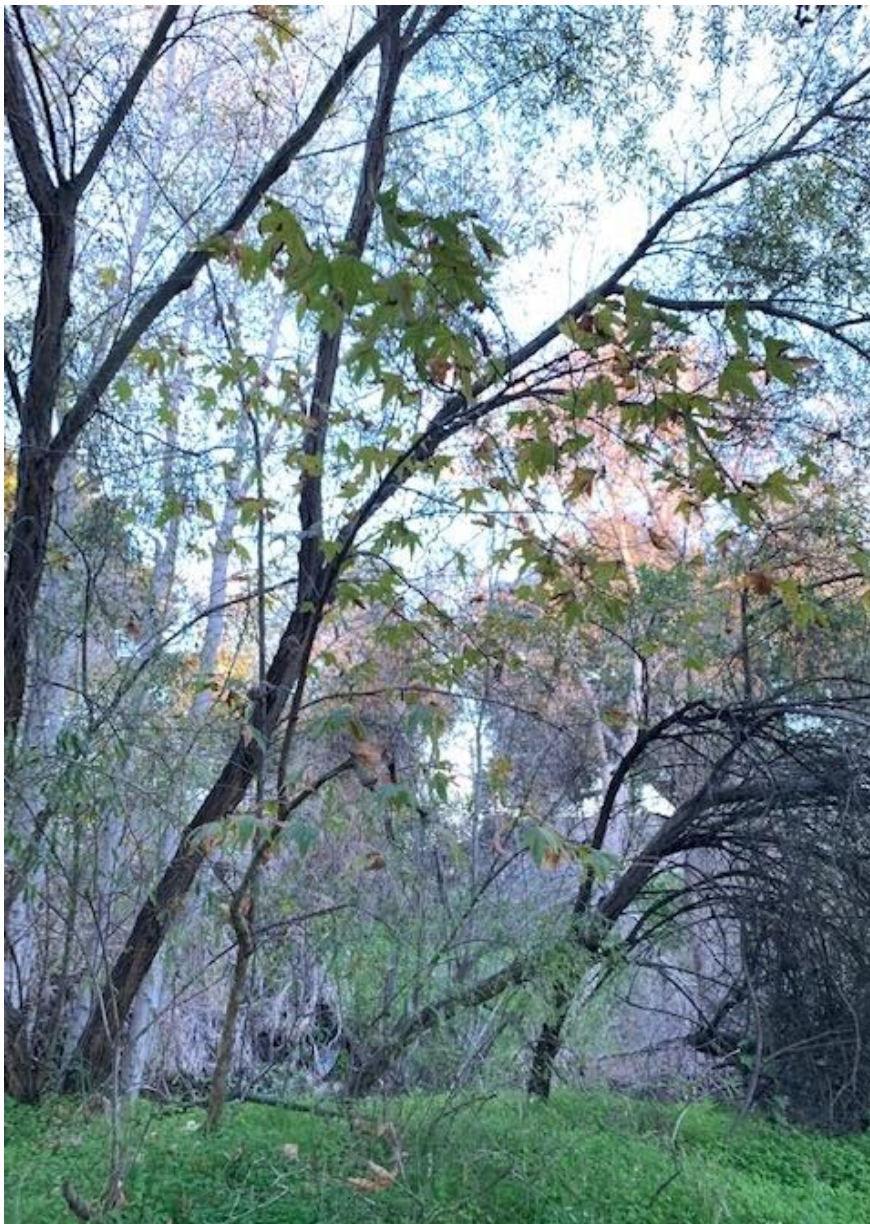
Figure 104. Site 13.
Sycamore tree on west
bank of San Jose Creek
approximately 300 feet
south of Berkeley
Footbridge. Trautwein.
January 27, 2022.

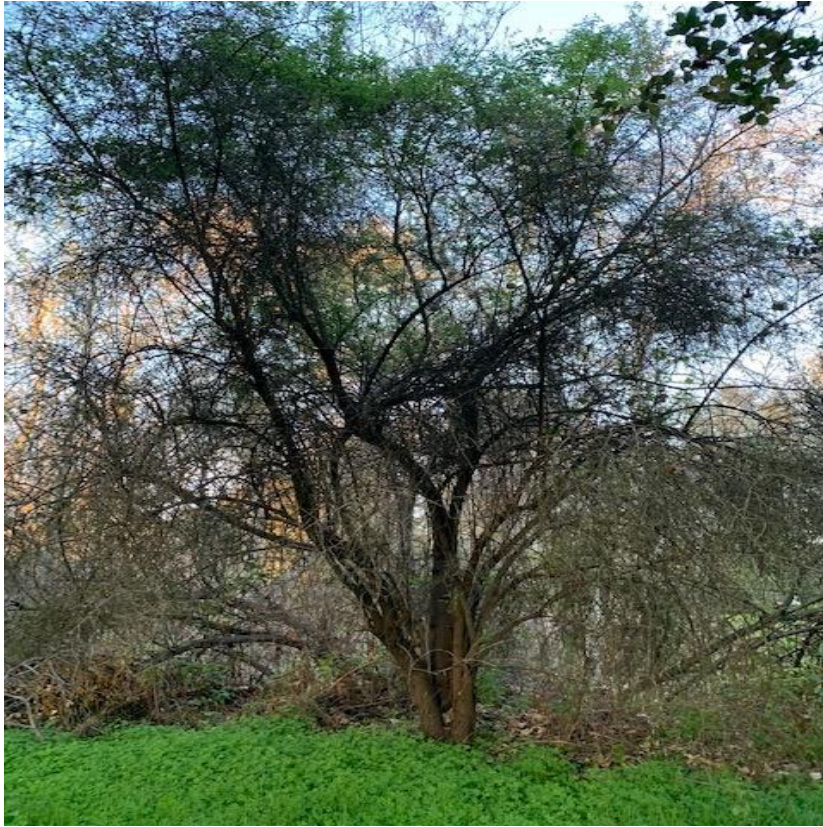
Figure 105. Site 13. Large elderberry on west bank of San Jose Creek approximately three hundred feet downstream from Berkeley Footbridge. Trautwein. January 27, 2022.

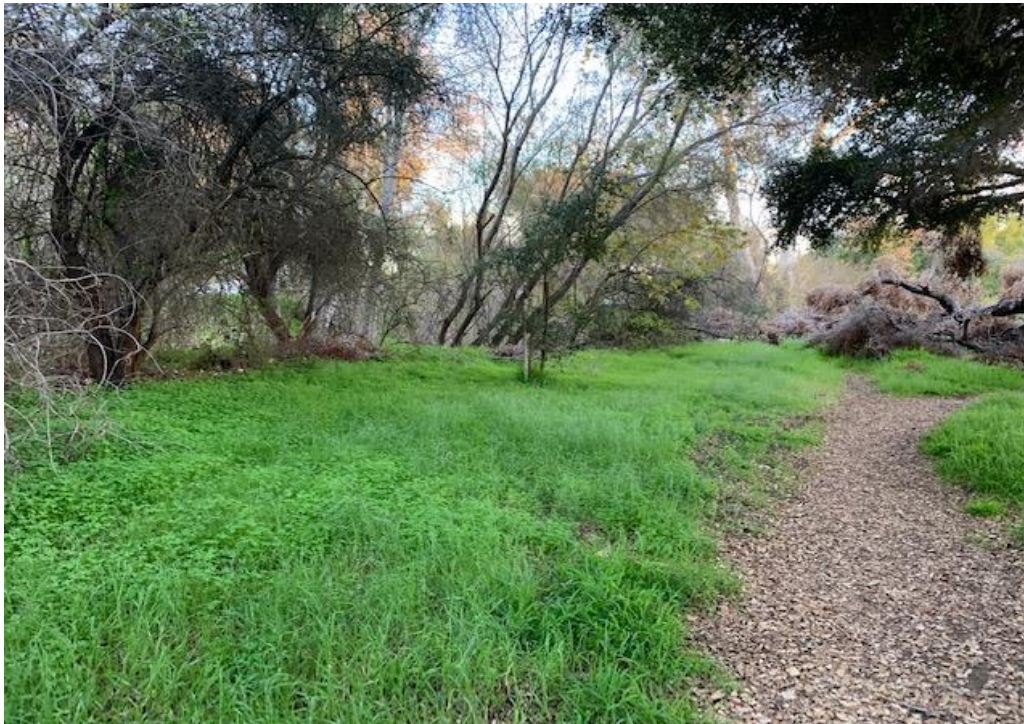
Figure 106. Site 13. Looking south. Approximately three hundred feet south of Berkeley Footbridge on west bank. Note lack of native plants and 100% cover by invasive exotic herbaceous plants except for the immediate bank top. Note sole oak tree in center of image planted in SBCFCWCD's Site 13. It is EDC's understanding that this oak tree was required as mitigation for oak pruning by a Somerset Avenue resident which EDC reported to the City of Goleta. If so, this oak tree cannot be double-counted as mitigation for SBCFCWCD. Trautwein. January 27, 2022.

- Remove all herbaceous plants between access road and creek bank.
- Replant area with blackberries, elderberries, coast live oaks, and coast live oak and riparian understory species to ensure >80% cover within 5 years pursuant to CDFW performance standards. Cage plants to prevent vandalism.
- Control weeds to ensure <5% cover pursuant to CDFW performance criteria.
- Confirm coast live oak planted as mitigation for Somerset Road oak pruning.

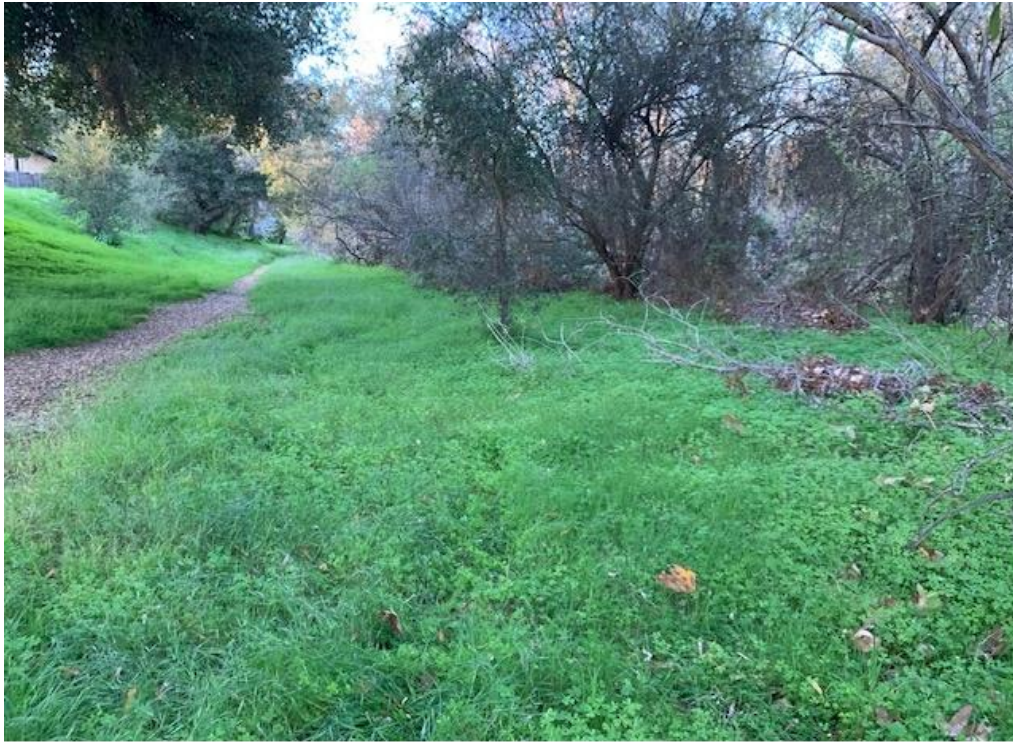
Figure 107. Site 13 looking north toward Berkeley Road. Note sole oak tree believed to be planted as a result of City of Goleta enforcement regarding neighbor oak pruning reported by EDC northeast of Somerset Avenue Accessway. Note absence of native understory plants. Trautwein. January 27, 2022.

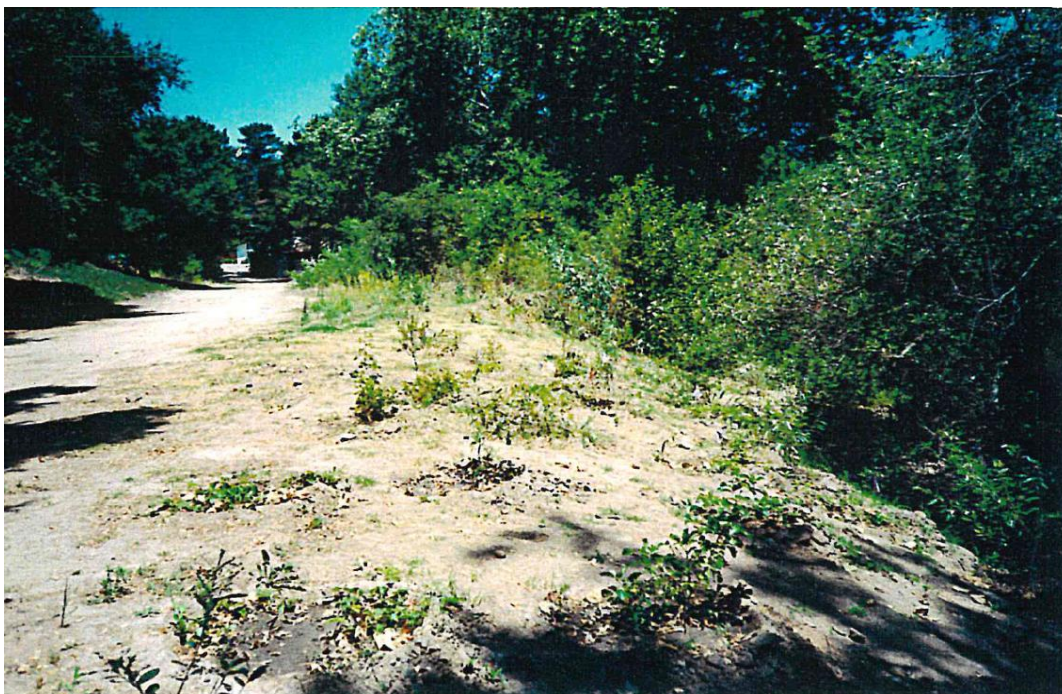
Figure 108. Site #13 in July 2000. Looking north towards Berkeley Road (same perspective as Figure 107 above). Note plants extended west (left) from top of west bank (right side of image) to almost access road/trail. As shown in Figure 107 above, only plants planted immediately atop the Creek bank survived. The remainder of the planted area is dominated by non-native invasive herbaceous plants including oxalis and exotic grasses. Image from SBCFCWCD Annual Maintenance and Revegetation Report. 2000.
