San Jose Creek Flood Control Revegetation Sites **And Los Carneros Mitigation Bank** **Review and Recommendations**

ENVIRONMENTAL DEFENSE CENTER
October 24, 2022

Natalie Blackwelder, EDC Watershed Program Intern
Brian Trautwein, Senior Analyst / Watershed Program Director

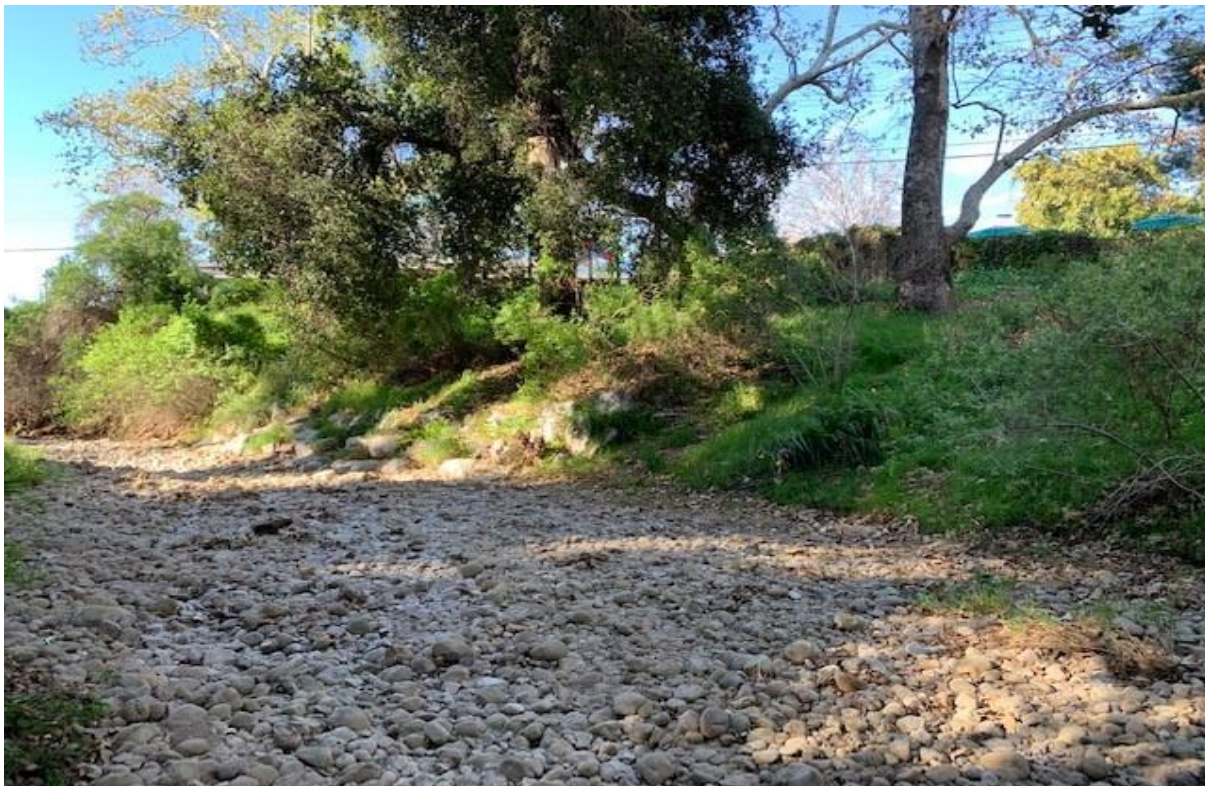
Figure 110. Looking downstream San Jose Creek at the Somerset Access Ramp Site. The west bank hosts a large sycamore, some oaks, nonnative grasses, elderberry, wild giant rye grass, and mulefat. Trautwein. February 2022.

- Remove oxalis and nonnative grasses for two consecutive years.
- Remove Shamel ash sapling at base of rock rip rap bank repair site
- Plant two coast live oak trees.
- Replant twenty wild blackberry and 10 giant wild ryegrass plants at 5-ft centers after oxalis and nonnative grasses are eradicated.
- Plant one hundred mugwort plants on one-foot centers.
- Water and weed until established, percent cover of invasive herbaceous plants is <5%, and percent cover of native plants increases to at least 80% pursuant to CDFW SAA success criteria.

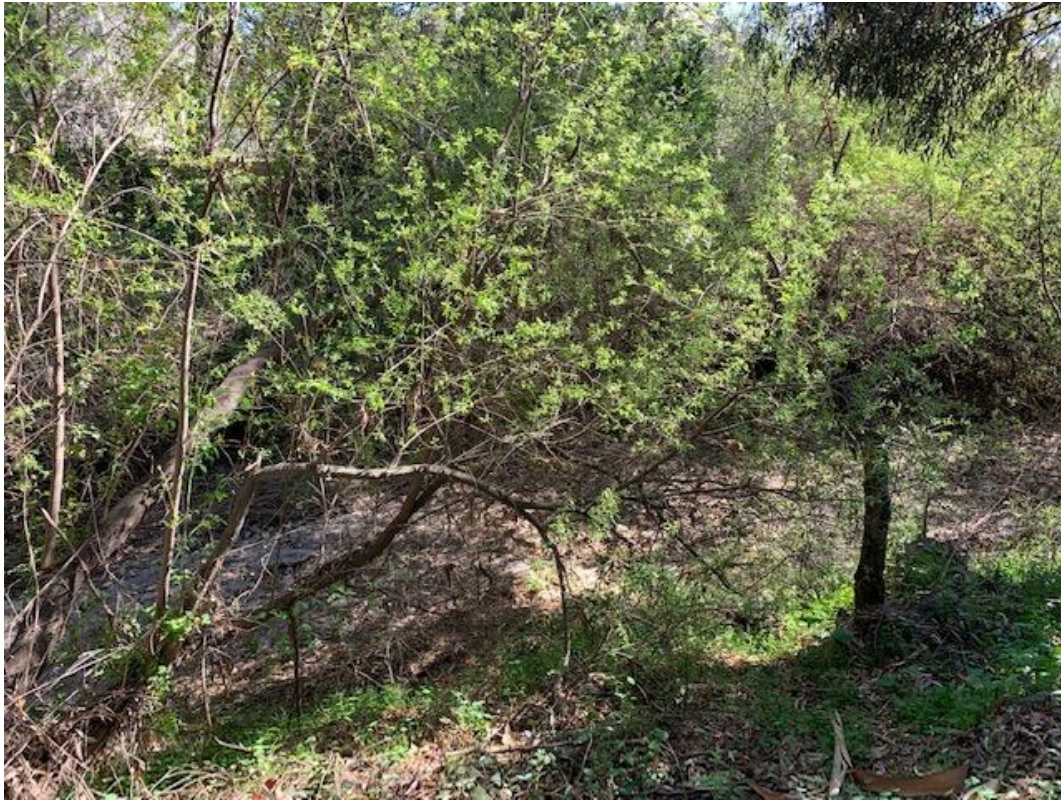
Figure 117. San Jose Creek Highway 101 Revegetation Site on west bank looking east across Creek. Several remaining willows from the 1996 revegetation project. Trautwein. February 18, 2022.

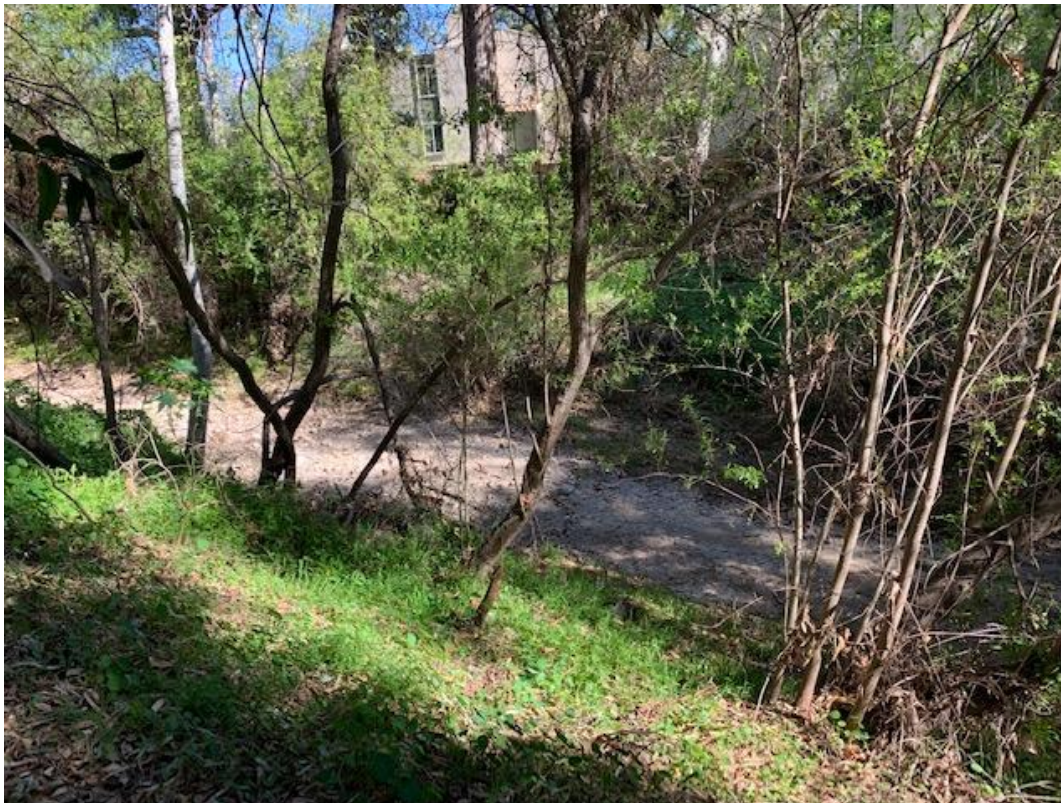
Figure 118. View from west bank looking northeast showing several remaining willows from 1996 revegetation project. Ground cover is nonnative grasses and nasturtium. Trautwein. February 18, 2022.

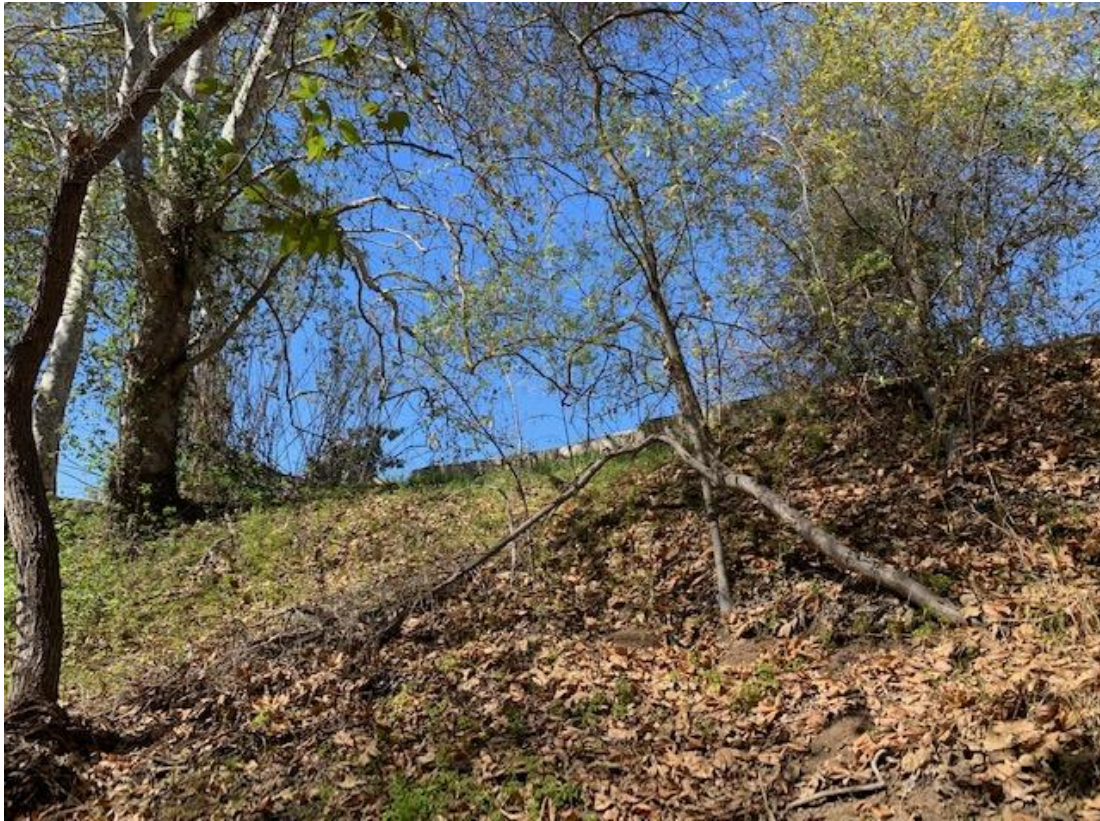
Figure 121. Several remaining willow trees are present at the Hanson Aggregate Site on the west bank of San Jose Creek beneath large sycamores. The bank is covered by nonnative plants such as oxalis and kikuyu grass. Note the concrete block wall at the top of the bank. Trautwein. February 18, 2022.

- Remove the nonnative species present and replace with native understory, including blackberry, native shrubs, including wild rose, toyon, and lemonade berry, as well as native trees, such as willows, sycamores, California bay laurels and/or cottonwoods.
- Report the block wall to the City and CDFW to ascertain permit status.

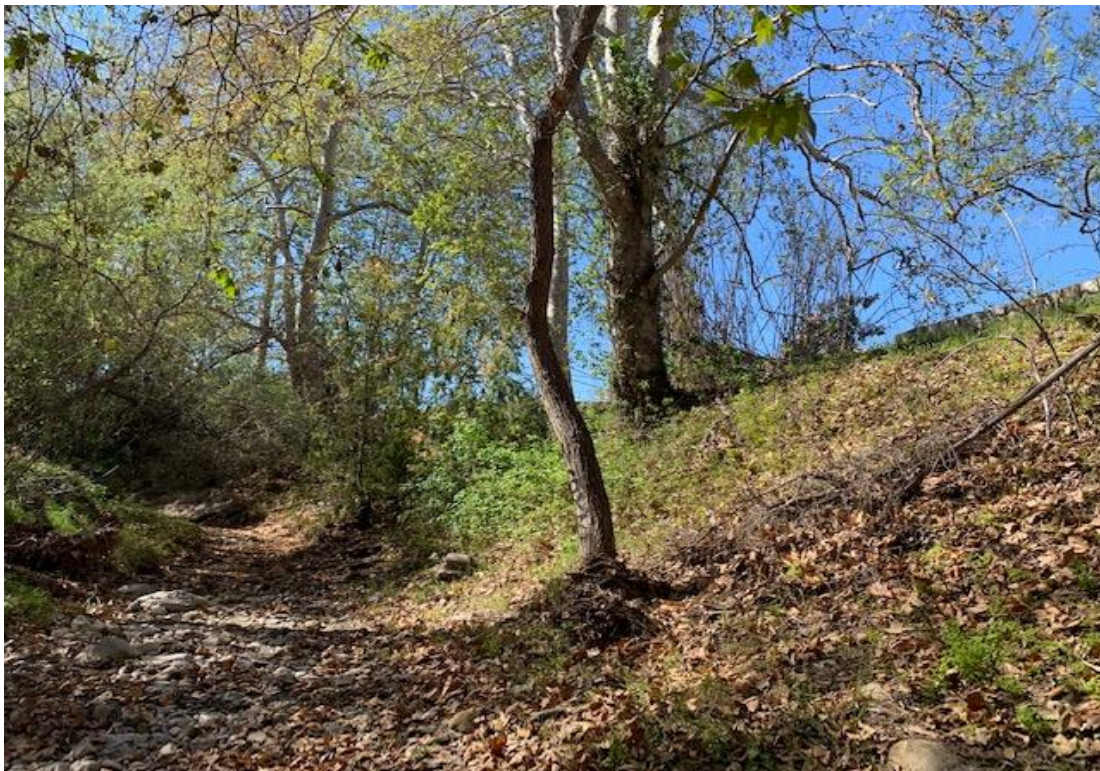
Figure 122. Looking downstream along the west bank of San Jose Creek at the Hansen Aggregate Site. One of remaining willow trees from 2003 revegetation is present in the foreground and several large sycamores in background. Willows. Trautwein. February 18, 2022.

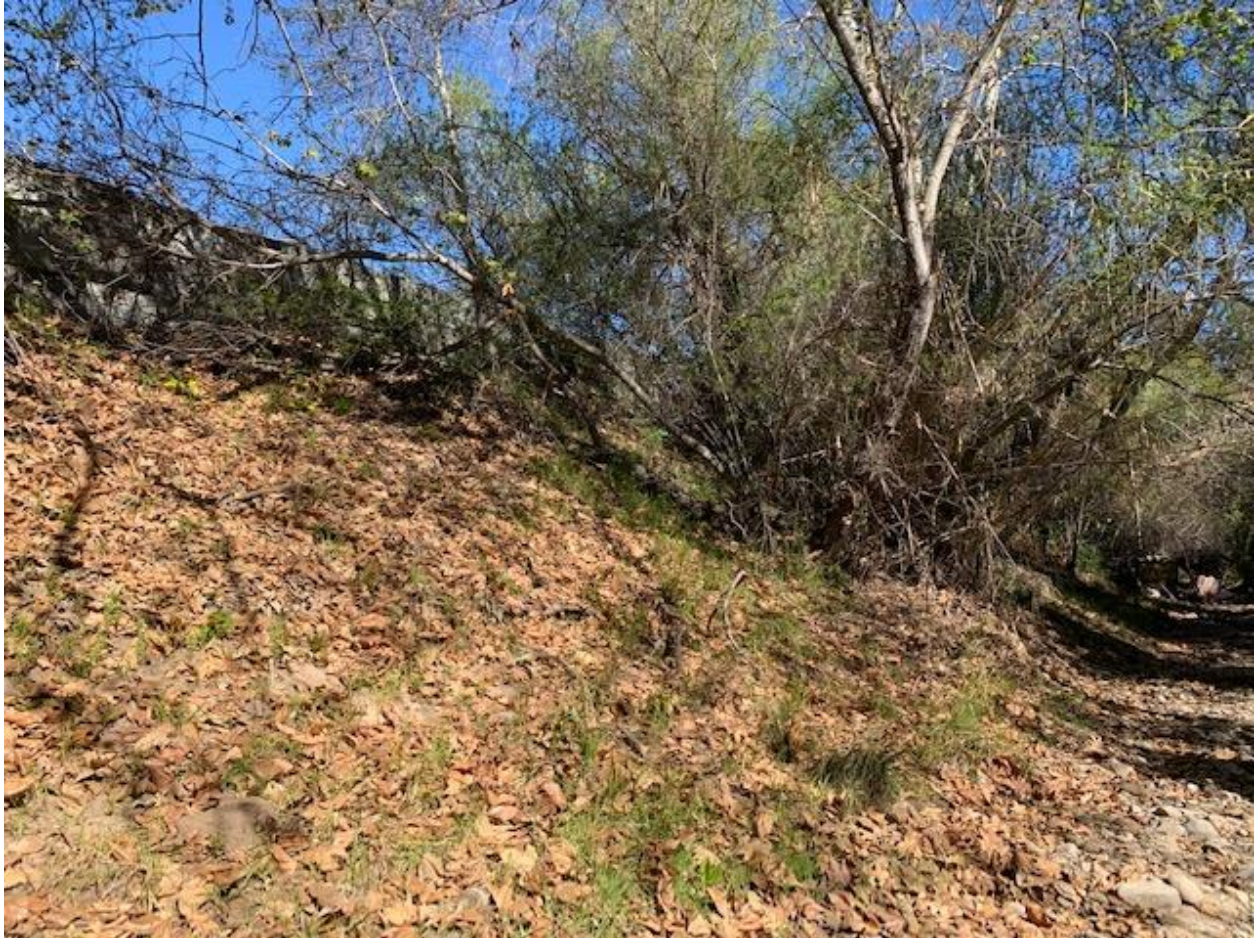
Figure 123. Looking downstream along San Jose Creek at the Hansen Aggregate site. There are wild roses surviving from the 2022 revegetation project and these are spreading underneath the canopy of sycamores and willows. Trautwein. February 18, 2022.

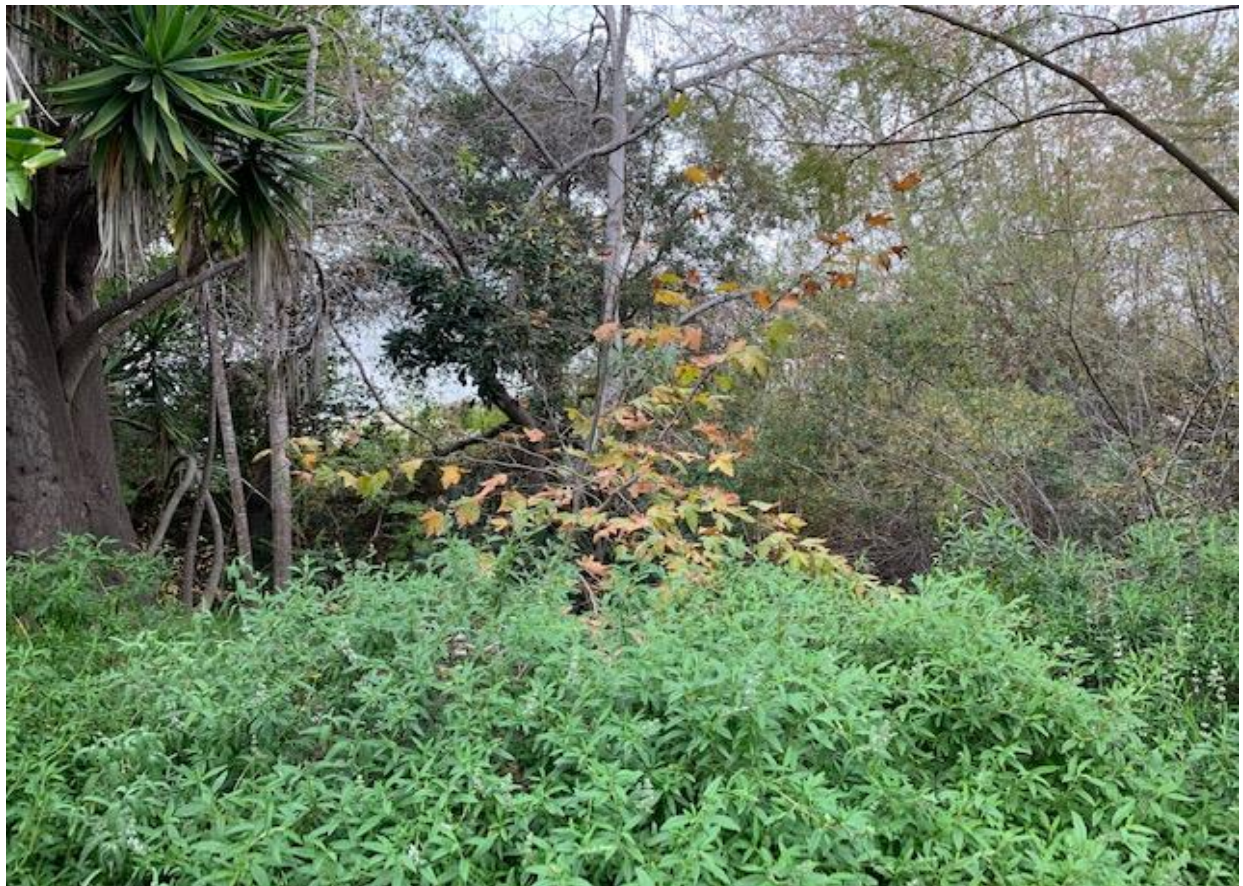
Figure 125. La Goleta Site Section #1. Healthy black sage (lower third of image) and sycamore sapling middle center. Trautwein. January 31, 2022.

- This site includes greater plant species diversity than many of the other revegetation sites evaluated.
- The plants are generally healthy, especially the black sage. (Figure 125)
- The location of Section 1 provides a good buffer between the condominiums, parking lot, and Creek.

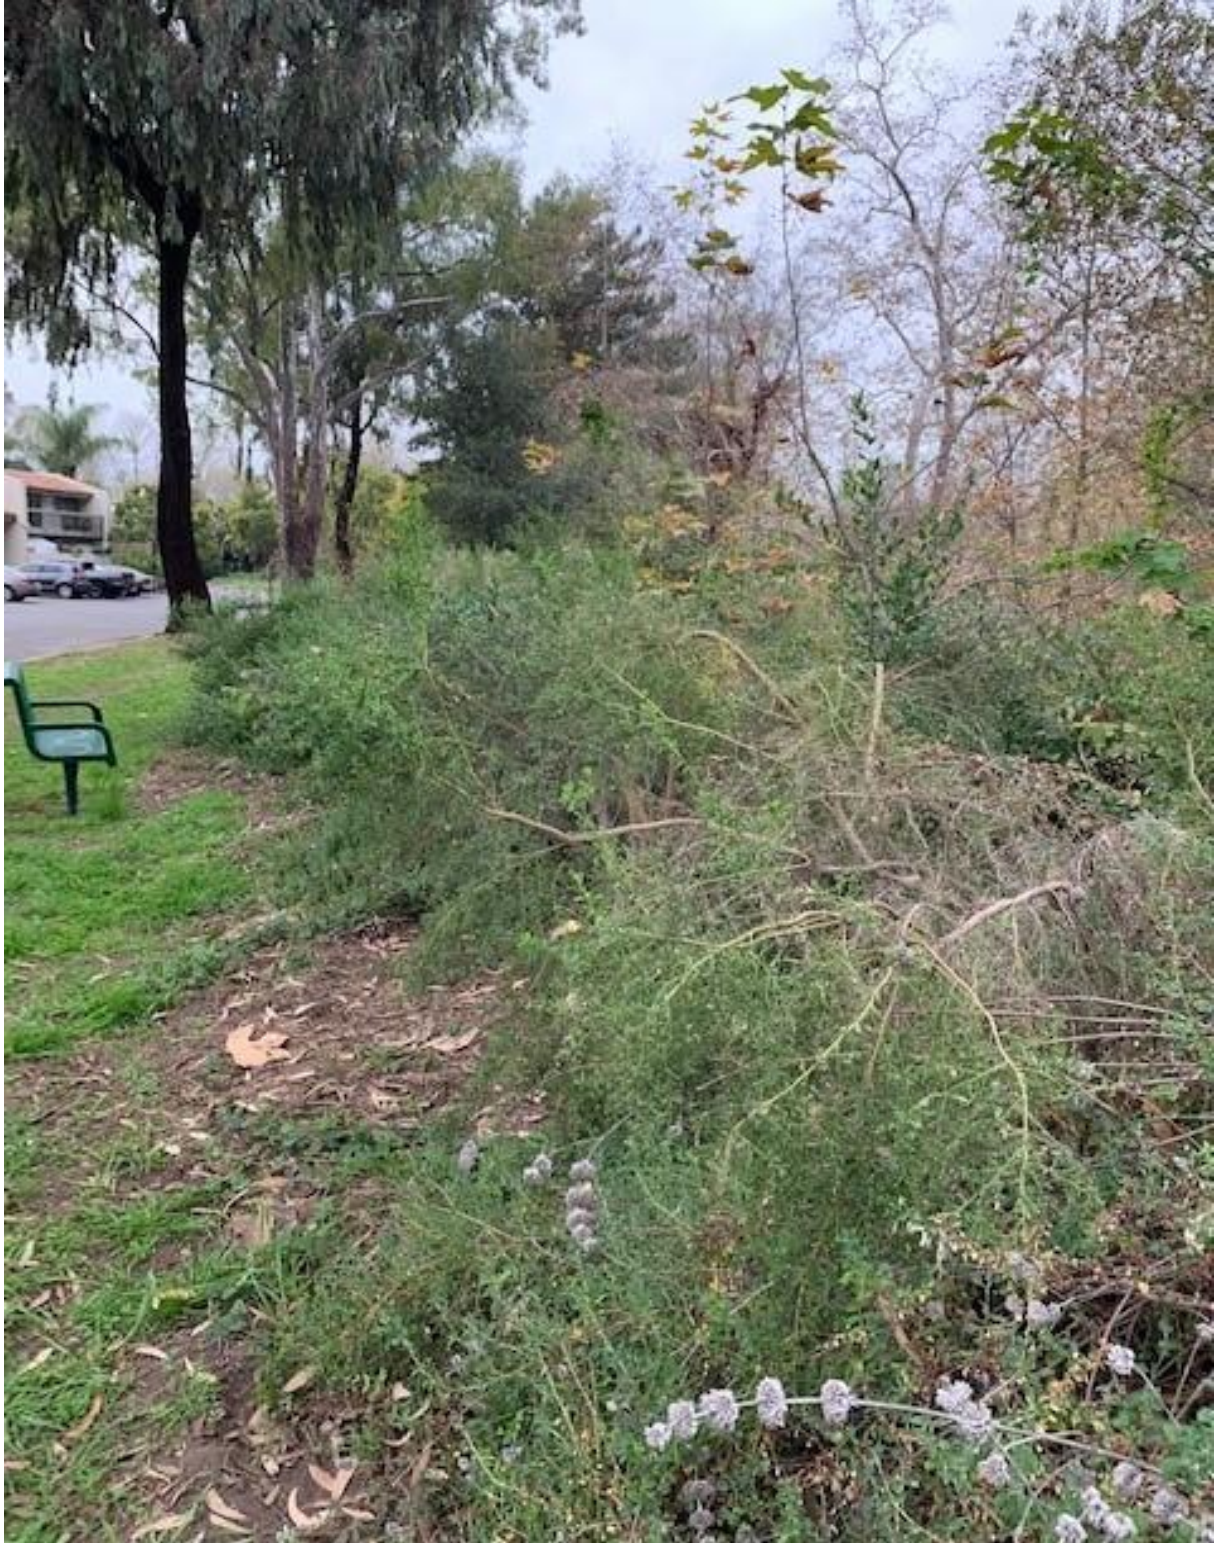
¹⁹³ Numerous coyote brush throughout the site were severely pruned adversely affecting their general condition and contribution to the restored habitat. (Figure 128)

Figure 128. Coyote brush, purple sage, black sage, lemonade berry, and sycamore at La Goleta Site Section 5. Coyote brush was pruned heavily. Trautwein. February 2022.

- Do not prune or trim the coyote brush – these plants have been unnecessarily cut back. (Figure 128)
- Remove the nonnative kikuyu grass.
- Increase percent cover of natives to 80% or 90% to ensure CDFW cover-based performance criterion is met or exceeded.
- Future planting of willows should be placed closer to the creek bed where water access is more available.

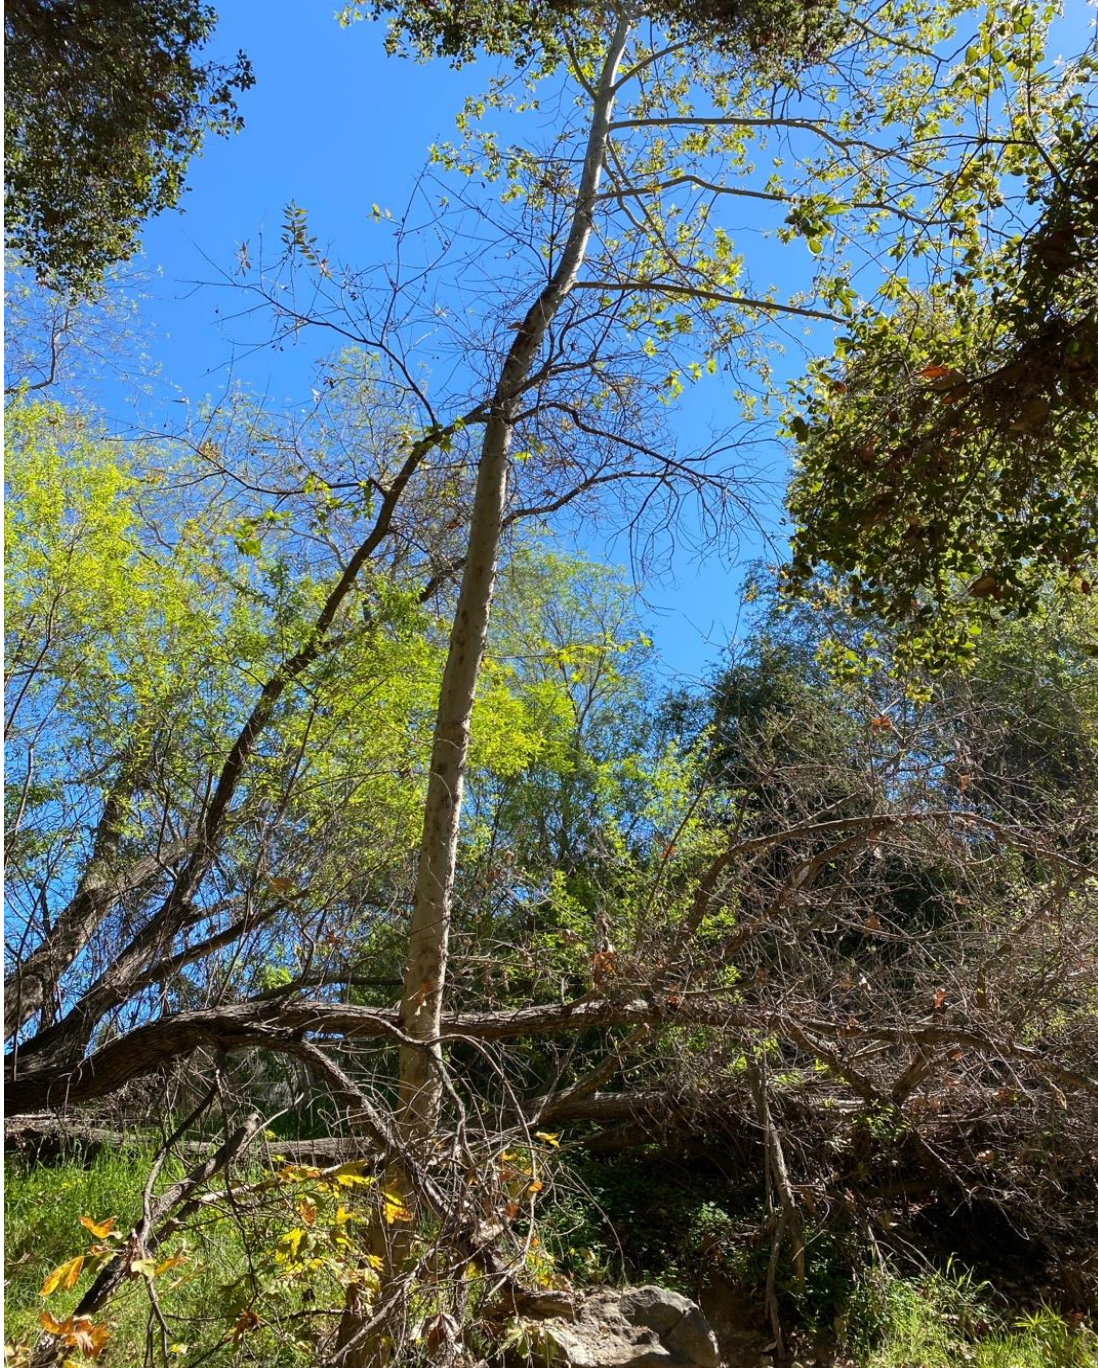
Figure 130. Four native tree species including black cottonwood, sycamore, willow, and coast live oak are present at the Armitos Road Site. Blackwelder. February 28, 2022.

- Remove nonnative species from understory and replace with native mug wort, blackberry, and giant rye grass.
- Remove Shamel ash, castor bean, bottlebrush, and Eucalyptus trees. Replace with native woody species like cottonwood, sycamore, and willow and oak trees farther away from the Creek.

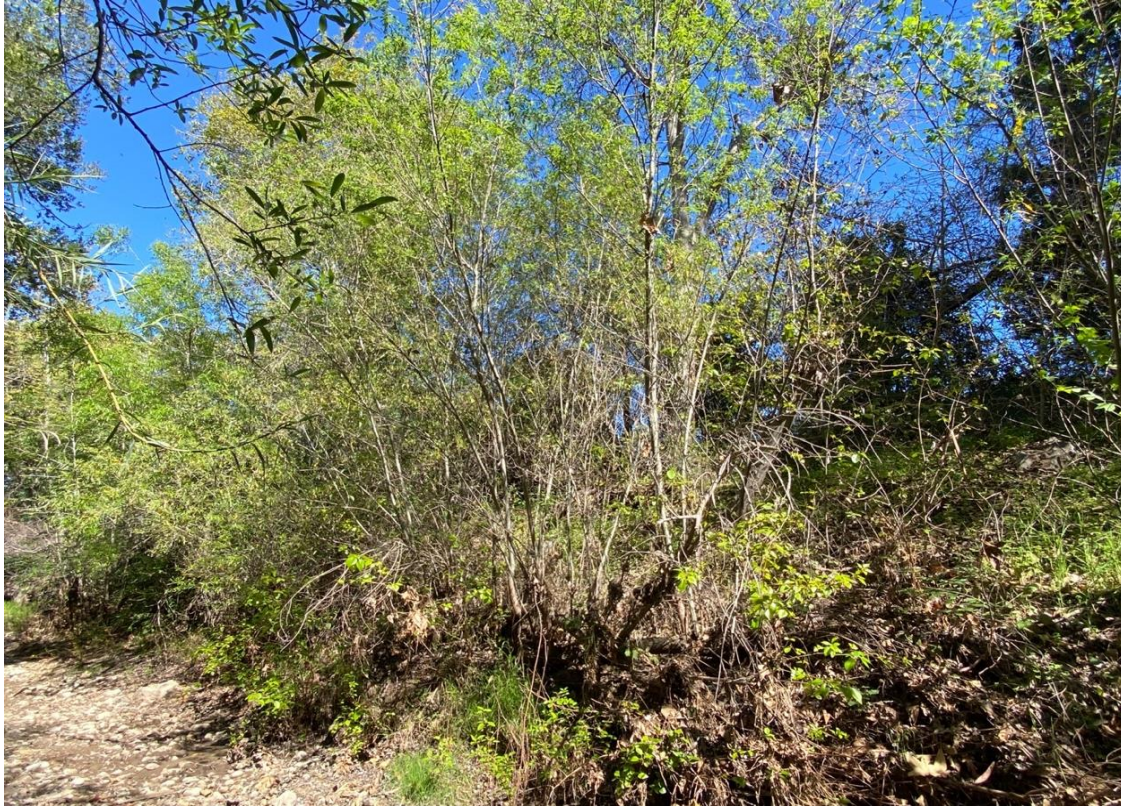
Figure 131. Looking upstream at the Armitos Site. Several young willow and cottonwood trees populating the east bank of San Jose Creek. Blackwelder. February 28, 2022.

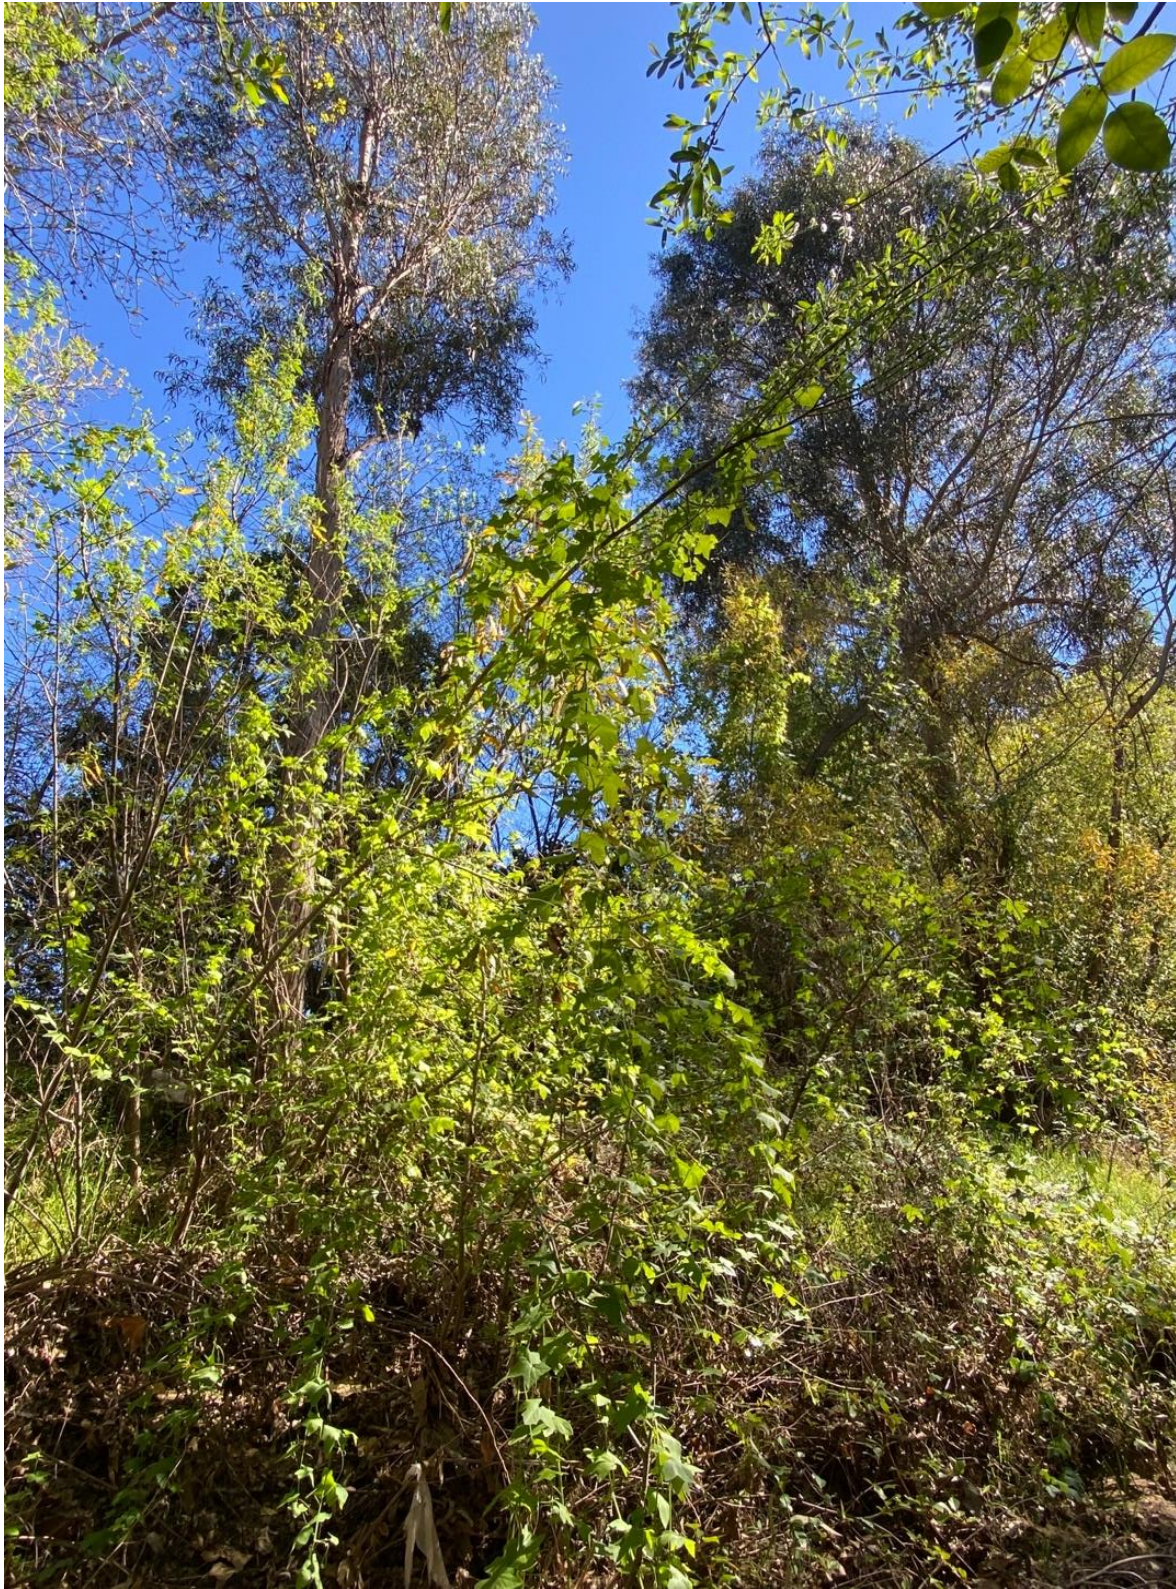
Figure 133. Native wild cucumber within native willow branches. Two large nonnative, invasive eucalyptus trees in the background. Blackwelder. February 28, 2022.

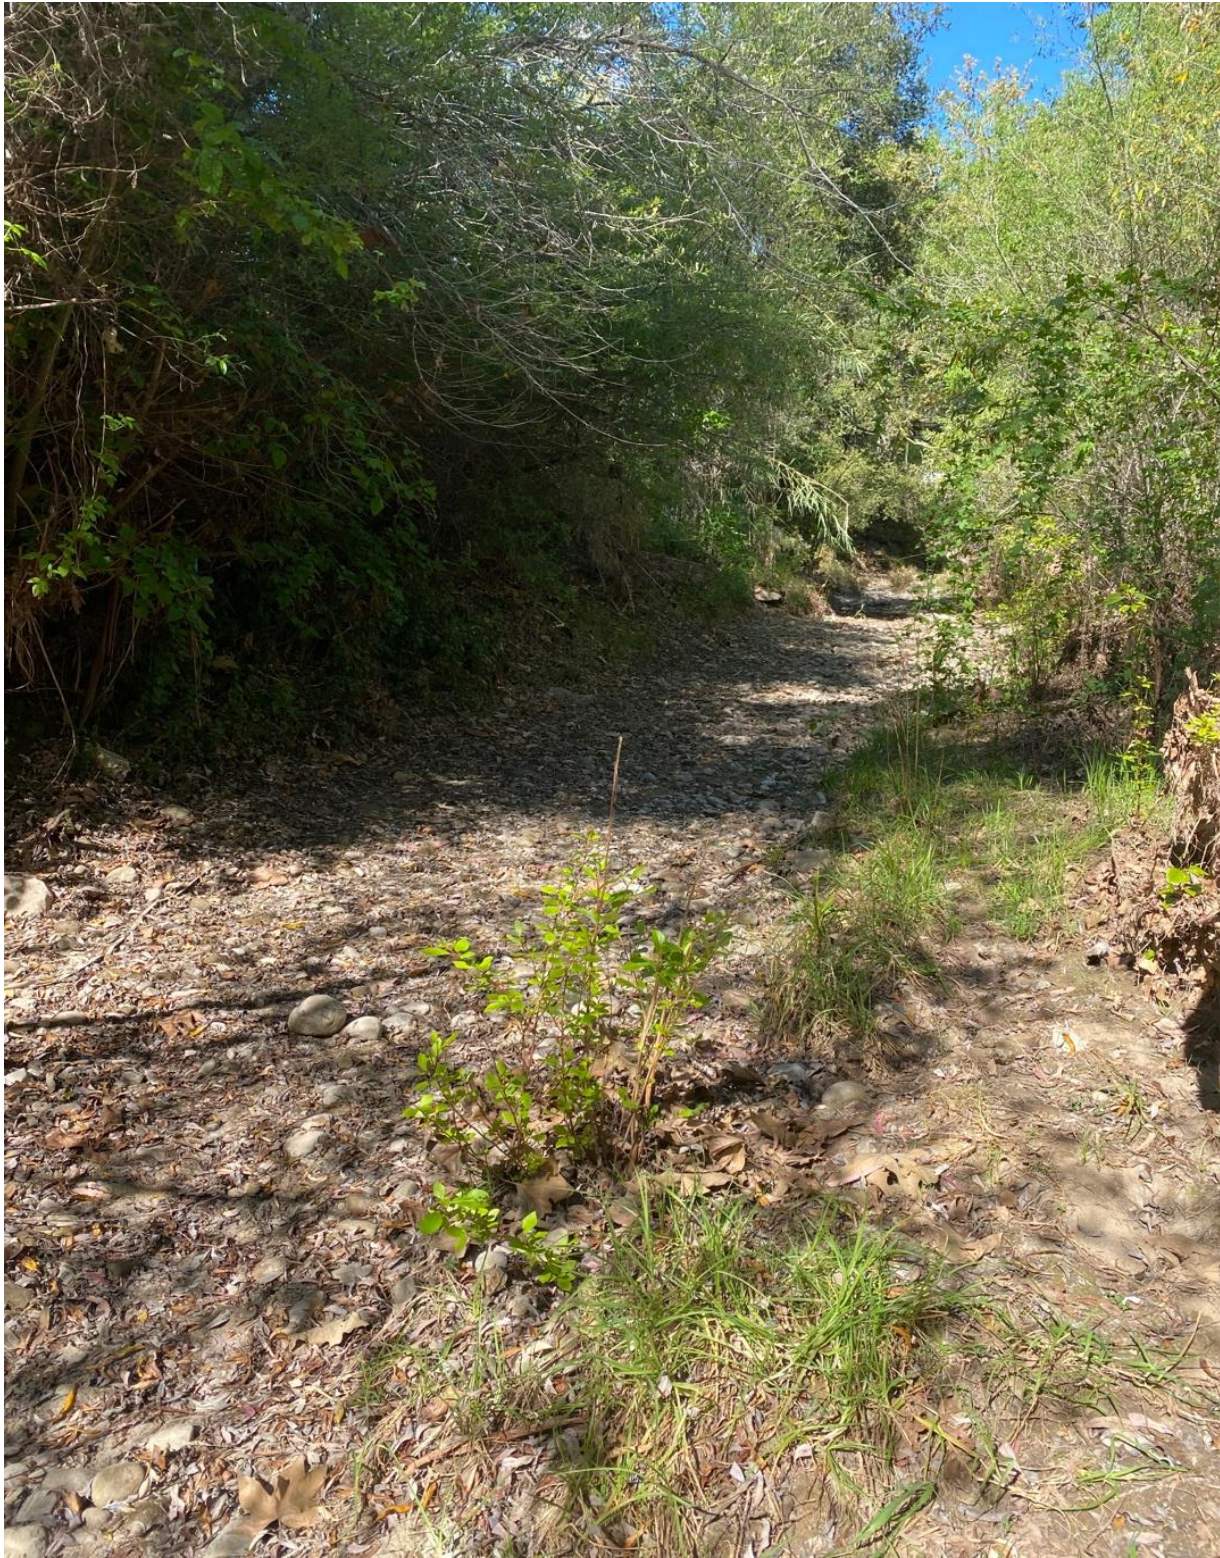
Figure 134. Looking upstream at the Armitos Site on San Jose Creek. The Creek bed is clear of obstructive vegetation although a small cottonwood sucker is sprouting up in the creek bed. Blackwelder. February 28, 2022.

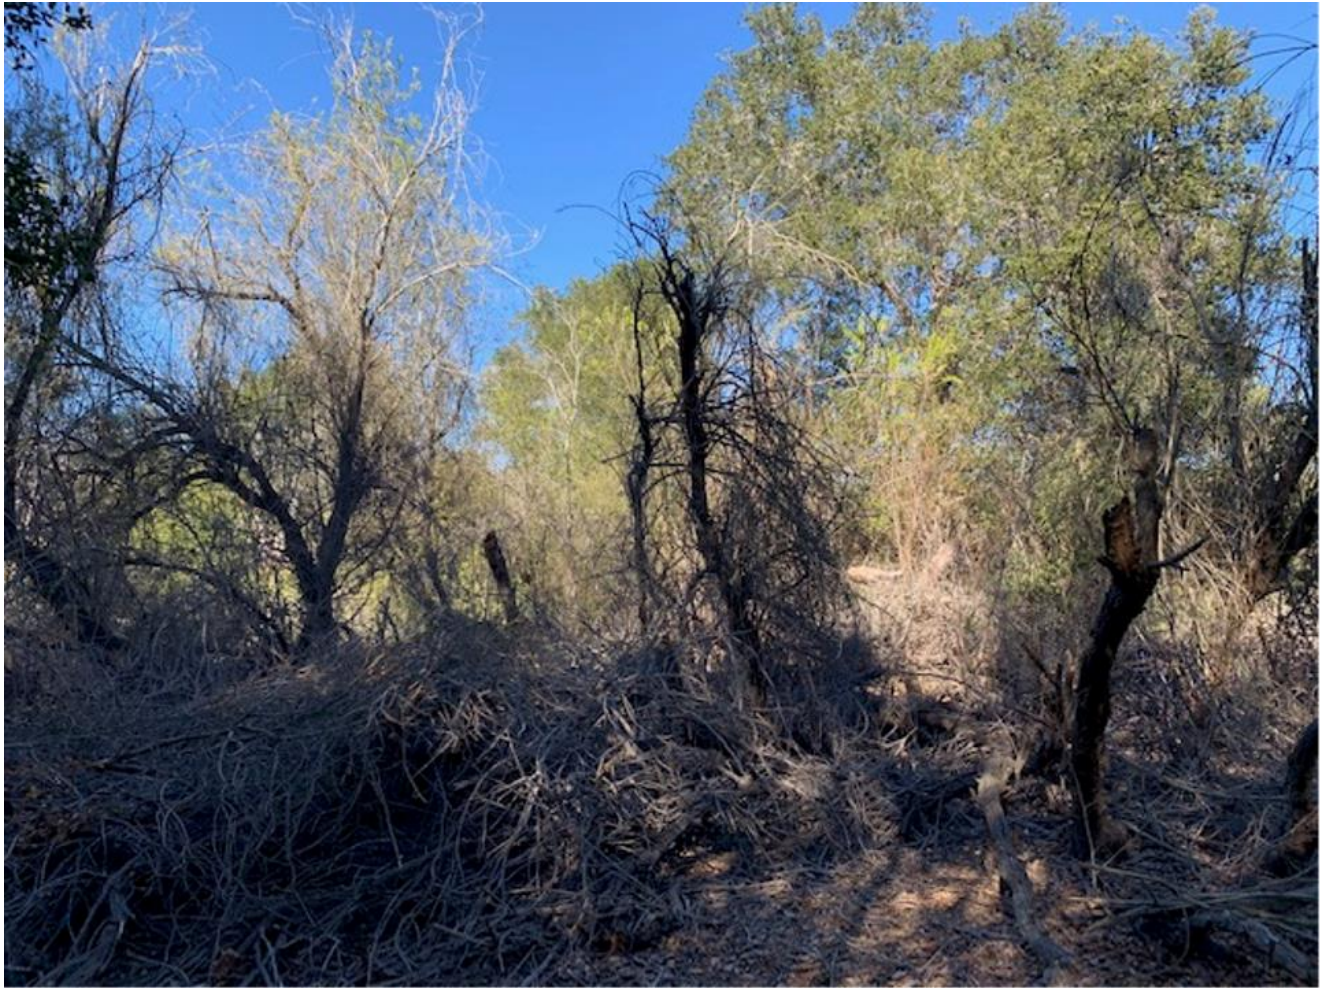
Site D is one of the moister polygons and the largest polygon in the bank. It currently supports willows, sycamores, coast live oaks, cottonwoods, and at least one small bay sapling and an understory consisting almost entirely of wild blackberry in the southern portion of the Site. The cottonwoods approach 10" DBH and appear to be spreading by root suckers. The willows and sycamores appear healthy although some may be drought-stressed. Some willows have succumbed to the drought in drier portions of Site D. (Figure 135) Overall the southern portion of Site D is in good condition while the northern portion is in fair to good condition.

Figure 135. Some willows have not survived the climate change-induced drought in Site D, but overall, the Site is in fair to good condition despite the climate change drought. Trautwein. February 7, 2022.

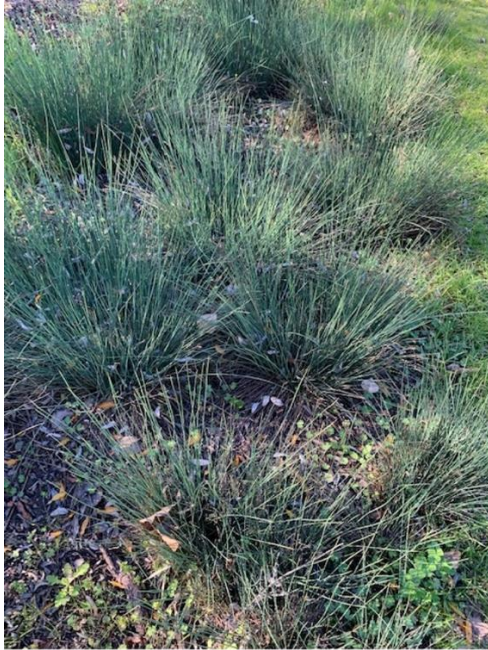
Site K is located toward the southern end of the Lake Los Carneros Mitigation Bank. It is a moist area suitable for riparian species. Willows and wild blackberries installed by SBCFCWCD thrive here. Rushes were noted in or near Site K. (Figure 136)

Figure 136. Rushes in or near Site K.
Trautwein. February 7, 2022.

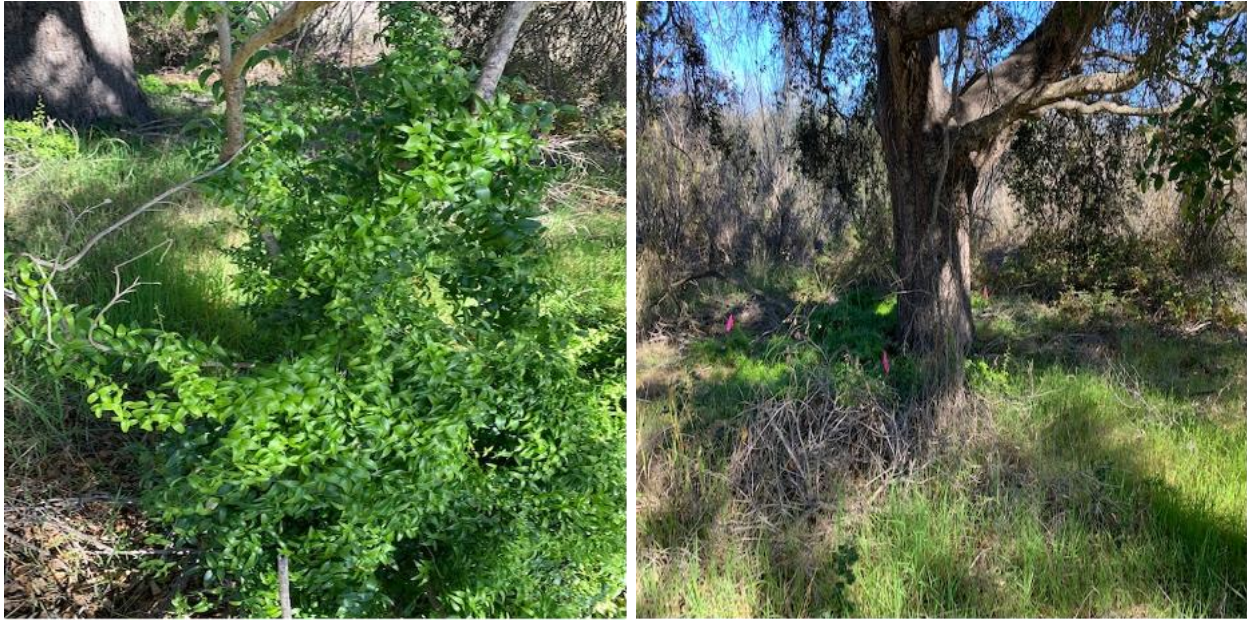
Figure 137 a. and b. Nonnative Cape smilax under oak in Site L. Trautwein. February 7, 2022.

- Continue to monitor Site L annually or every other year using aerial photos and field surveys.
- If riparian vegetation transitions to upland vegetation, plant upland species, control nonnatives that may colonize the area, and apply the .75:1 credit ratio for upland areas.
- Eradicate Cape ivy in this section and monitor for reinfestations.
- Eradicate exotic Cape smilax denoted by pink flags underneath large coast live oak tree on west wide of Site along main trail.²⁰⁵ (Figures 137 a and b)

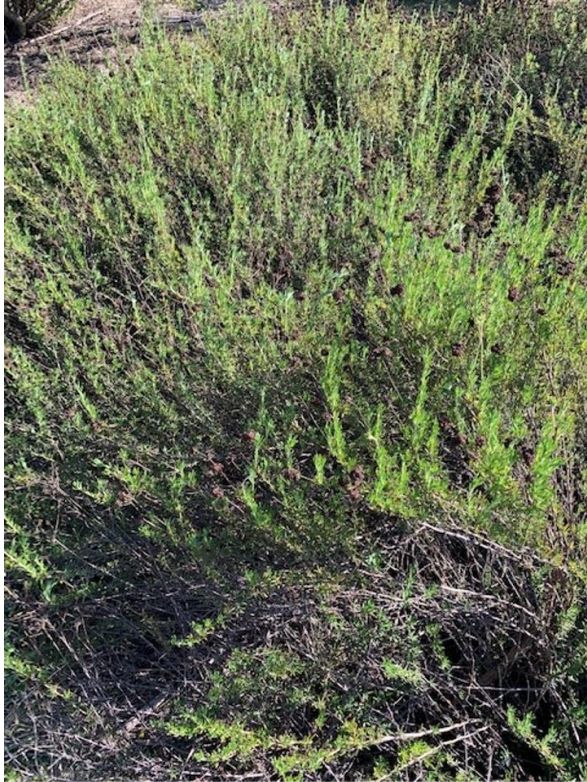
Figure 138. Buckwheat in northern portion of Site O. Trautwein. February 7, 2022.

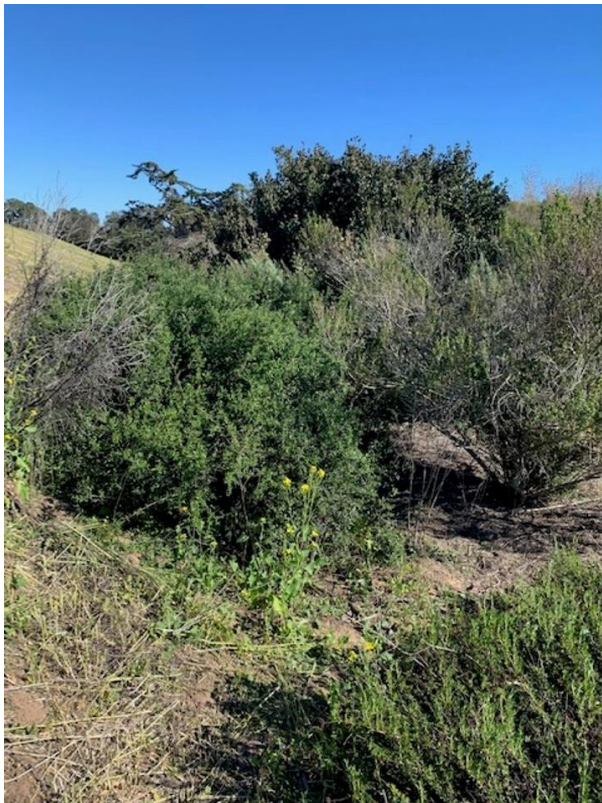
sycamore. (Figure 139) Providing upland plant communities enhances the functionality of the adjoining riparian woodlands by allowing for use by a greater number of wildlife species.²⁰⁶ Overall plant health ranges from poor to good with riparian species closest to the Dam (northern portion of Site O) generally in the poor to fair range with some dead willows. (Figure 140) Some sycamores in this area are in good condition.

Figure 139. Upland plant community in northern portion of Site O including coyote brush, lemonade berry, and buckwheat, with nonnative mustard growing between native plants. Note dam in background. Trautwein. February 7, 2022.

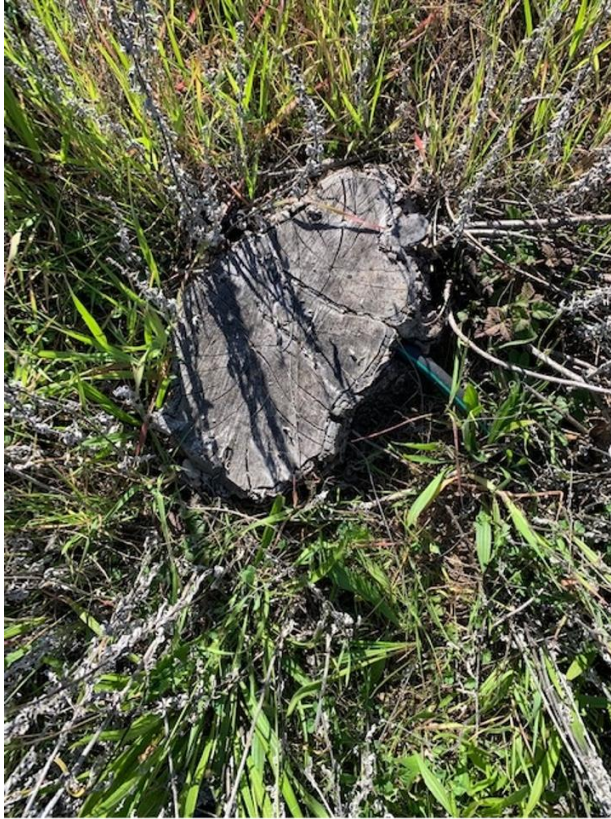
Figure 140. Some willows have died due to apparent lack of water in the northern portion of Site O, including this one which grew around an irrigation line. Trautwein. February 7, 2022.

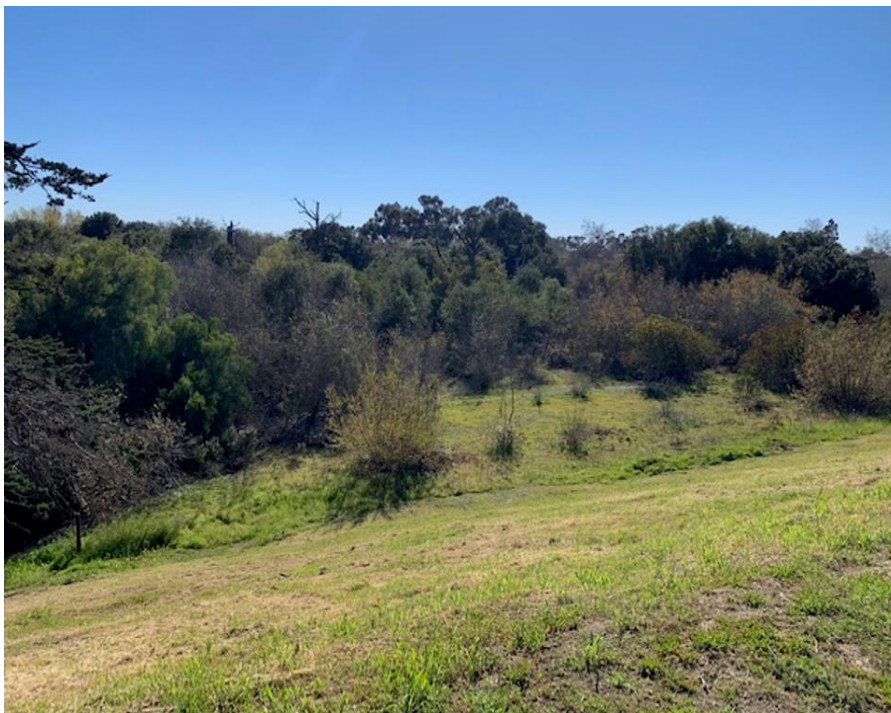
Aerial photos from as recently as 2019 showed good percent cover of natives e.g., 75-80%, however, it appears that since watering ceased during the current megadrought, some native plants have not fared well. The percent cover still appears to be in the range of 70-80% but lower in the northern portion of Site O. (Figures 141 and 145) Nonnative herbaceous plant communities are present in the northern portion of Site O and dominate the understory. Overall, Site O may be the least successful polygon in the Lake Los Carneros Mitigation Bank.

Figure 141. Northern portion of Site O closest to the dam contains open areas dominated by nonnative plants. Trautwein. February 7, 2022.

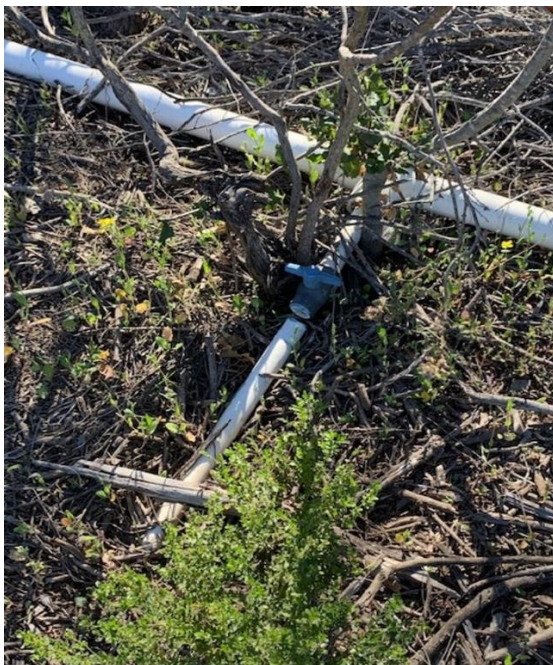
Figure 142. Irrigation lines are broken in some areas and should be removed to prevent plastic pollution. Trautwein. February 7, 2022.

- Continue to monitor annually or every other year using aerial photos and field surveys to ensure riparian sites remain riparian and do not transition to native or nonnative upland plant communities because such a transition would signal long-term failure of mitigation.
- If riparian vegetation transitions to upland vegetation, apply the .75:1 credit ratio for upland areas.
- Control invasive species including Shamel ash and Cape ivy.
- Monitor for other invasive species and control to prevent significant infestations, e.g., castorbean, pampas grass, and mustard.
- Retain Monterey cypress snags.
- Remove all irrigation lines once sites are established. Reinstall only if needed to prevent loss of riparian vegetation due to the megadrought. (Figure 142)
