Evaluating the Efficacy of Restoration Projects for Mitigation: An Assessment of Private Riparian Revegetation Projects in Santa Barbara County

Brian Trautwein, Senior Analyst / Watershed Program Director Elijah Baker, Watershed Program Intern Special Report: June 13, 2024

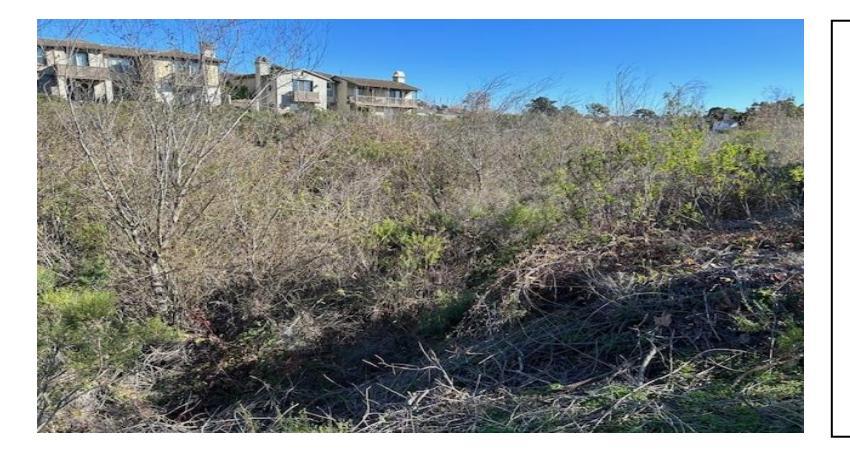
Figure 1. Willow woodland in Section 4 of the revegetation area. Arroyo willows are deciduous and lose their leaves in winter as shown here. Willow trees onsite generally appear in poor to fair condition, possibly due to drought and lack of water due to a blockage in Devereux Creek. Brian Trautwein. January 5, 2024.

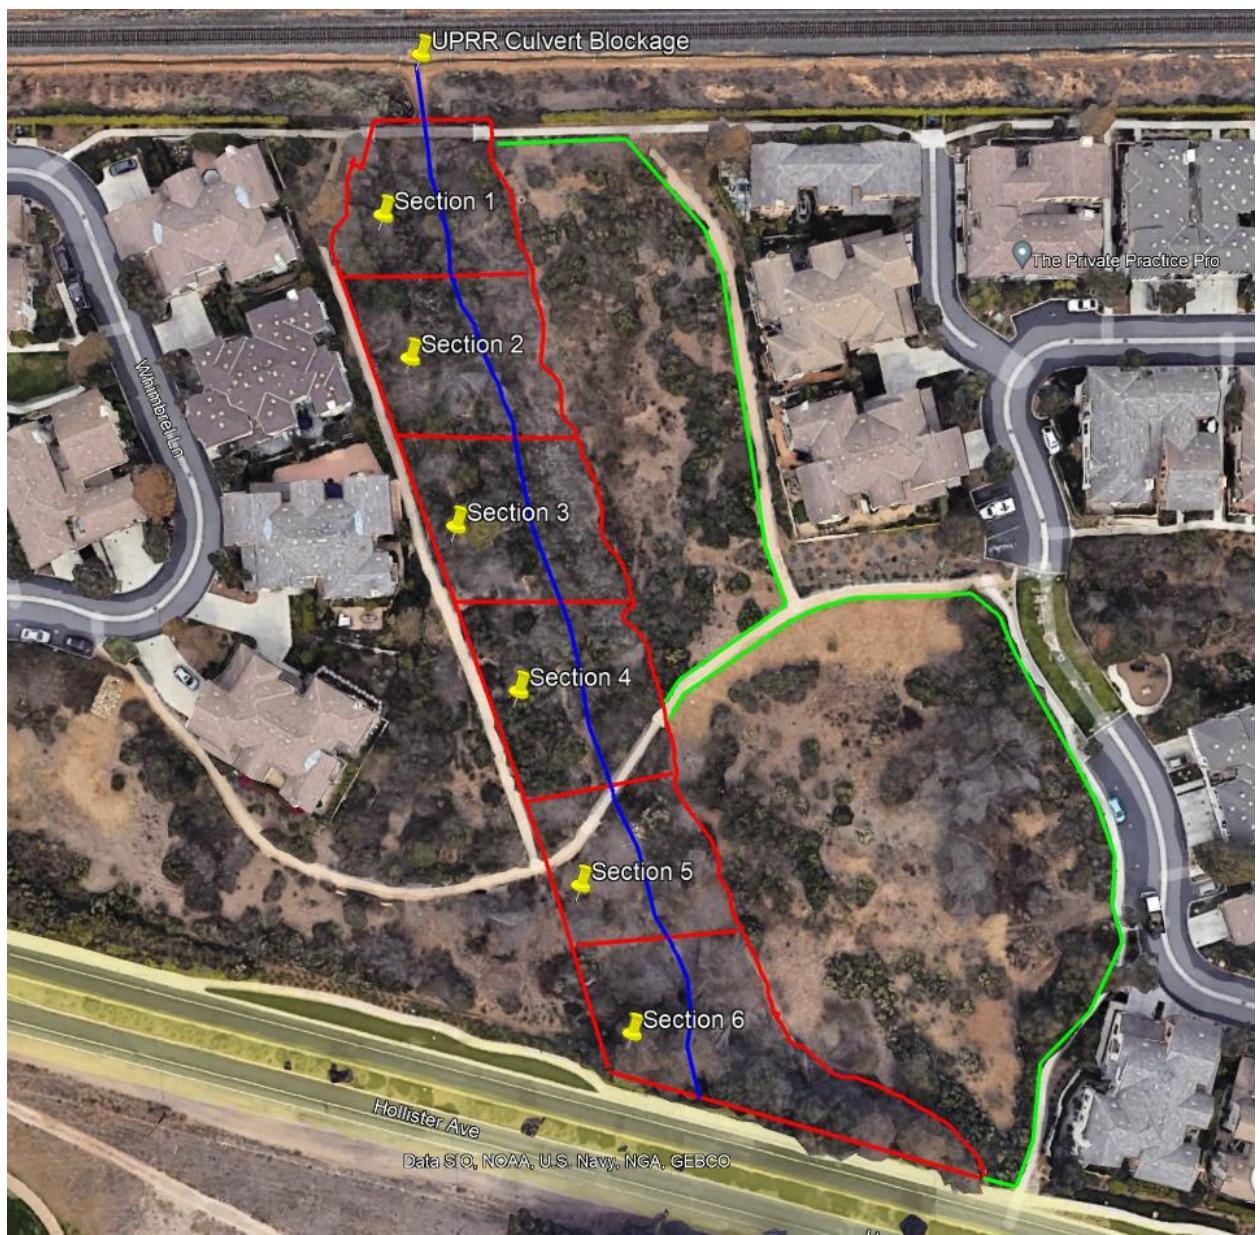
Figure 2. Devereux Creek restoration area. Six survey segments (red polygons) and two native grassland restoration area survey polygons (green).

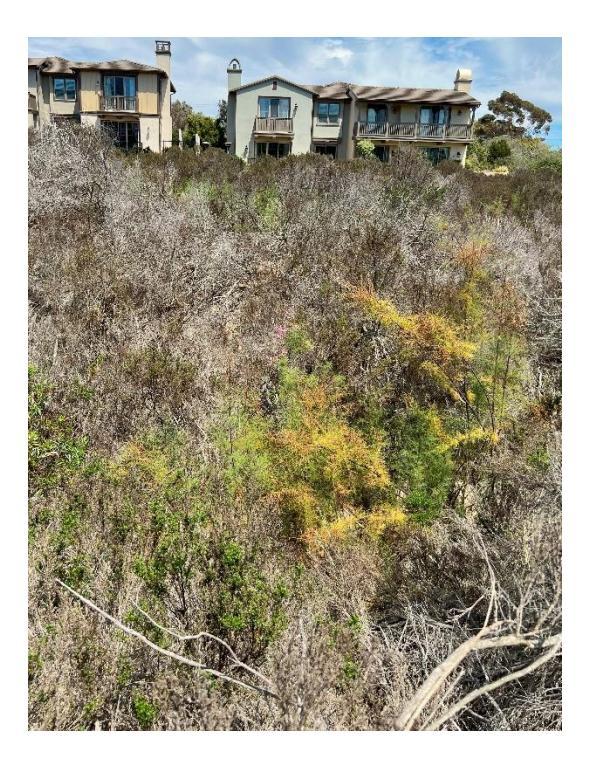
Figure 3. An invasive tamarix plant was observed growing Devereux Creek. Riparian and coyote brush scrub vegetation is desiccated in the revegetation area. Brian Trautwein. August 5, 2022.

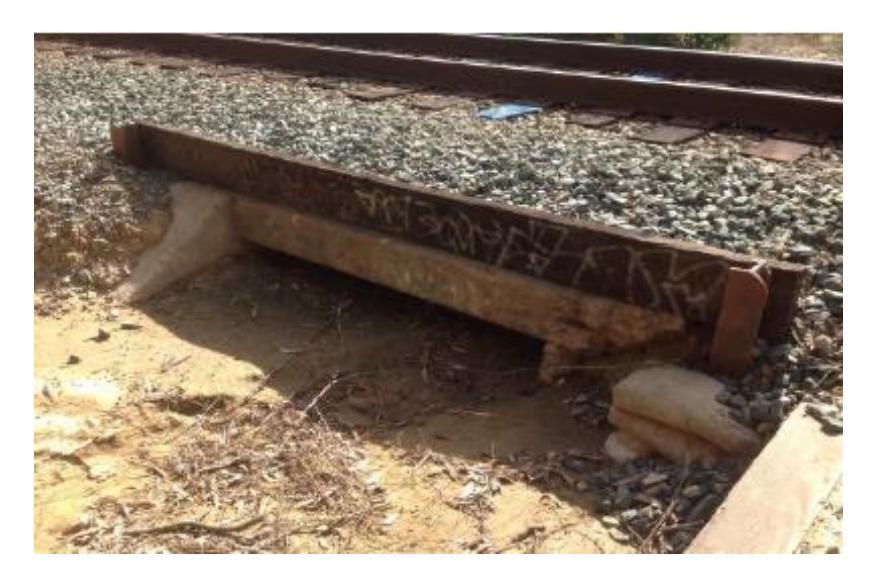
Figure 4. The UPRR culvert for Devereux Creek located just north of Haskell's Landing is blocked with sediment preventing runoff from flowing down the Creek and through the revegetation project site.

In 2023, EDC and other community groups requested the Goleta City Council collaborate with UPRR and interested parties to unblock the culvert. City Public Works staff advised City Council that the project would require studies and permits. However, FCD already has programmatic CDFW, ACOE, and RWQCB permits and US Fish and Wildlife Service and National Marine Fisheries Service Endangered Species Act authorizations for desilting creeks and culverts as part of its Annual Maintenance Program.⁶⁴ The FCD, CDFW, ACOE, and RWQCB conceptually support using these permits to unblock the culvert.⁶⁵ A Coastal Development Permit ("CDP") is also required. The CCC informed EDC that a CDP could be issued within approximately six months after receipt of a complete application, including any required studies.⁶⁶

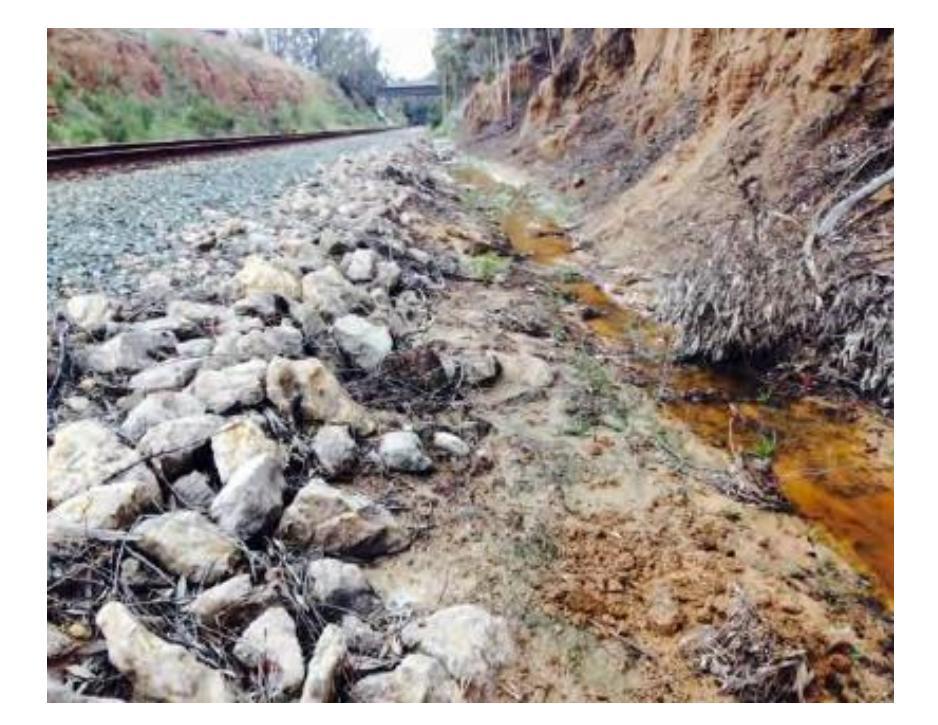
Figure 5. The blocked culvert diverts water from Devereux Creek 860 meters west along the railroad tracks into Bell Canyon Creek. UPRR installed rock rip rap to protect the tracks from erosion caused by high flows in Devereux Creek where it has been rerouted along the railroad tracks.

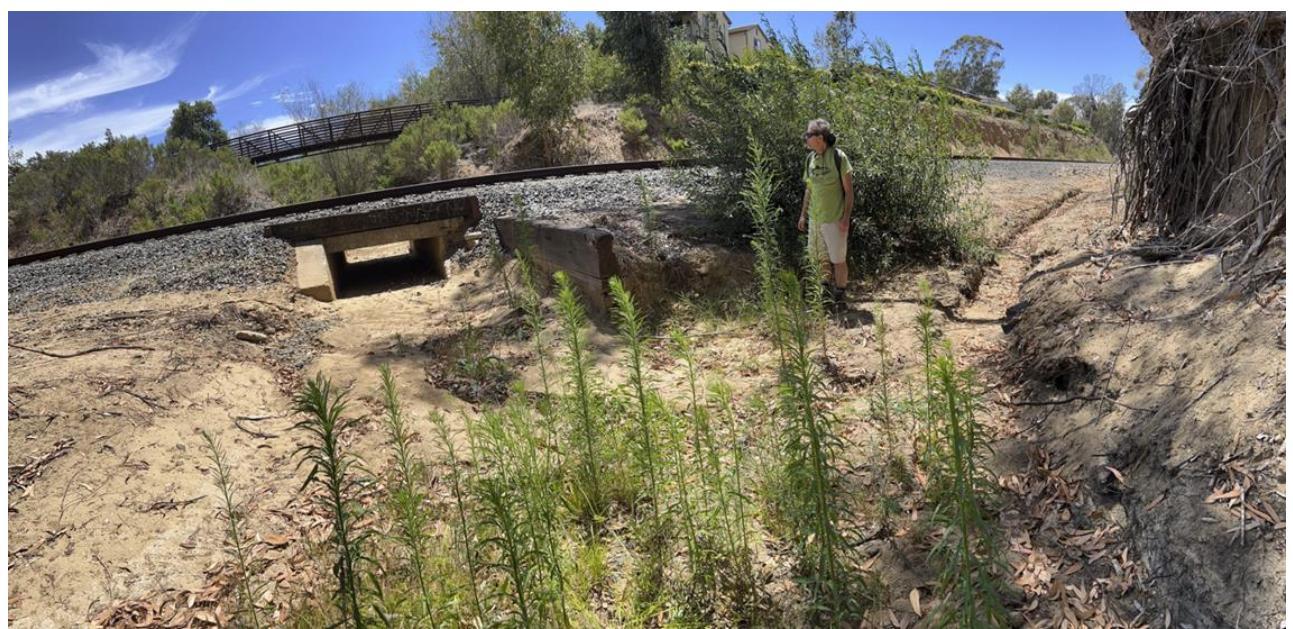
Figure 6. The Devereux Creek culvert under the railroad tracks remains blocked despite some clearance. (Middle left) In 2022, a ditch was excavated to facilitate diversion of Devereux Creek's flows away from the Creek toward Bell Canyon Creek. (Middle right) The Haskell's Landing Project and Devereux Creek Footbridge are in the background.

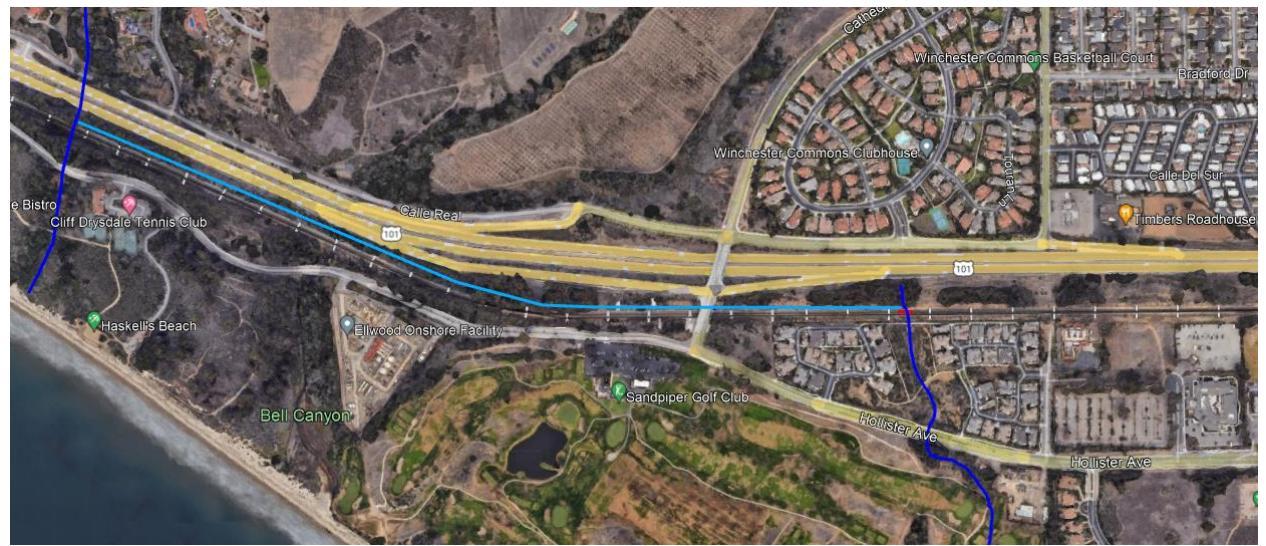
Figure 7. UPRR's blocked culvert (red line) diverts Devereux Creek from its natural course (dark blue line in lower right side of image) west 860 meters (light blue line) into Bell Canyon Creek (dark blue line in upper left corner of image). Google Earth. 2024.

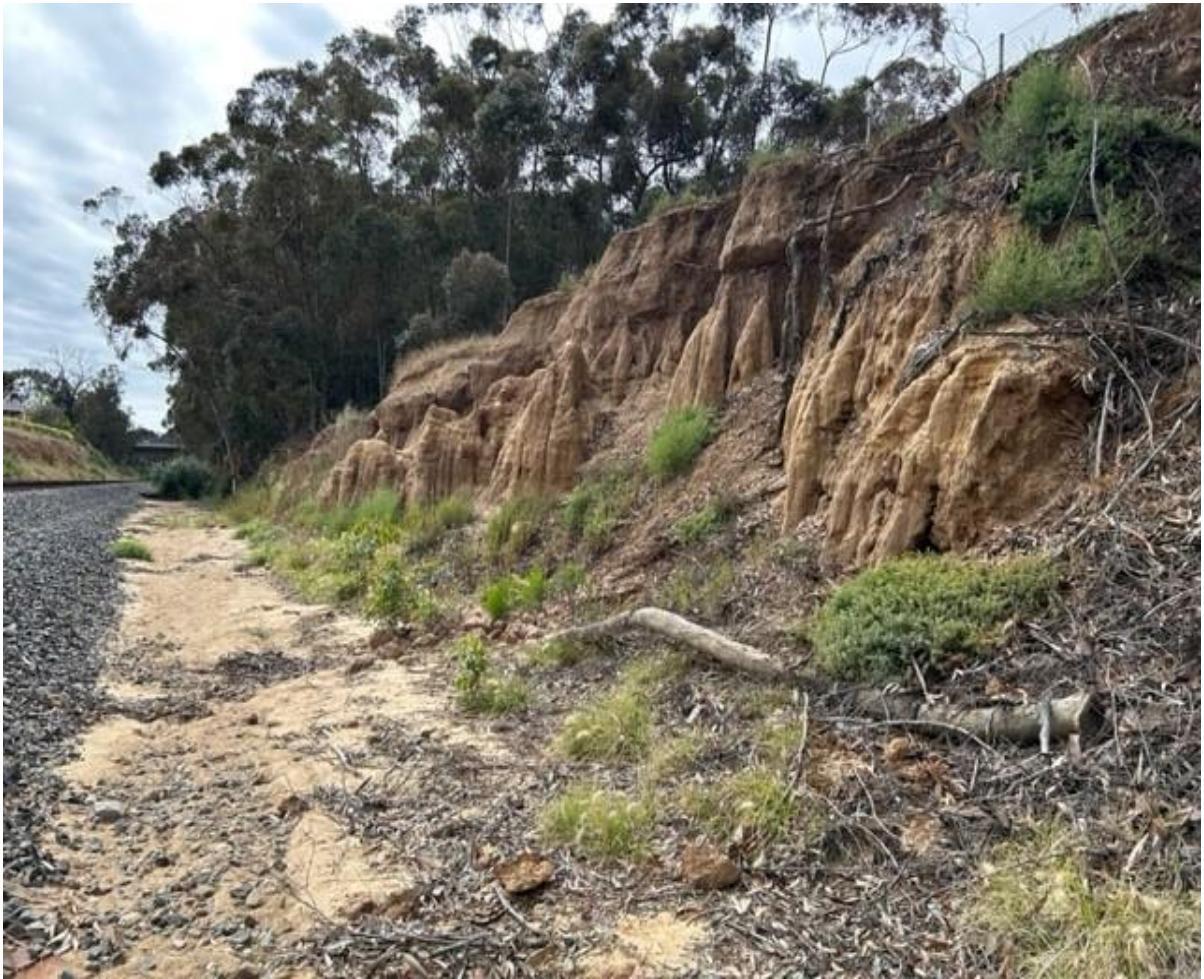
Figure 8. Eroding escarpments along the UPRR corridor provide a source for the sediment that continues to block the culvert and Devereux Creek. Note that the tan-colored sediment to the left of and below the eroding escarpment is conveyed during storms to Devereux Creek via a drainage.

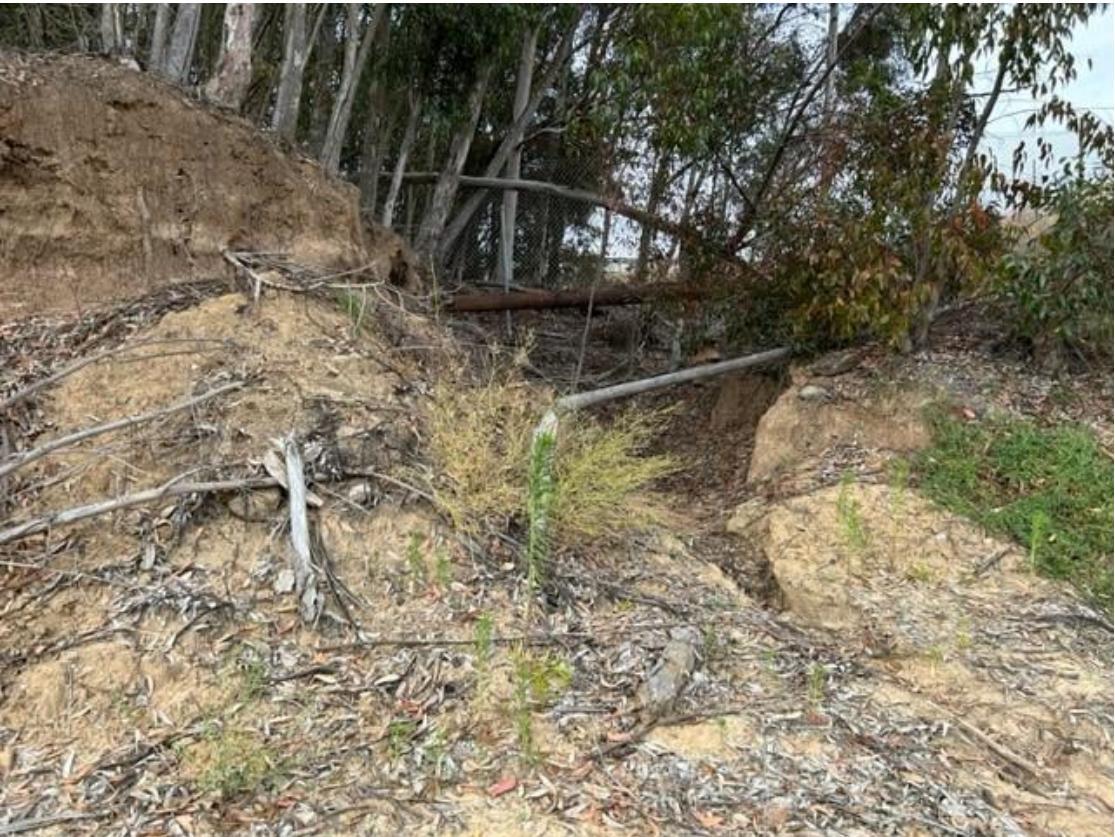
Figure 9. Eroding gullies along the UPRR corridor provide a source of sediment which likely contributes to blocking Devereux Creek, preventing flows through the UPRR culvert and the Haskell's Landing revegetation site.

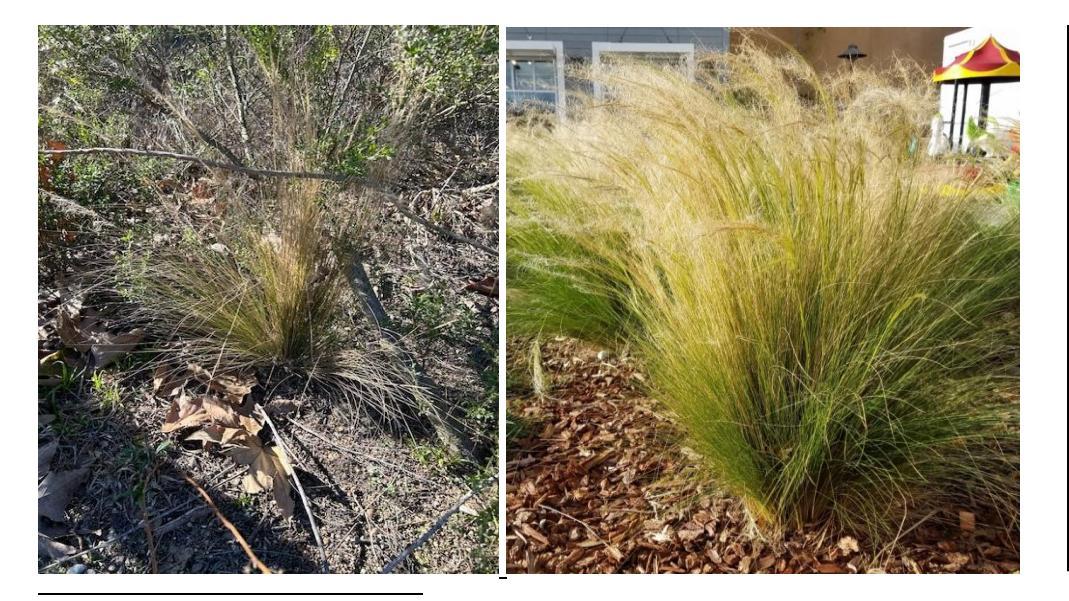
Nonnative Mexican feathergrass (*Stipa/Nassella tenuissima*) was also observed along the walkway in the revegetation area west of the Creek in Section 2. (Figure 10) This species is invasive in the Santa Barbara region.⁷⁵ Hunt documented fountain grass (*Pennisetum* spp.), acacia, and bladder pod vine (*Aruajia sericifera*).⁷⁶ These should be eradicated from the site.⁷⁷

Figure 10. Mexican feathergrass (*Stipa / Nassella tenuissima*) should be eradicated from the revegetation site (left) and surrounding landscaped areas (right). Brian Trautwein. January 5, 2024.

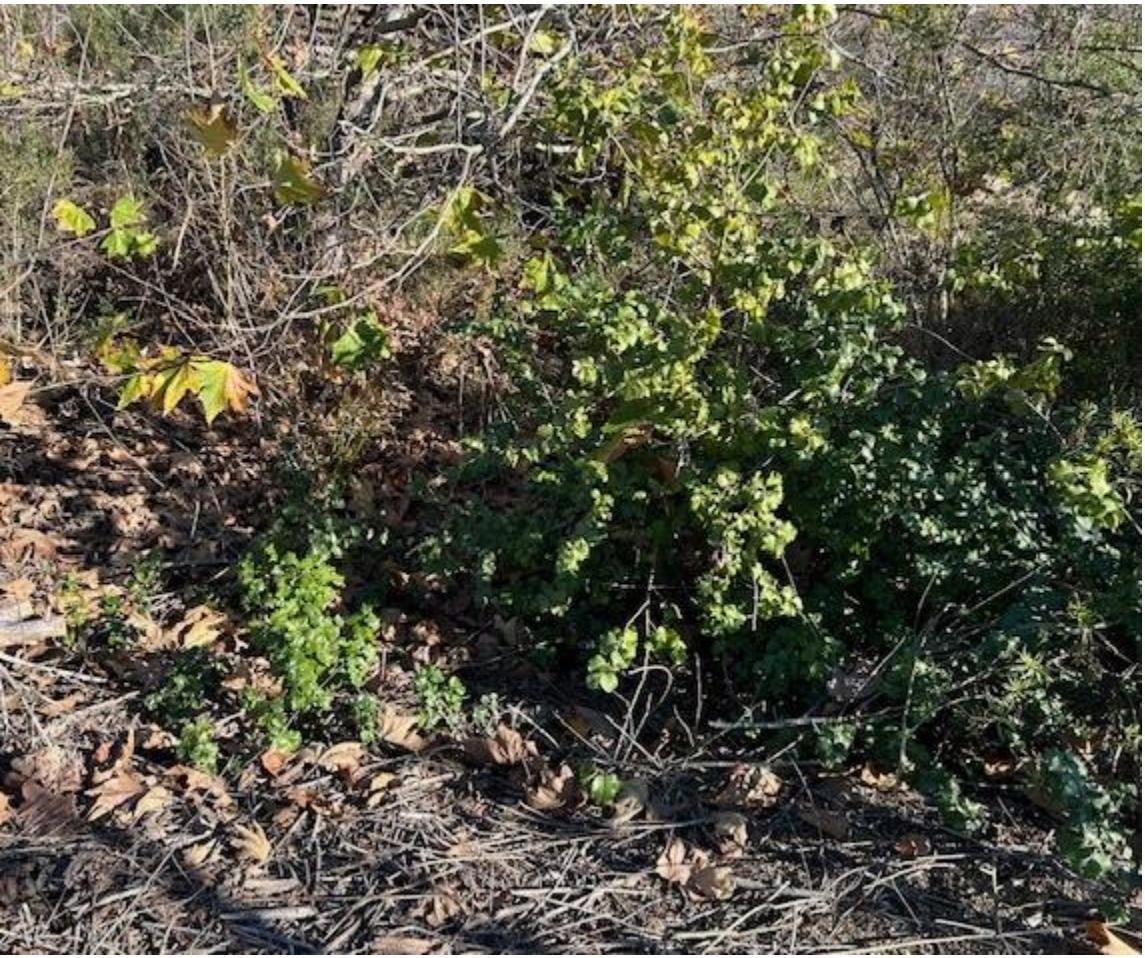
Catalina Island cherry (*Prunus ilicifolia* spp. *lyonii*) was observed onsite and is spreading by seed within the revegetation area. (Figure 11.) While native to the Santa Barbara Channel Islands and some coastal areas of mainland southern California,⁷⁸ EDC has documented this species in locations where it is spreading and outcompeting native plants.⁷⁹ This species is used for landscaping and may hybridize with the native holy-leaf cherry (*Prunus ilicifolia*). Mature and seedling Catalina Island cherry plants should be removed from the revegetation area and from throughout the Hideaways housing development.

Figure 11. Apparent Catalina Island cherry plants are spreading in the revegetation area. These plants should be removed and can be replaced with native holly-leaf cherry plants (*Prunus ilicifolia*). Brian Trautwein. January 5, 2024.

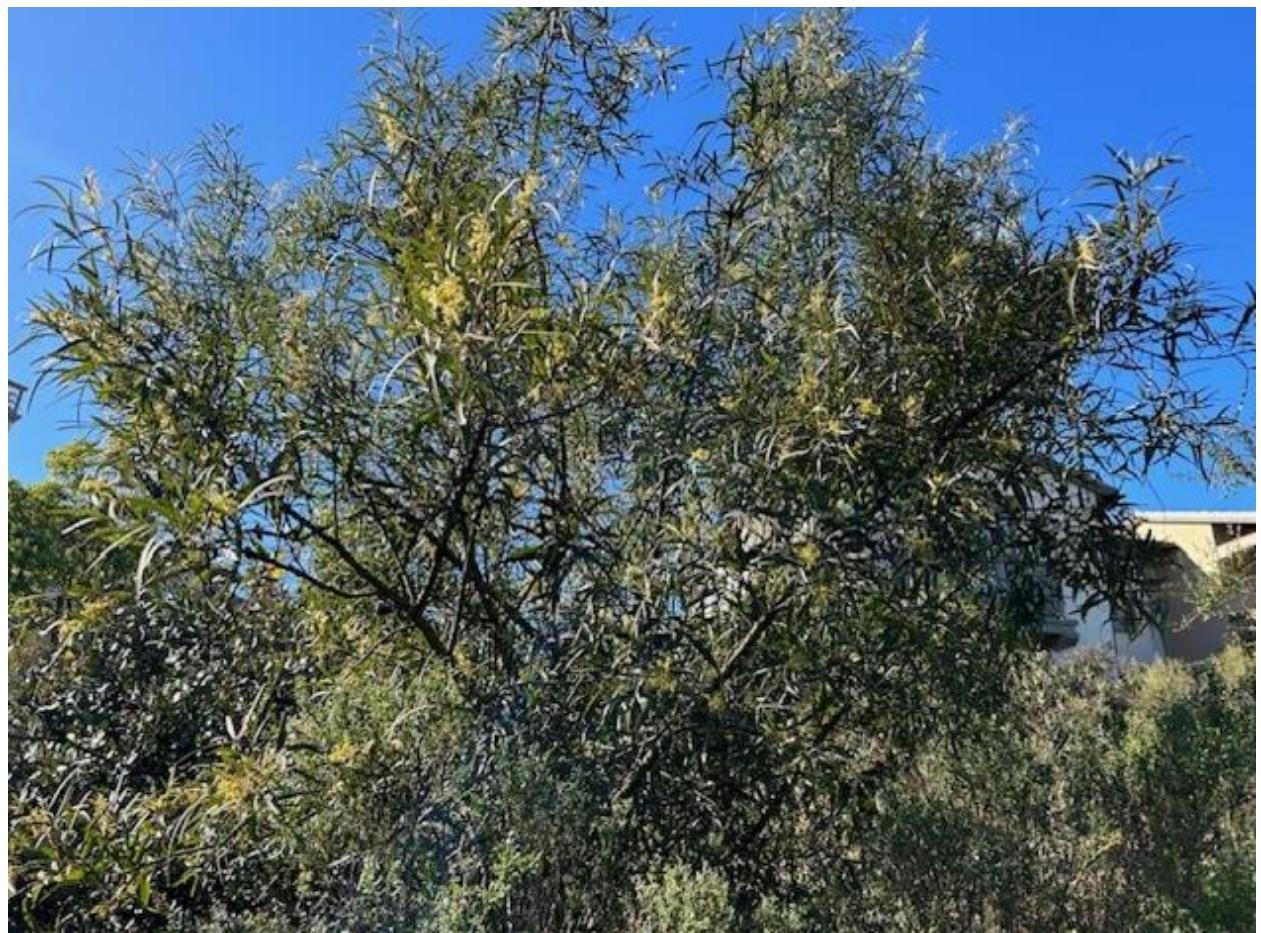
Figure 12. An unidentified nonnative tree or shrub was photographed in Section 4. Brian Trautwein. January 5, 2014.

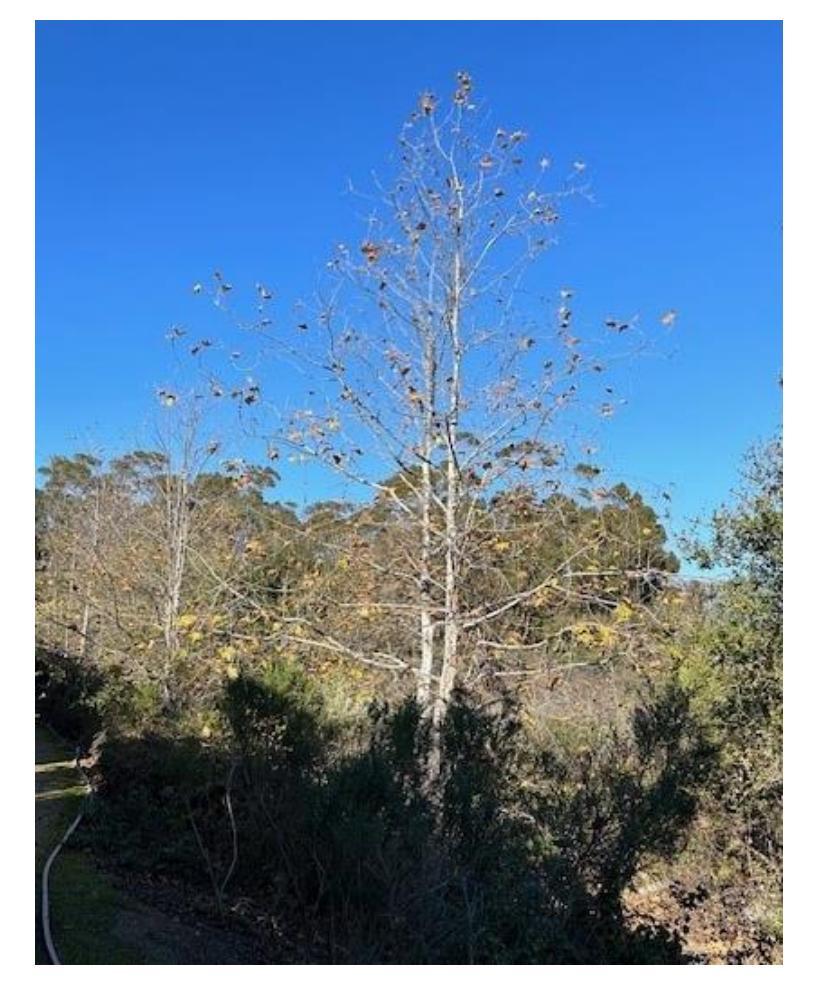
Figure 13. Western sycamore trees (*Platanus racemosa*) are doing well in the revegetation area. Brian Trautwein. January 5, 2014.

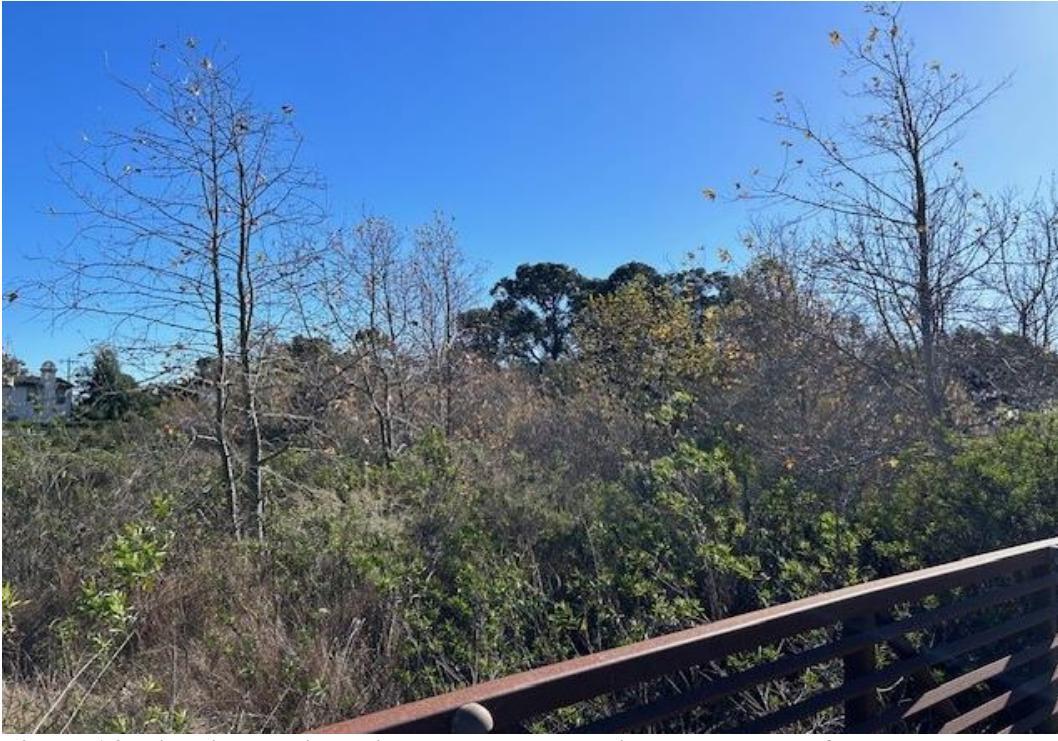
Figure 14. Riparian habitat with sycamore and willow trees, mulefat, and coyote brush in Section 2 looking downstream from footbridge toward Hollister Avenue. Brian Trautwein. January 5, 2024.

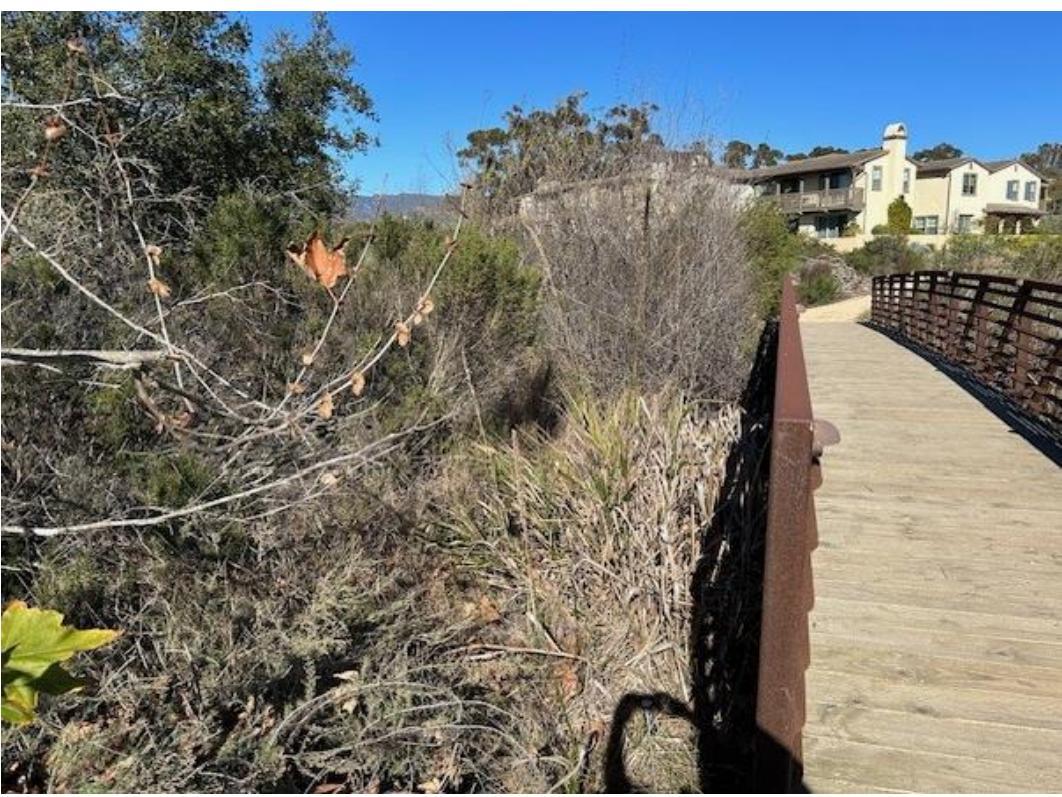
Figure 15. View to northeast across Devereux Creek at lower footbridge. Sycamore, willow, and coast live oak trees, California sage, and giant wild ryegrass in Section 3 upstream from (left of) the footbridge. Brian Trautwein. January 5, 2024.

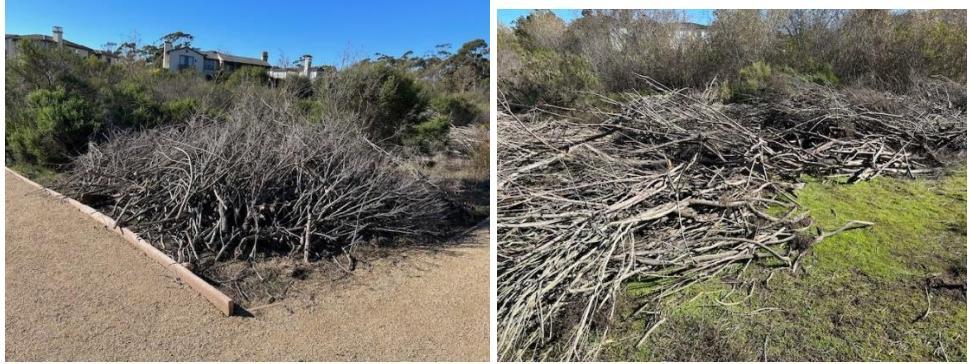
Figure 16. Coyote brush removed from native grassland area and stacked onsite. Brian Trautwein. January 10, 2024.

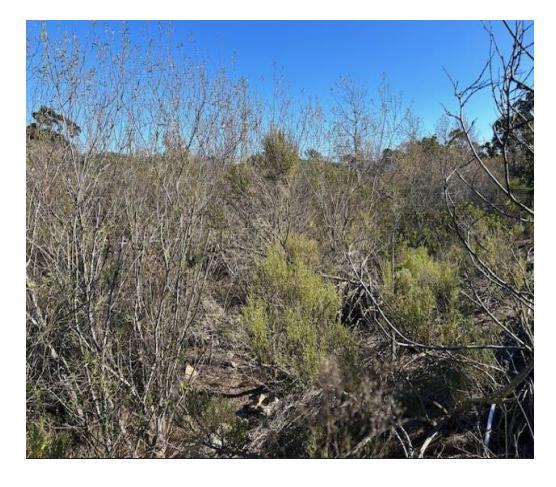
Figure 17. Coyote brush is an upland scrub pioneer species which often colonizes disturbed areas. It is spreading into the riparian area as shown here in Figure 4. Brian Trautwein. January 10, 2024.

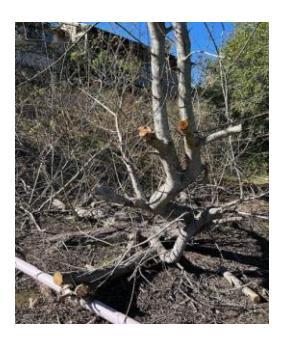
Figure 18. Several willow branches have been pruned. Dead and dying willow trees and branches should be retained as habitat unless they pose a safety risk in which case they should be removed and placed on the ground to decompose. Brian Trautwein. January 5, 2024.

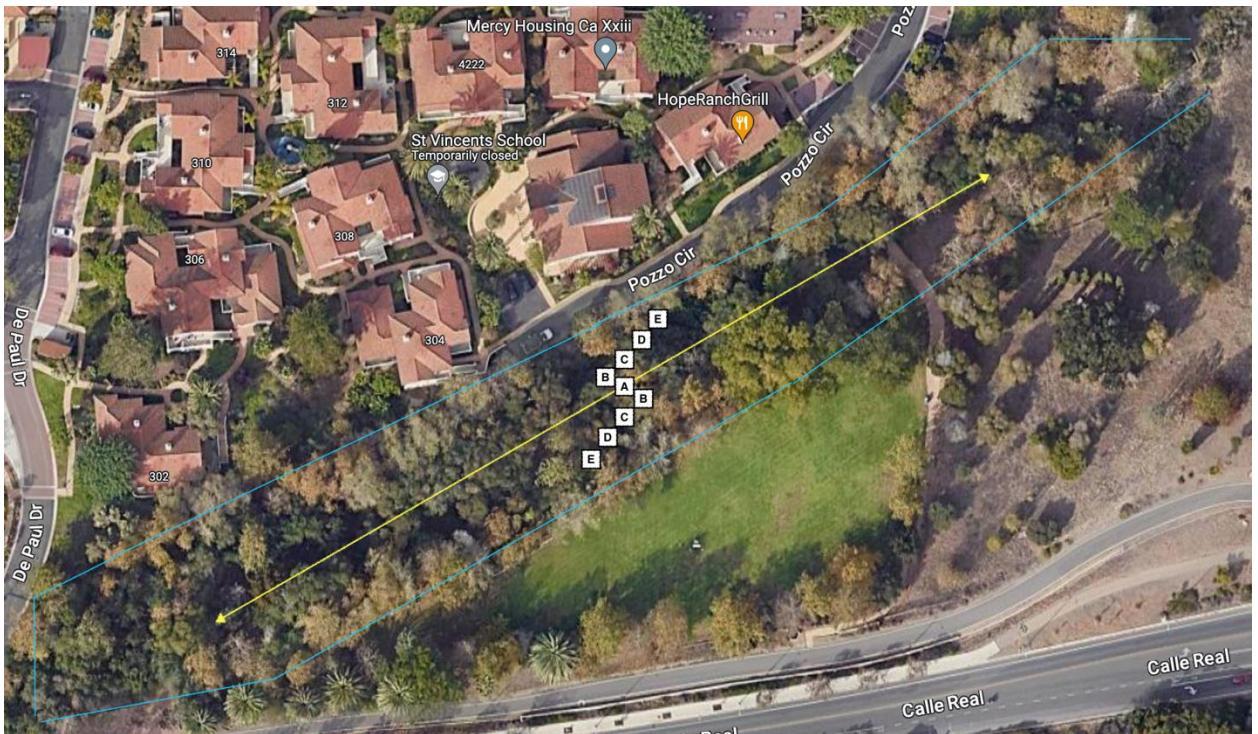
Figure 20: Blue line represents boundary of Cieneguitas Creek revegetation areas. Yellow line represents pathway walked and streambed. Letters A - E represent the Plan's five planting zones. Google Maps. 2023.

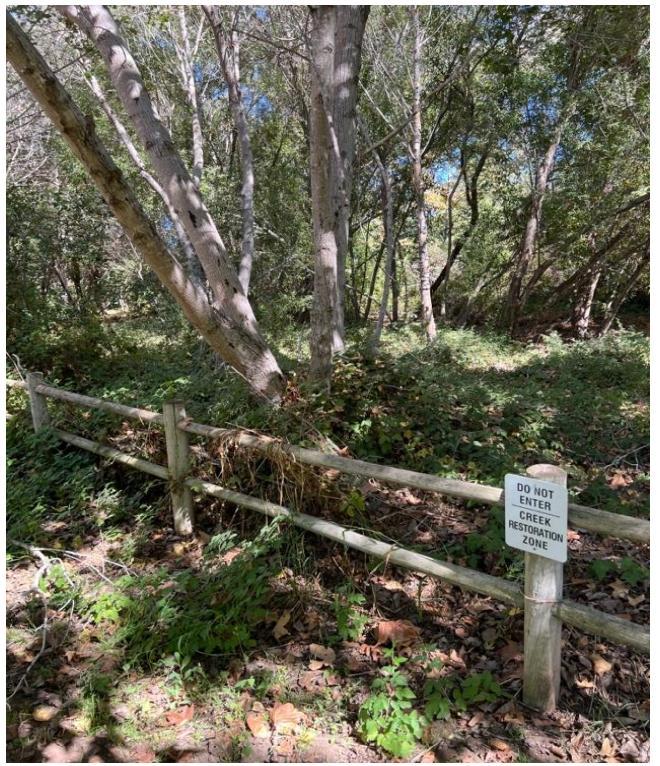
Figure 22. Wooden barrier between St. Vincent's Housing and the restored area of Cieneguitas Creek, with required signage posted. Elijah Baker. September 2022.

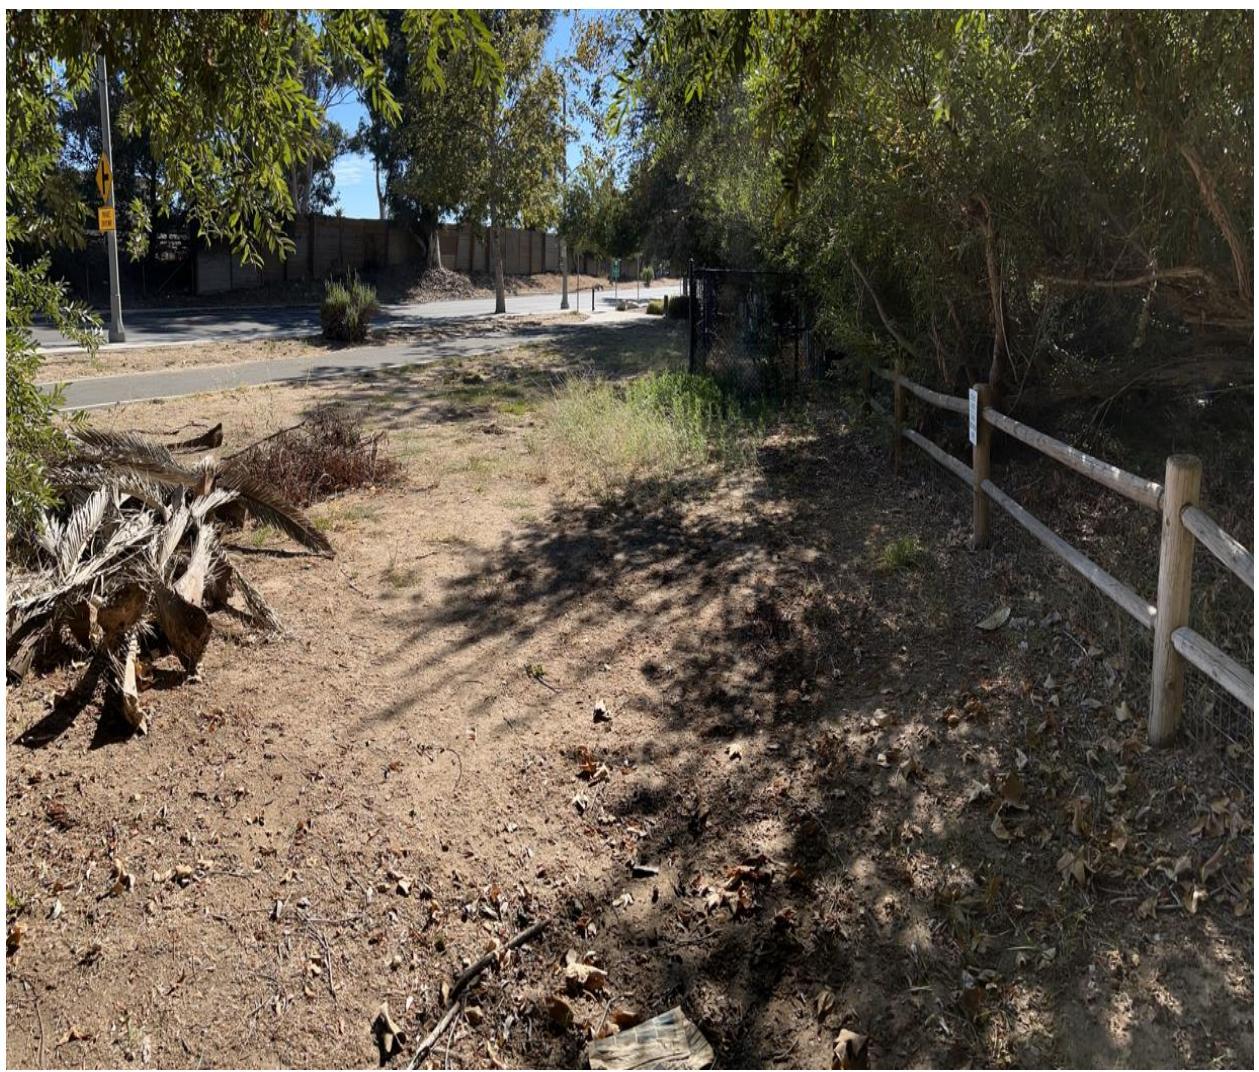
Figure 23. This unvegetated dirt area south of the revegetation site and north of Calle Real would make an ideal location to restore coastal sage scrub which would enhance habitat values within the restored riparian habitat, reduce erosion, and beautify the area. Elijah Baker. August 22, 2022.

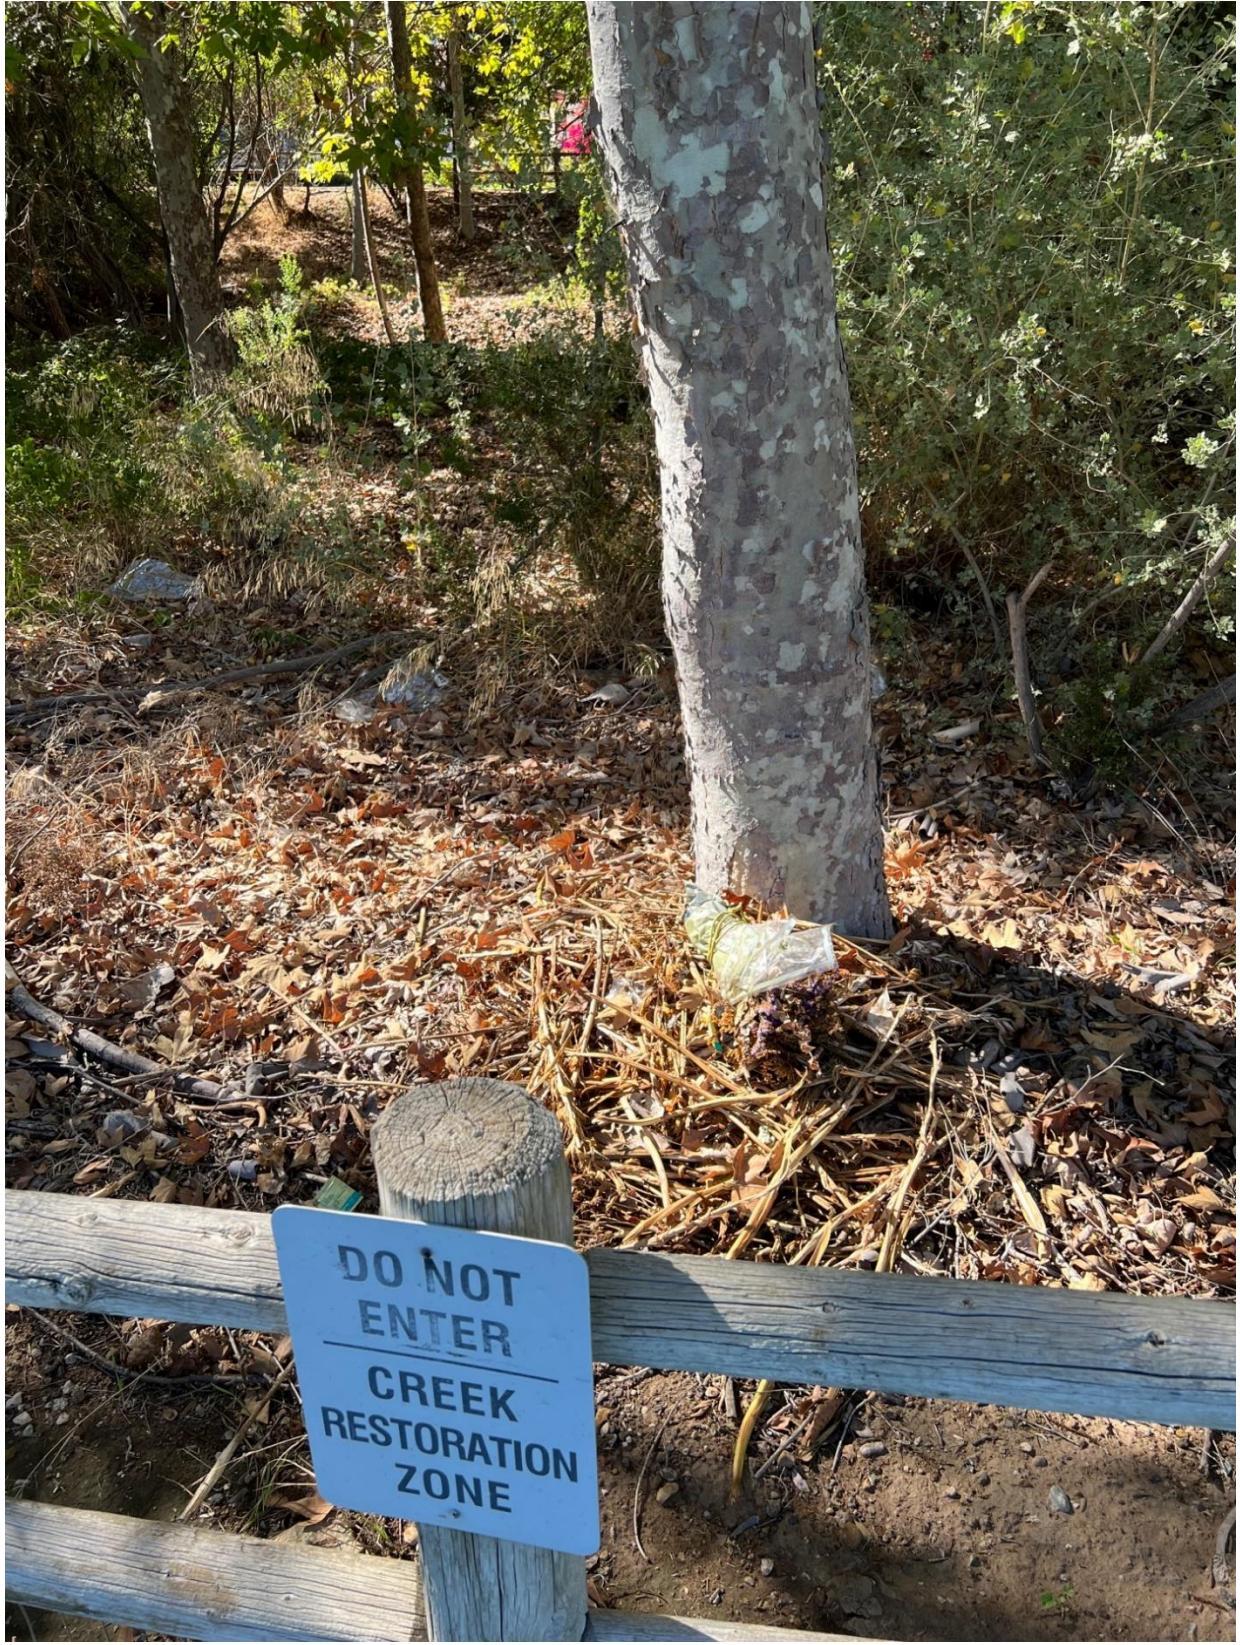
Figure 24. Creek restoration signage should be retained to discourage entry into habitat. Brian Trautwein. September 2022.

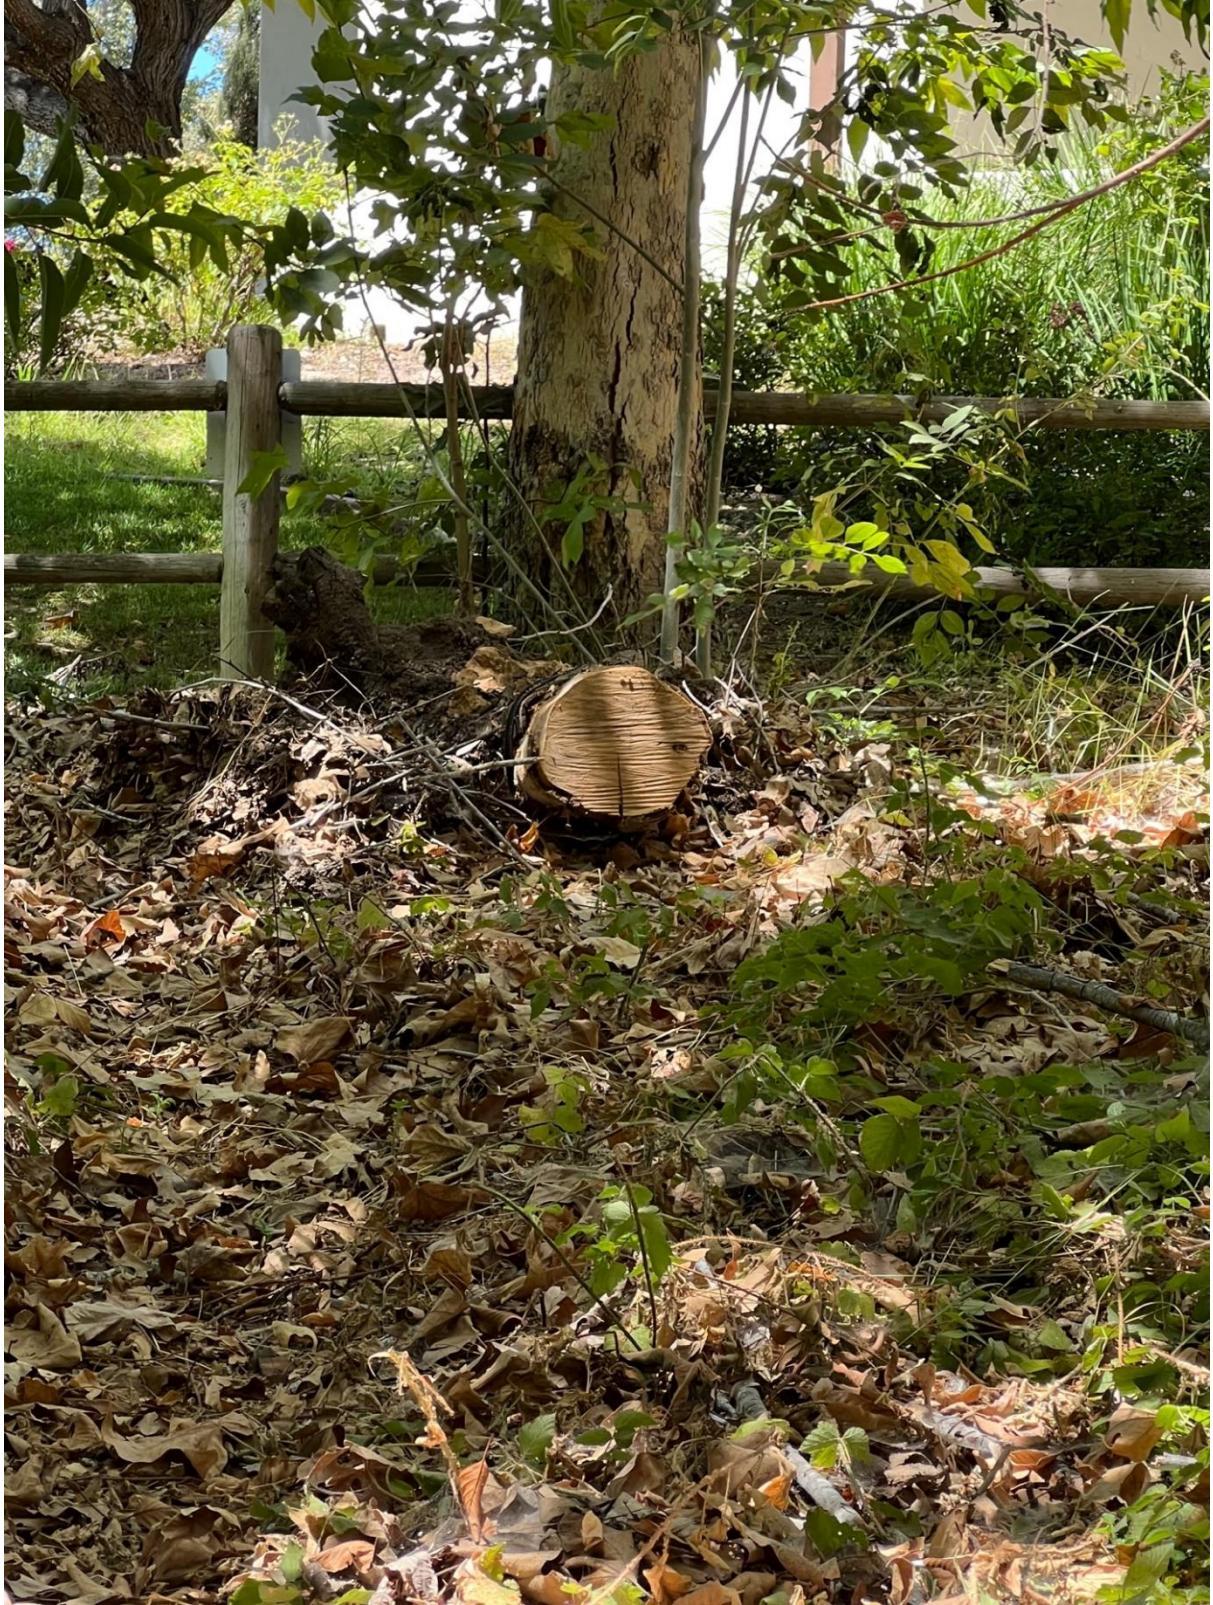
Figure 25. Native trees within and adjacent to the restoration area should not be cut. Dead trees (snags) should be left as habitat unless they are in close proximity to homes or paths or are a fire hazard. Brian Trautwein. September 2022.
