Evaluating the Efficacy of Restoration Projects for Mitigation: An Assessment of Private Riparian Revegetation Projects in Santa Barbara County

Brian Trautwein, Senior Analyst / Watershed Program Director Elijah Baker, Watershed Program Intern Special Report: June 13, 2024

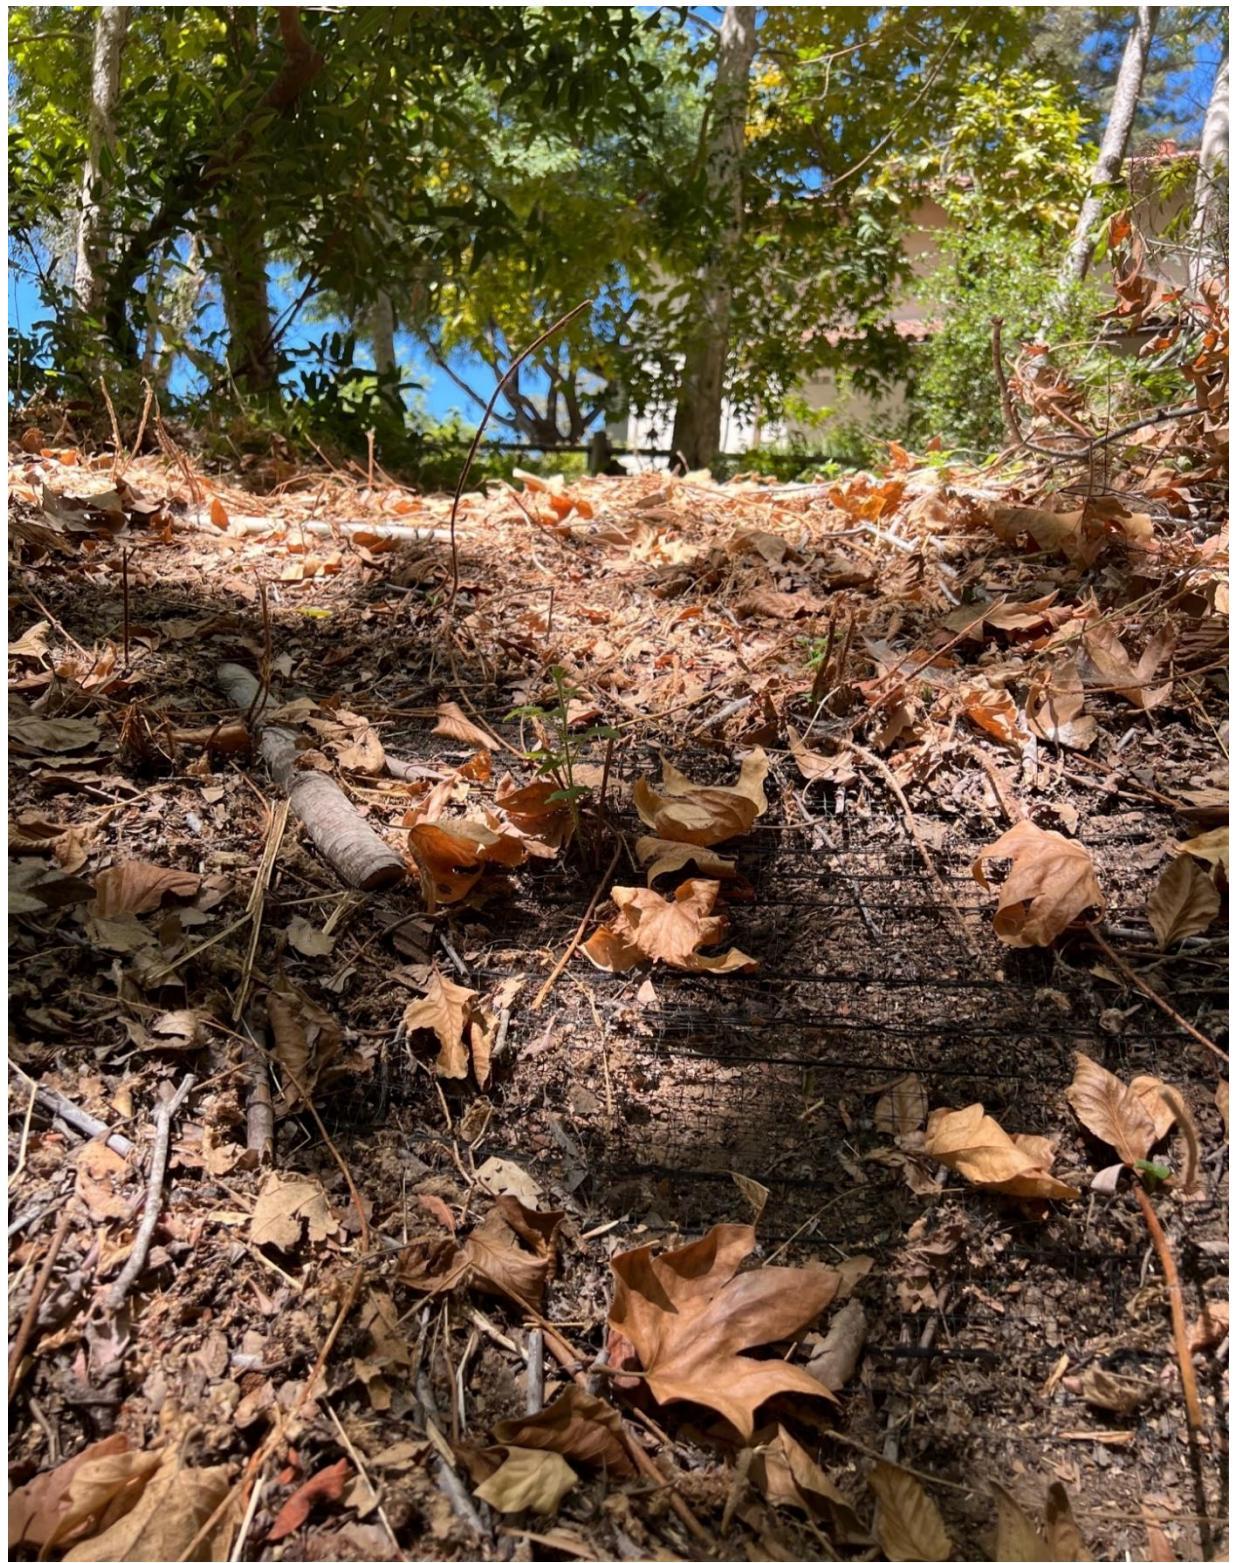
Figure 26. Plastic netting from erosion control should be removed. Elijah Baker. September 2022.

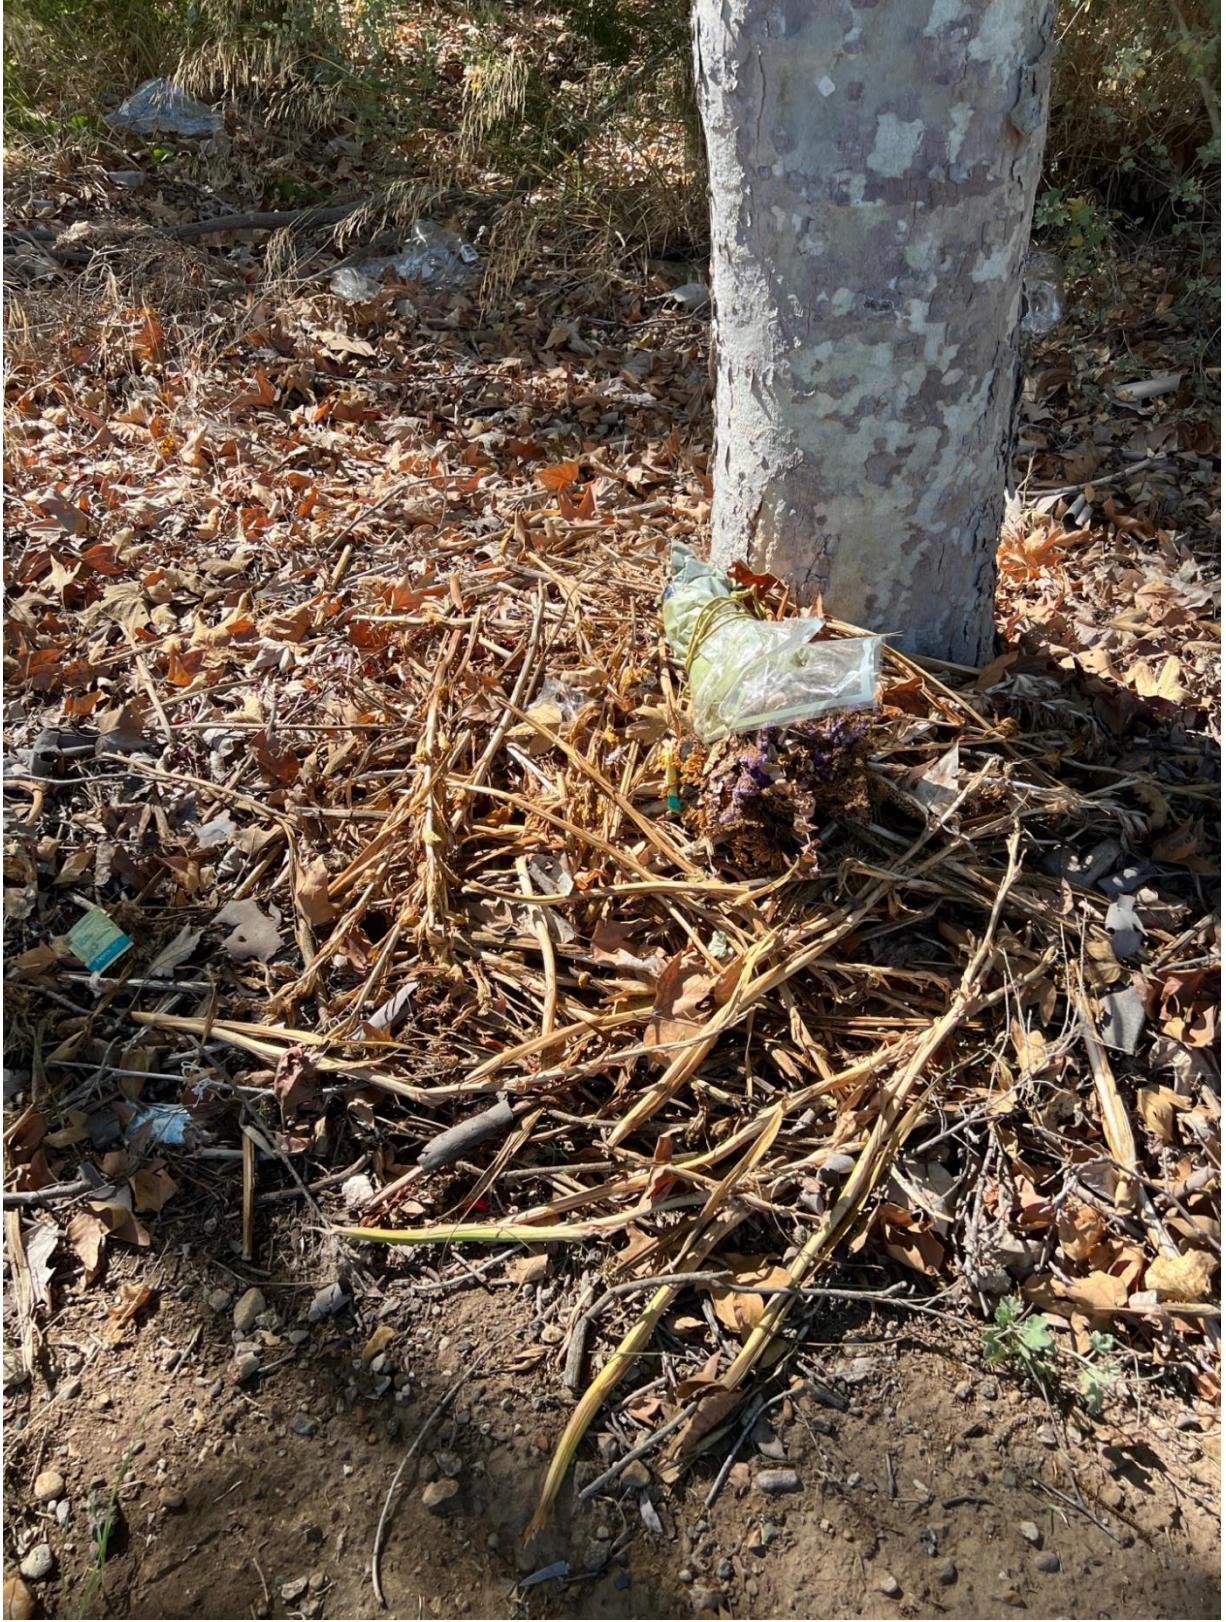
Figure 27. Spent bouquets are routinely discarded in the restoration area. Annual trash cleanups should be undertaken. Elijah Baker. August 22, 2022.

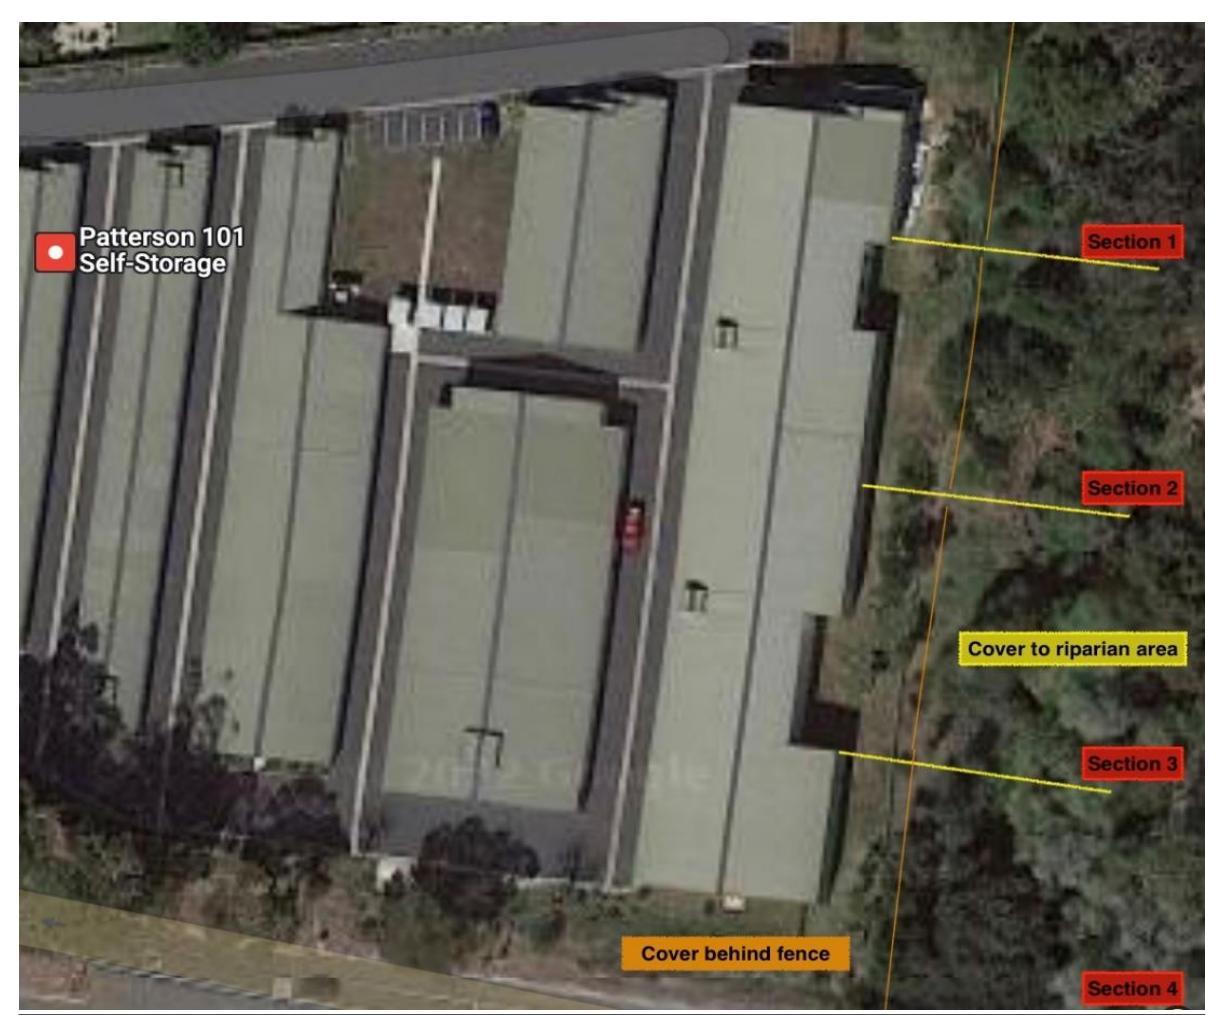
Figure 29. Patterson 101 Self-storage facility with the riparian habitat bordering Maria Ygnacio Creek. Yellow lines divide the revegetation area into four sections. The orange line approximates the location of the chain-link fence. The red text boxes identify the section number assigned by EDC. Google Earth. March 2021.

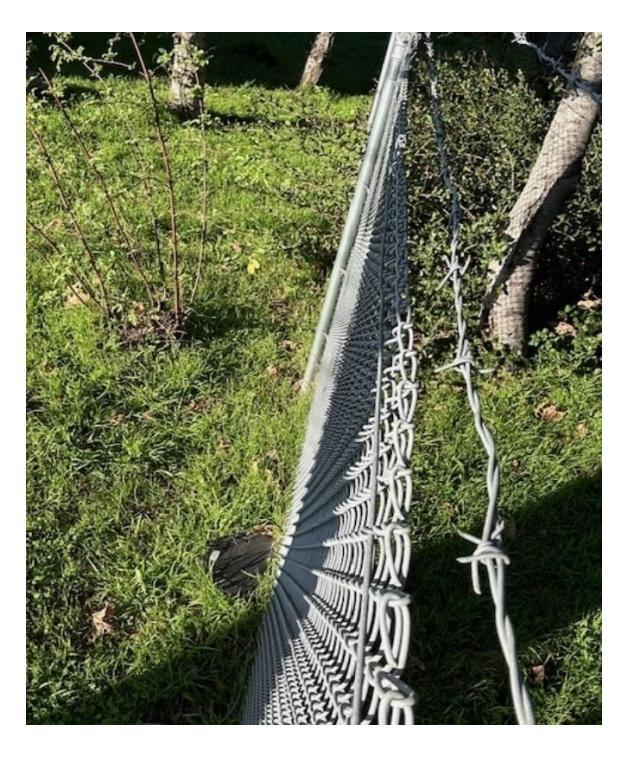
Figure 30. At least one poison rat bait station has been set out within the riparian restoration area next to a cyclone and barbed wire fence. Rat poison works its way up the food chain and can kill predators and scavengers. January 29, 2024.

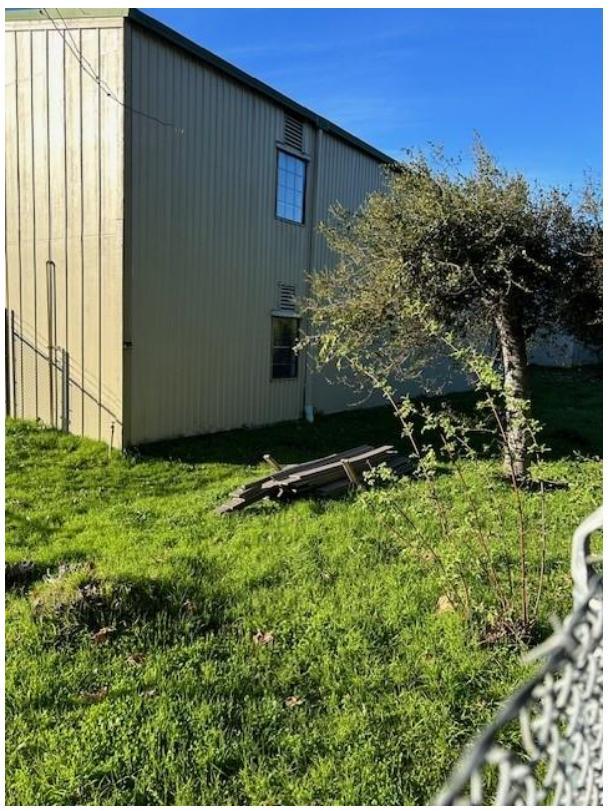
Figure 31. Boards and other miscellaneous items are stockpiled in the restoration area. January 29, 2024.

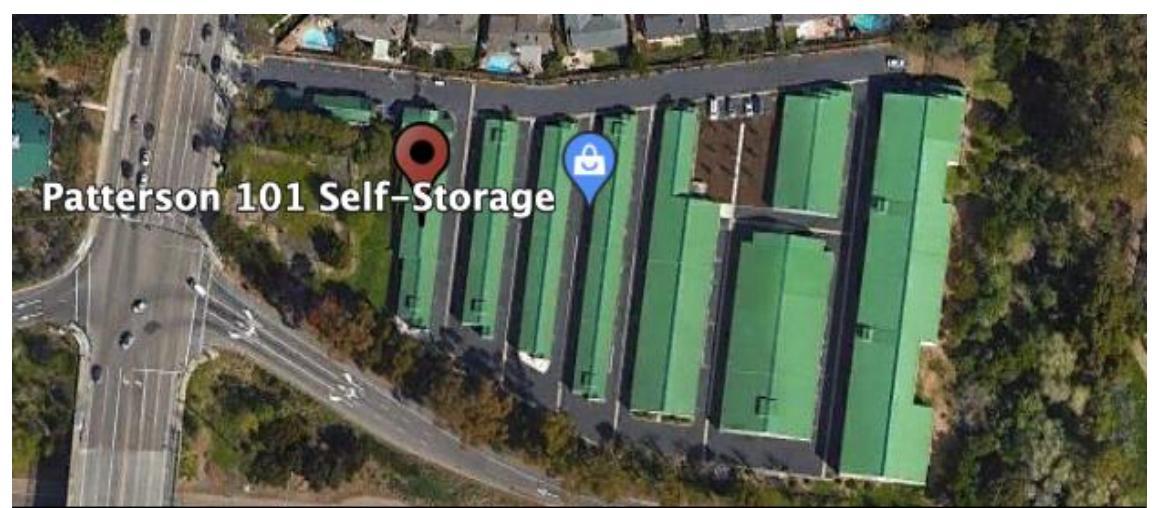
Figure 33. Image of Patterson 101 Self-storage facility. Note the densely vegetation riparian restoration area to the right (east) of the facility. Google Earth. February 2016.

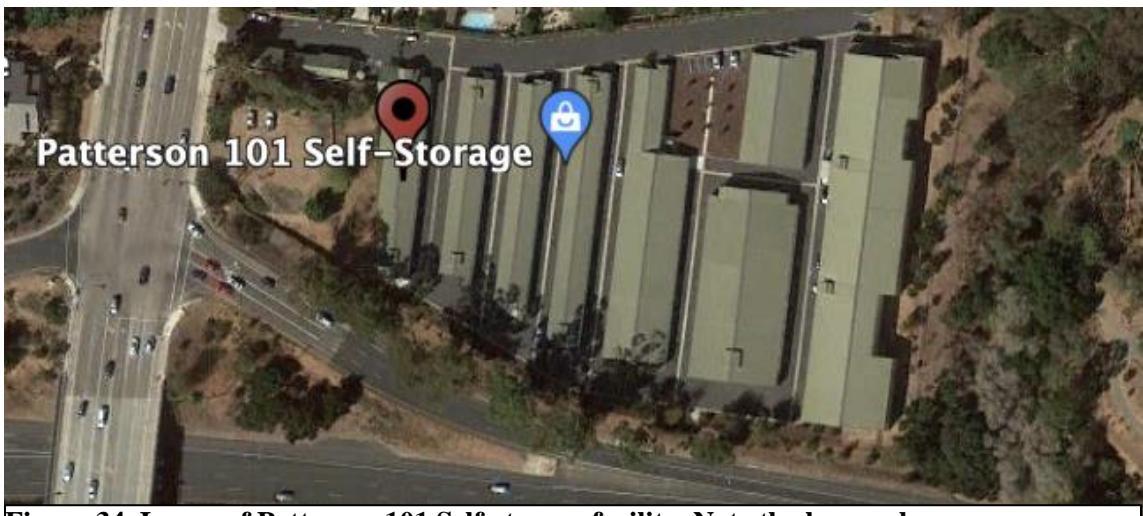
Figure 34. Image of Patterson 101 Self-storage facility. Note the barren brown areas within the riparian restoration area demonstrating clearing of native trees and shrubs to the right (east) of the facility between February and August 2016. Google Earth. October 2016.

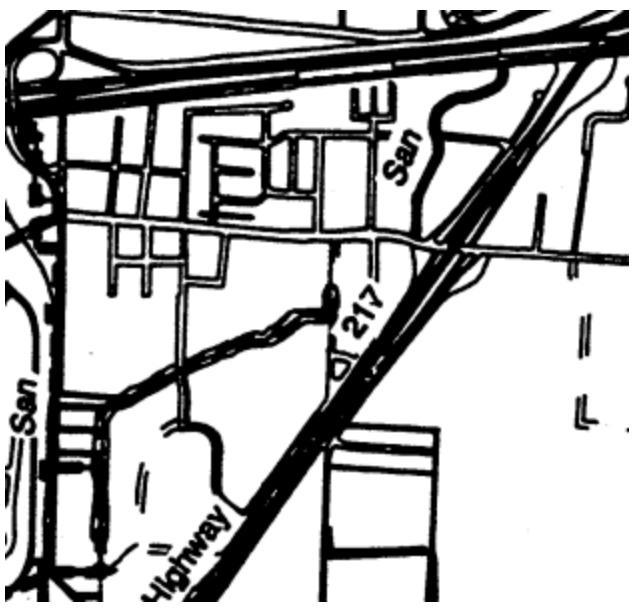
Figure 35. 1993 Goleta Community Plan ESHA Map showing riparian habitat on the Project site was mapped as ESHA before the Project was approved. Santa Barbara County Planning and Development Department. Available at <u>https://content.civicplus.com/api/assets/dad0b829-866a-4010-80c1-07ab63eb7ee7</u>

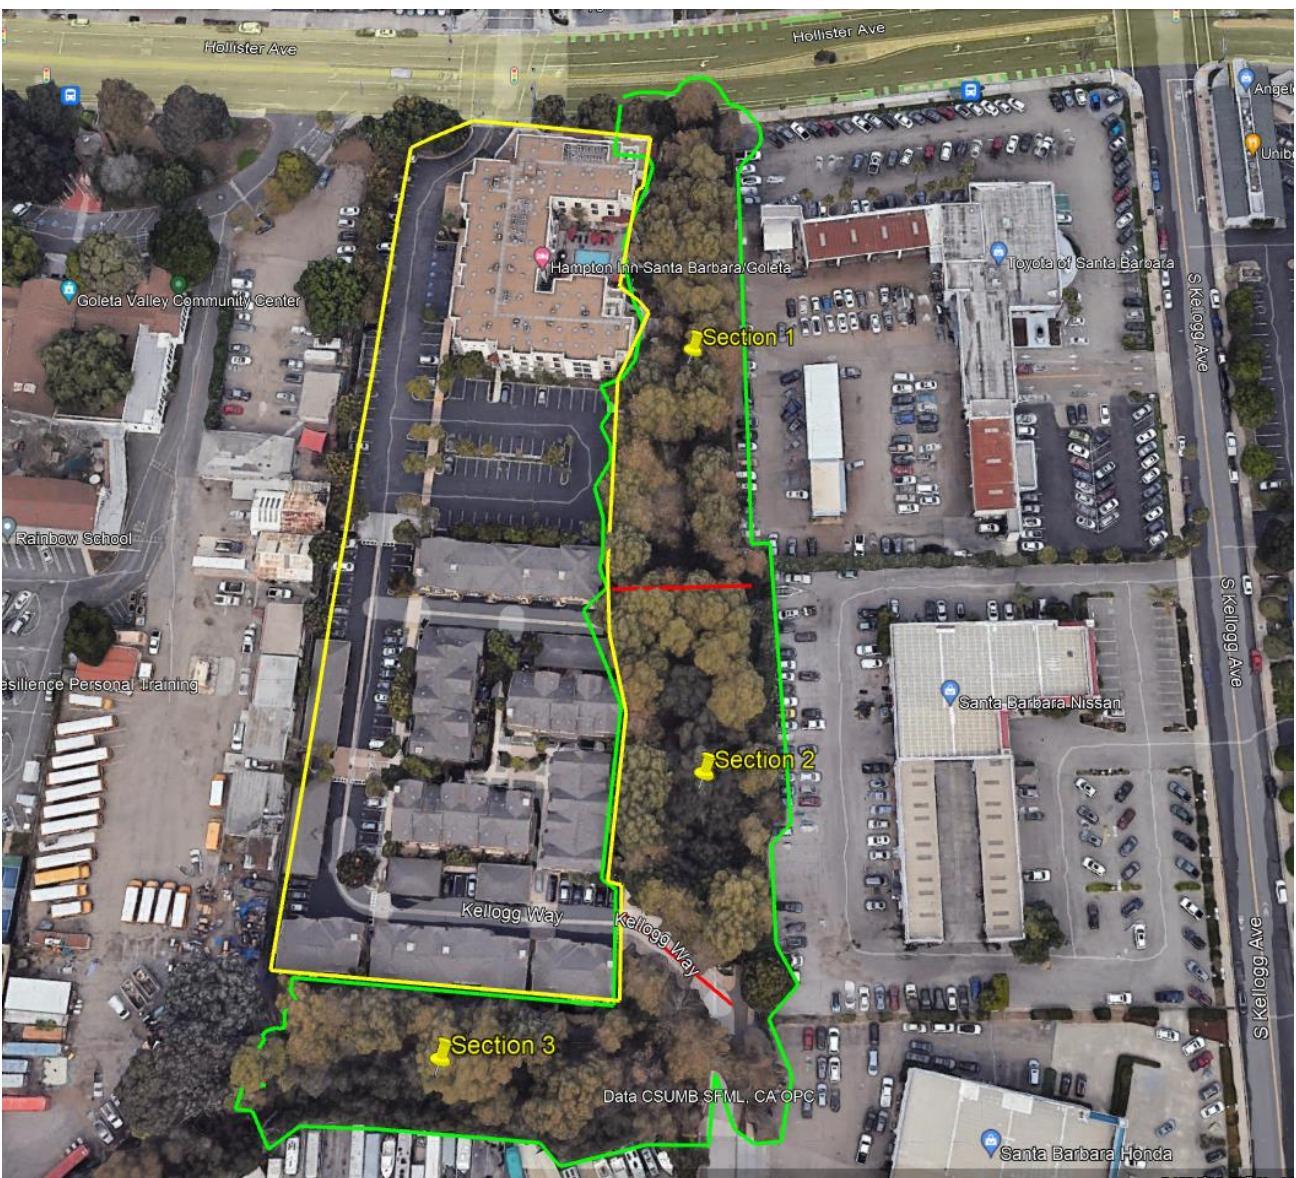
Figure 36. Hampton Inn Old San Jose Creek Revegetation Project Site. The green polygon is the revegetation area. The red lines divide the revegetation area into three sections for the purpose of our evaluation. The yellow polygon is the Hampton Inn and Village Project boundary. Google Earth.

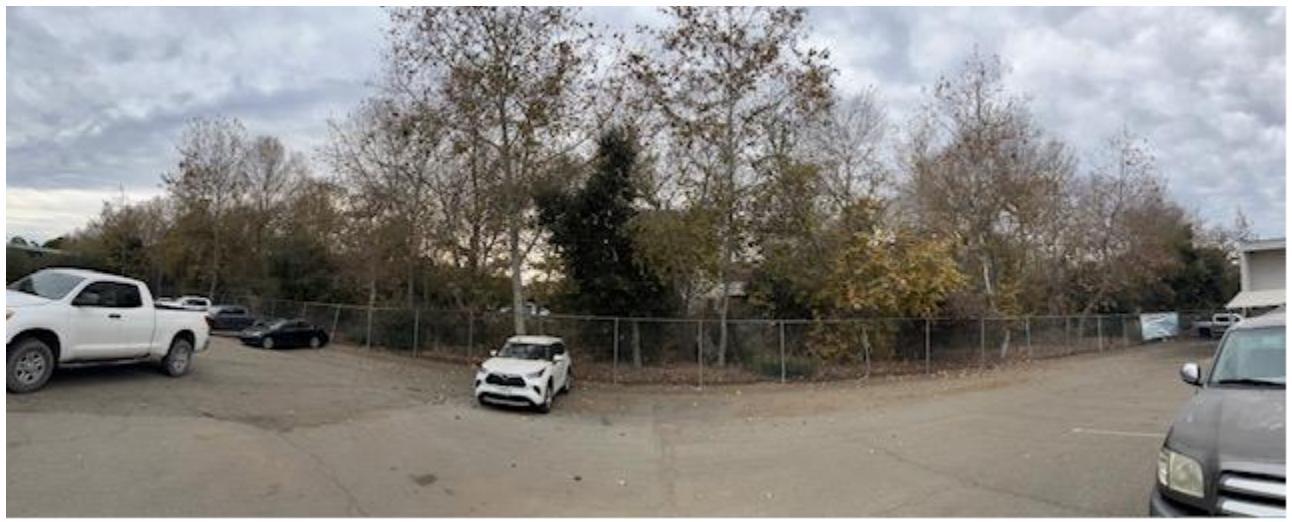
Figure 38. Hampton Inn Revegetation Project on Old San Jose Creek consisting of sycamore, coast live oak, and black cottonwood trees. Looking southwest from Toyota of Santa Barbara. Brian Trautwein. December 18, 2023.

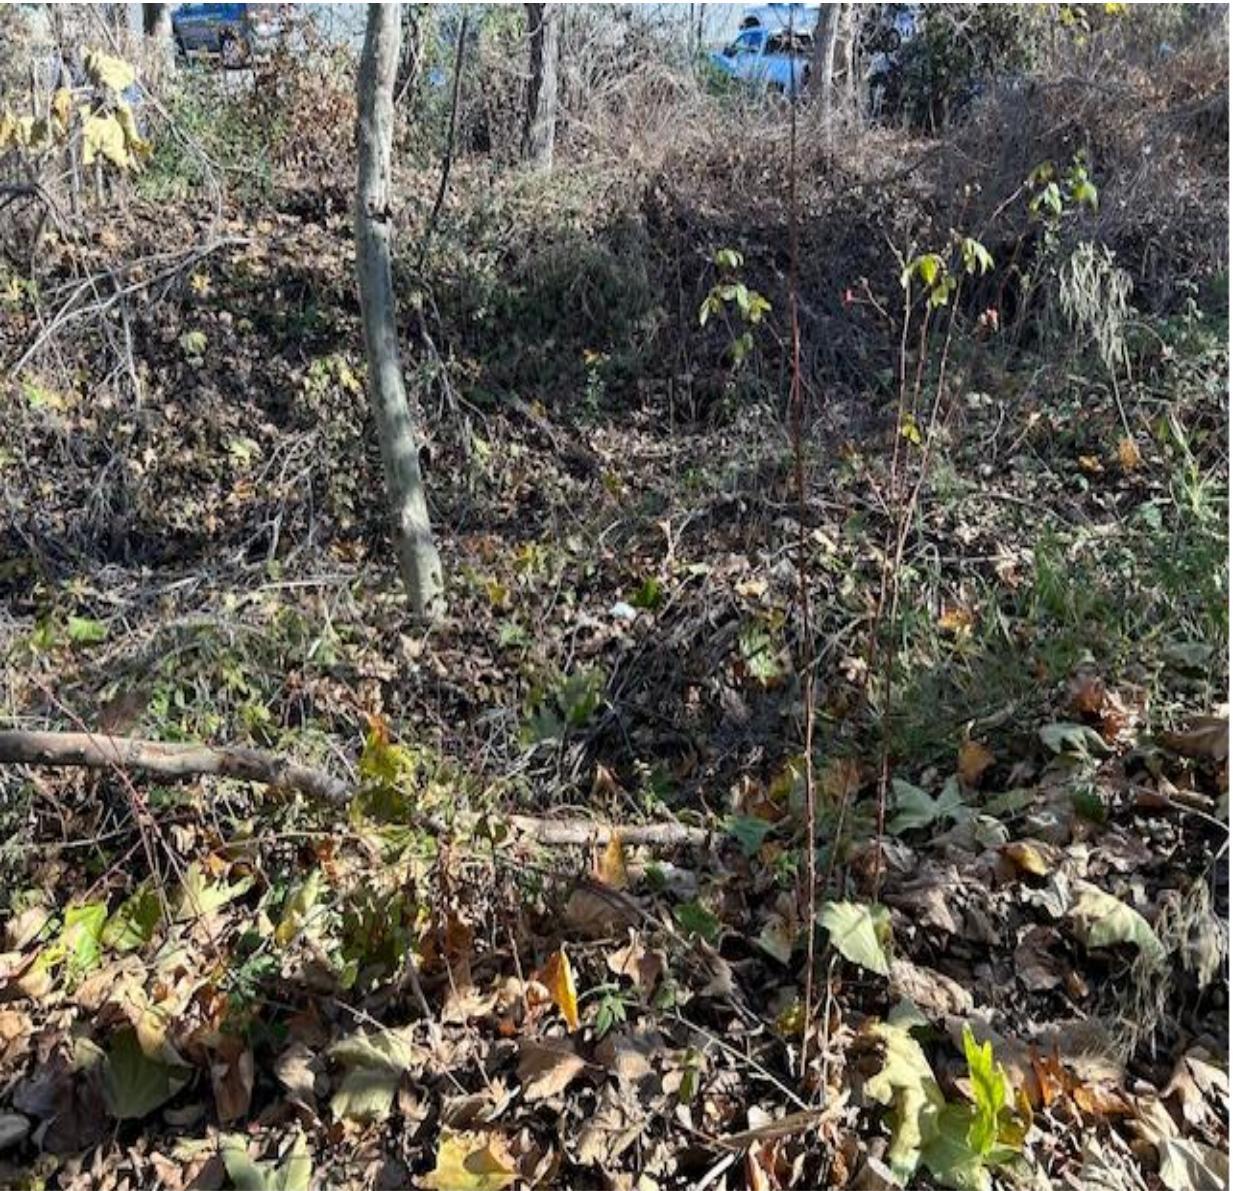
Figure 39. Native groundcover and understory species include scattered wild rose, wild giant rye, and wild blackberry. Groundcover was lacking throughout the revegetation area. Brian Trautwein. January 4, 2024.

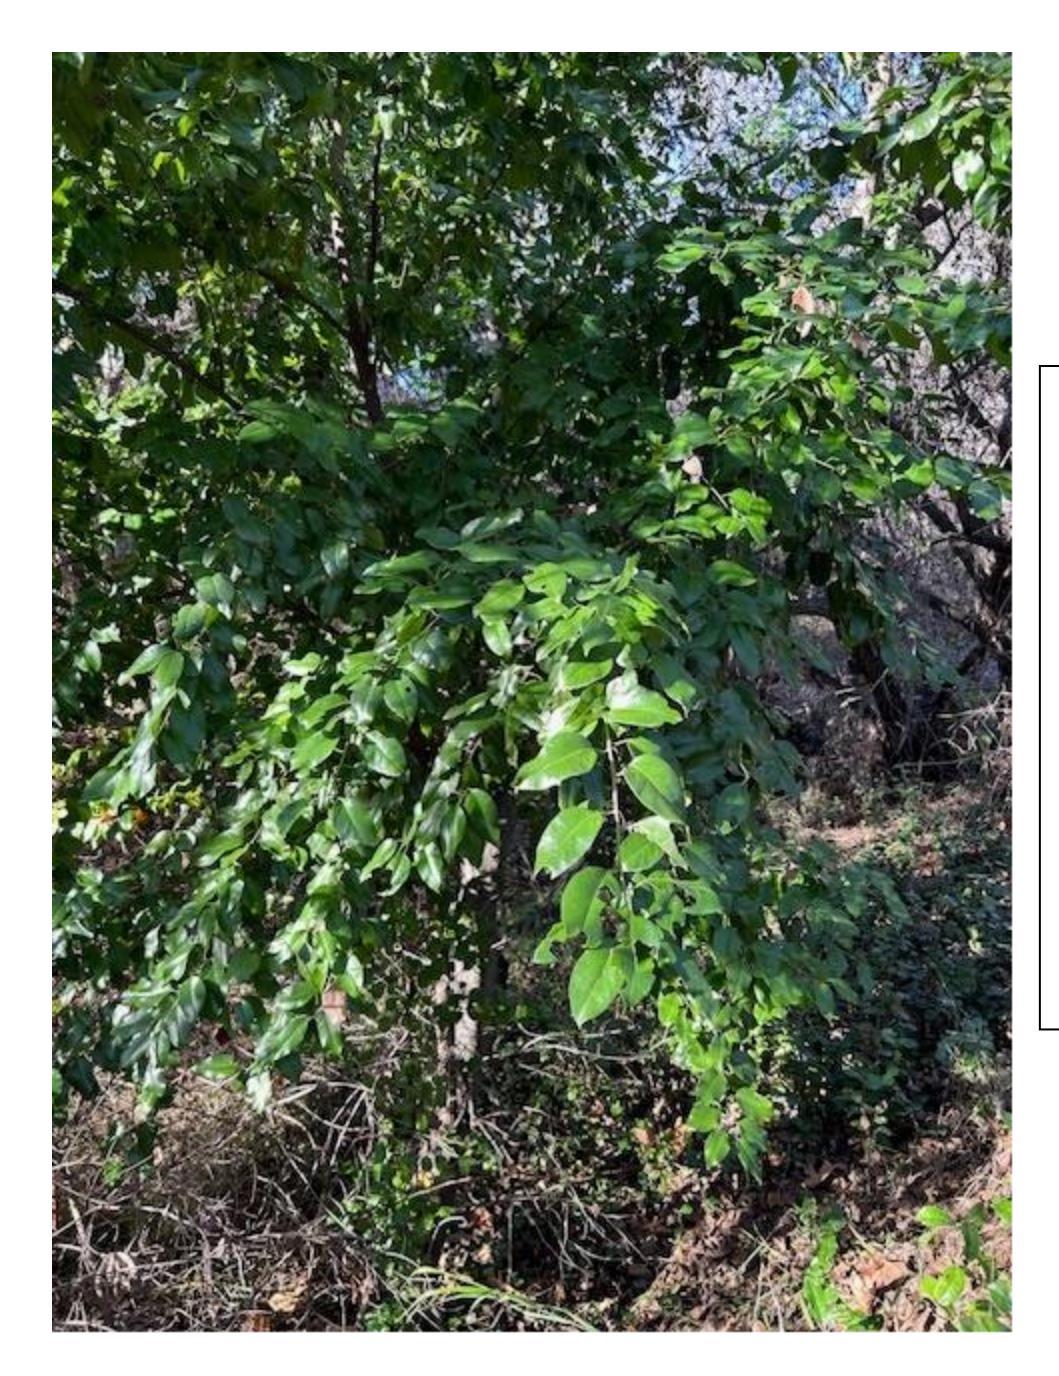
Figure 40. Catalina Island cherry is native to the Santa Barbara Channel Islands. It is used in landscaping on the mainland. It has become naturalized in riparian areas. The large shrub by the bridge separating Sections 2 and 3 and all seedlings should be identified as the native holly leaf cherry and retained or the nonnative Catalina Island cherry and removed. Brian Trautwein. January 4, 2014.

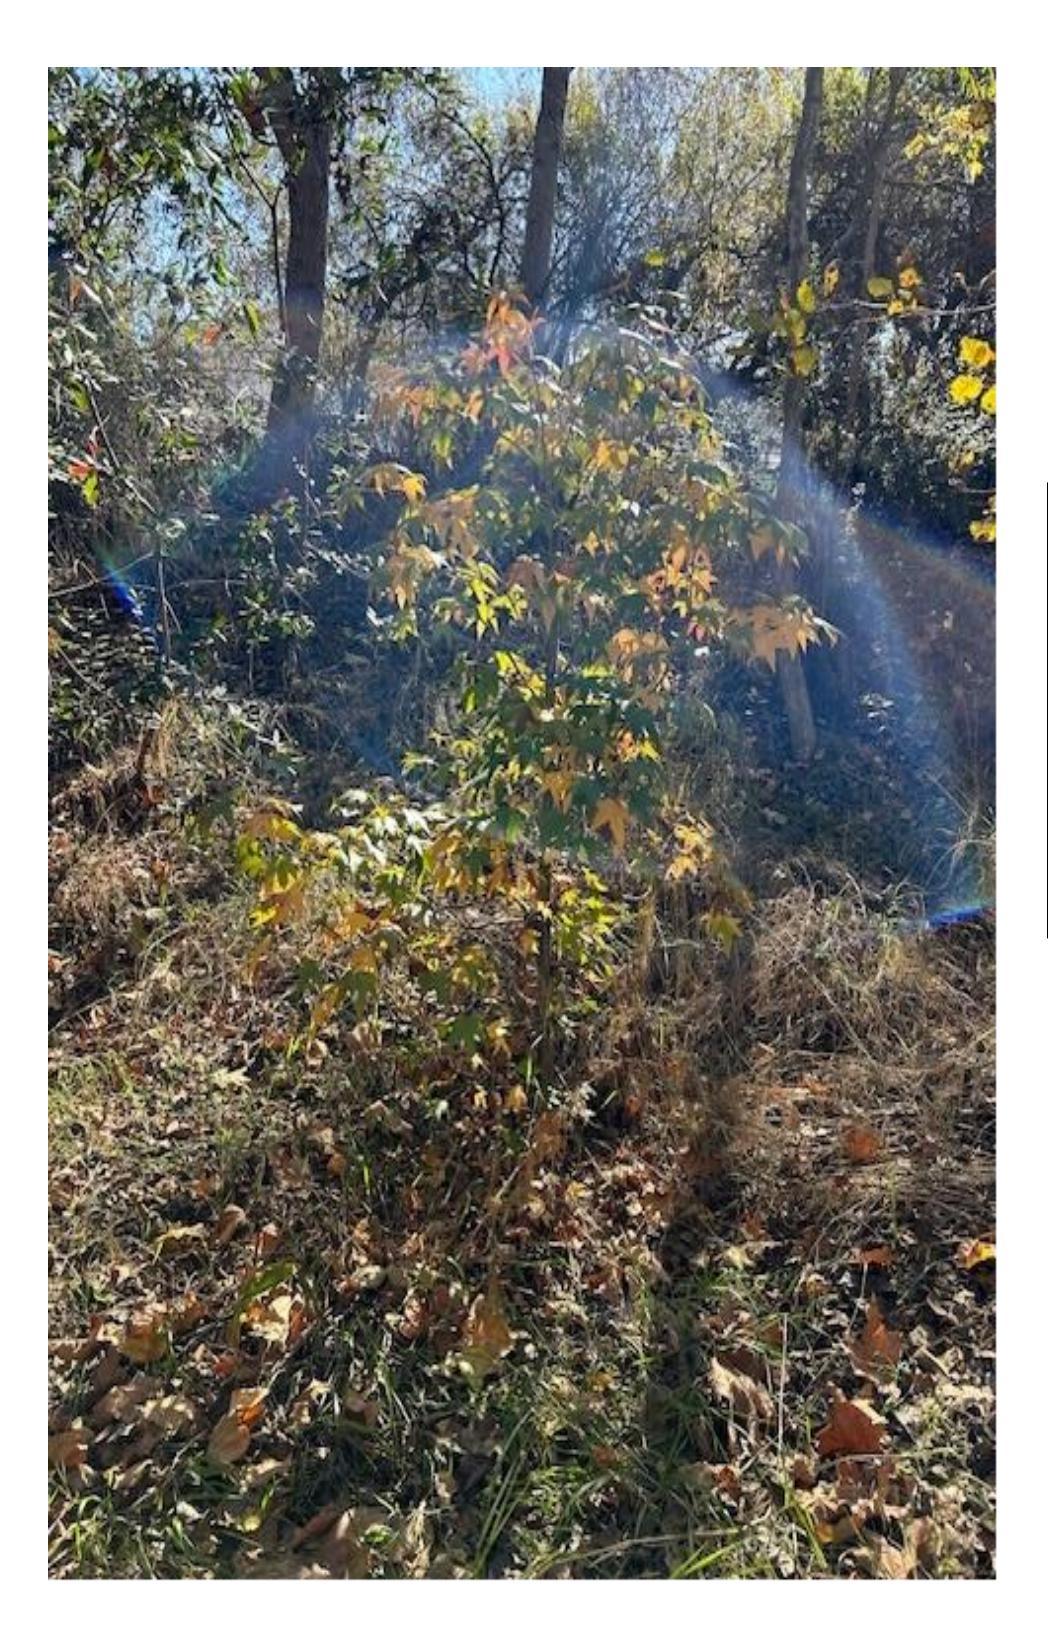
Figure 41. Liquid amber is a nonnative tree that was observed in Section 3 and should be removed from the revegetation area. Brian Trautwein. January 4,

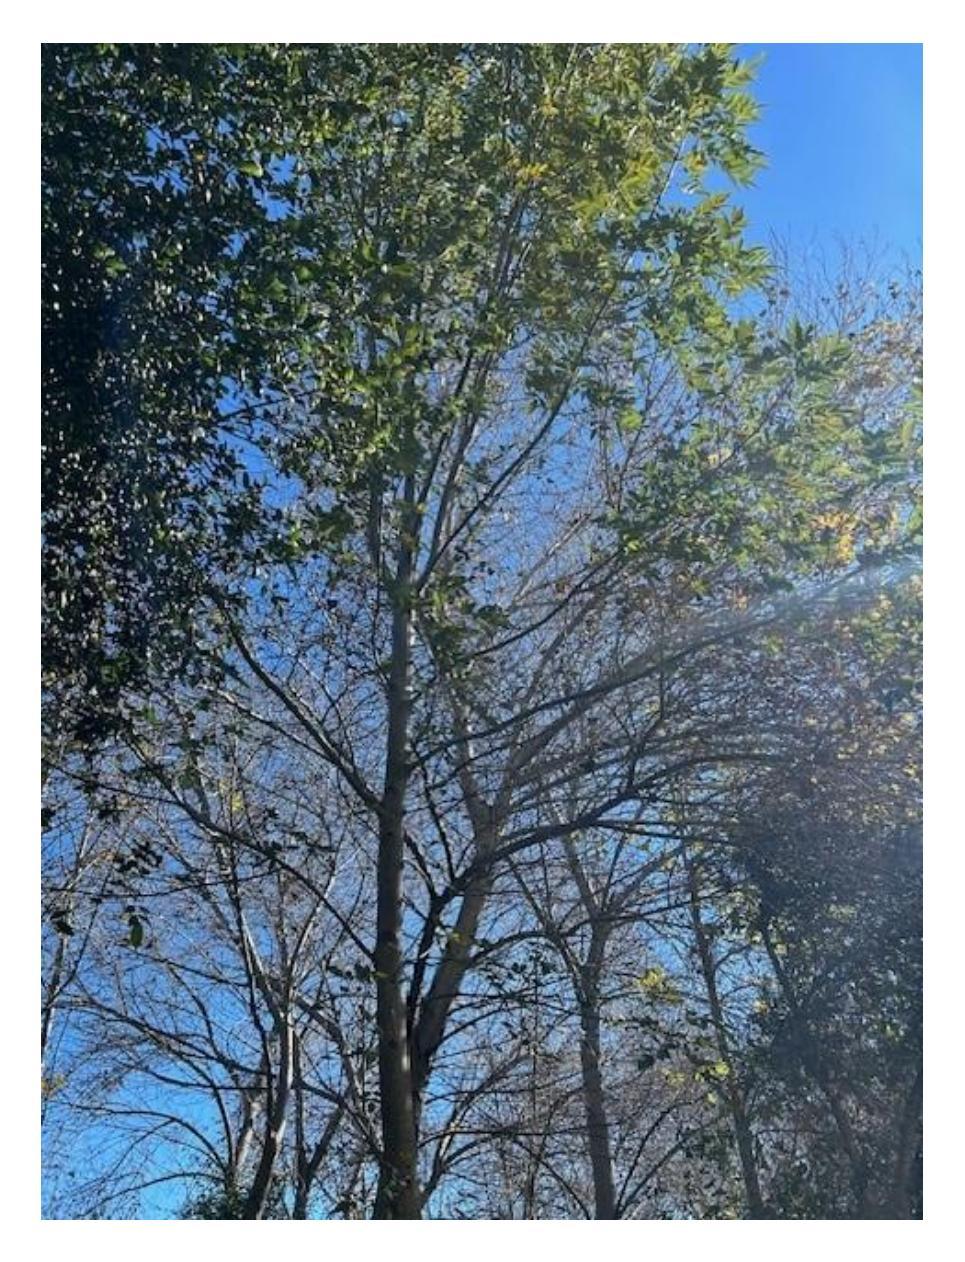
Figure 42. Shamel ash is an invasive tree that is spreading in local creeks and should be removed and replaced with native vegetation. Brian Trautwein. January 4, 2024.

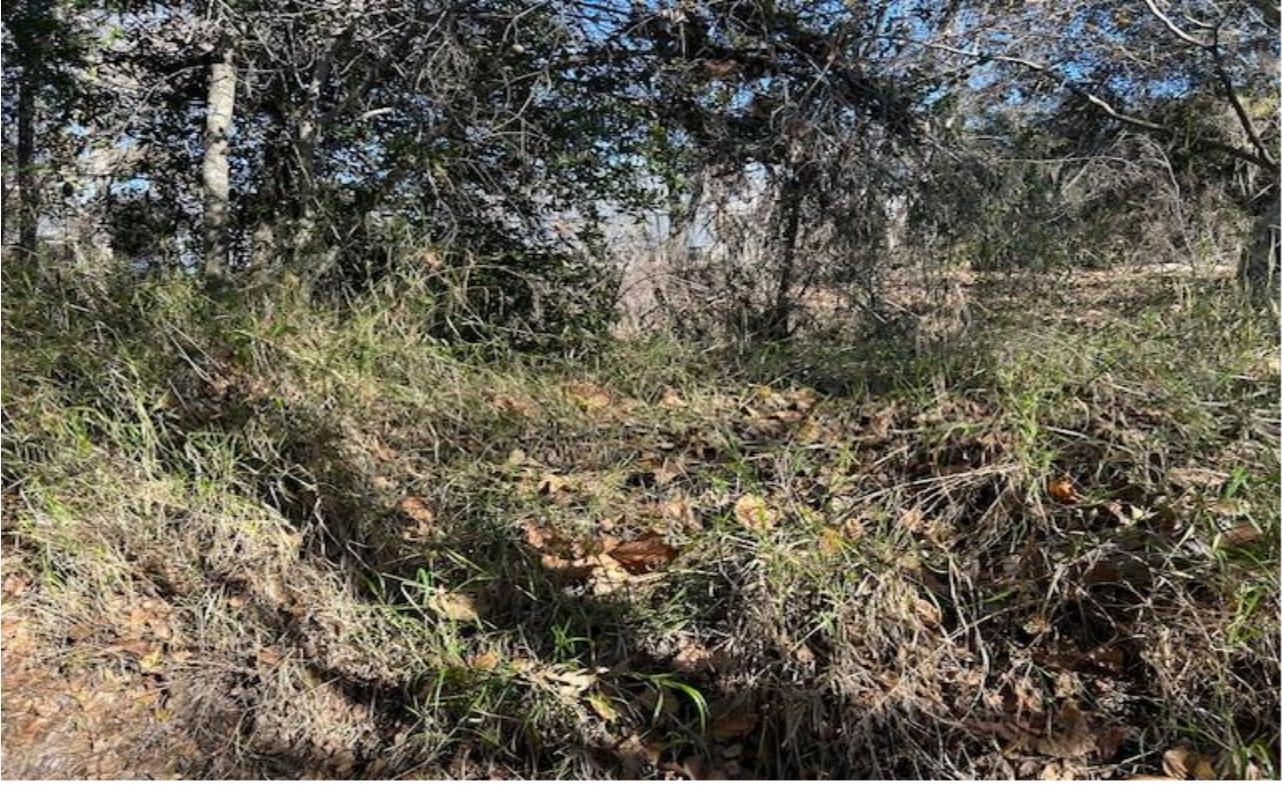
Figure 43. Smilograss (*Stipa milicea* var. *milicea*) is an invasive grass which is dominating the understory in the revegetation area and should be replaced with native groundcover and understory plants. Berian Trautwein. January 24, 2024.

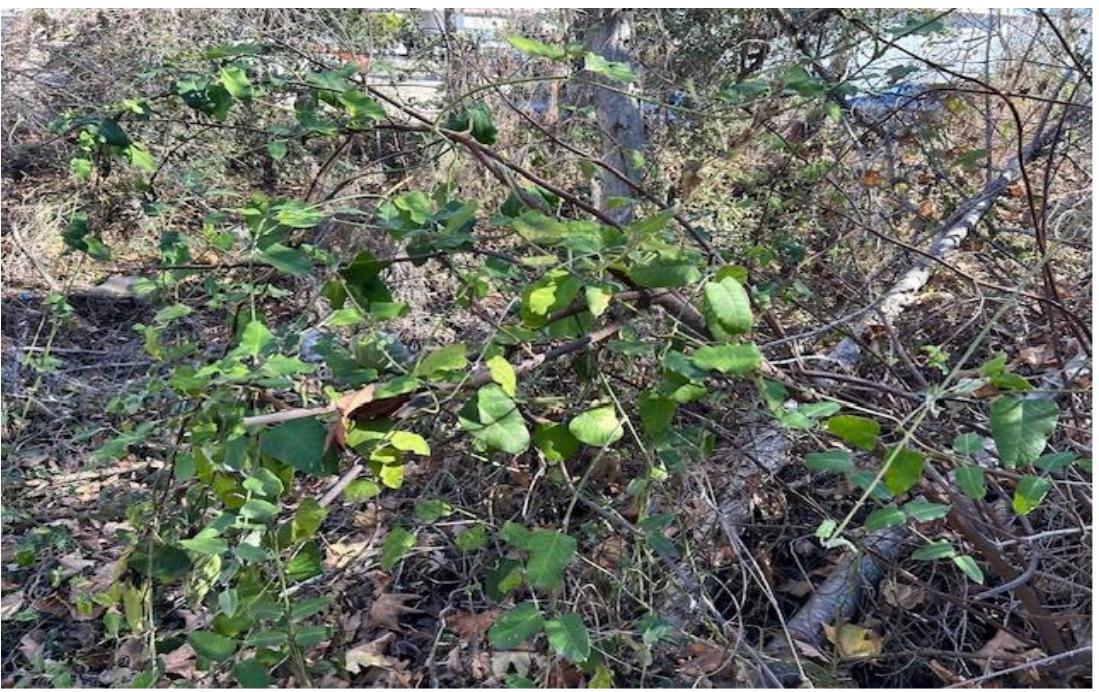
Figure 44. Nonnative moth vine (*Araujia sericifera*) is present in the revegetation area. This plant is growing up into native shrubs and can potentially grow into and smother native shrubs and trees. Brian Trautwein. January 4, 2024.

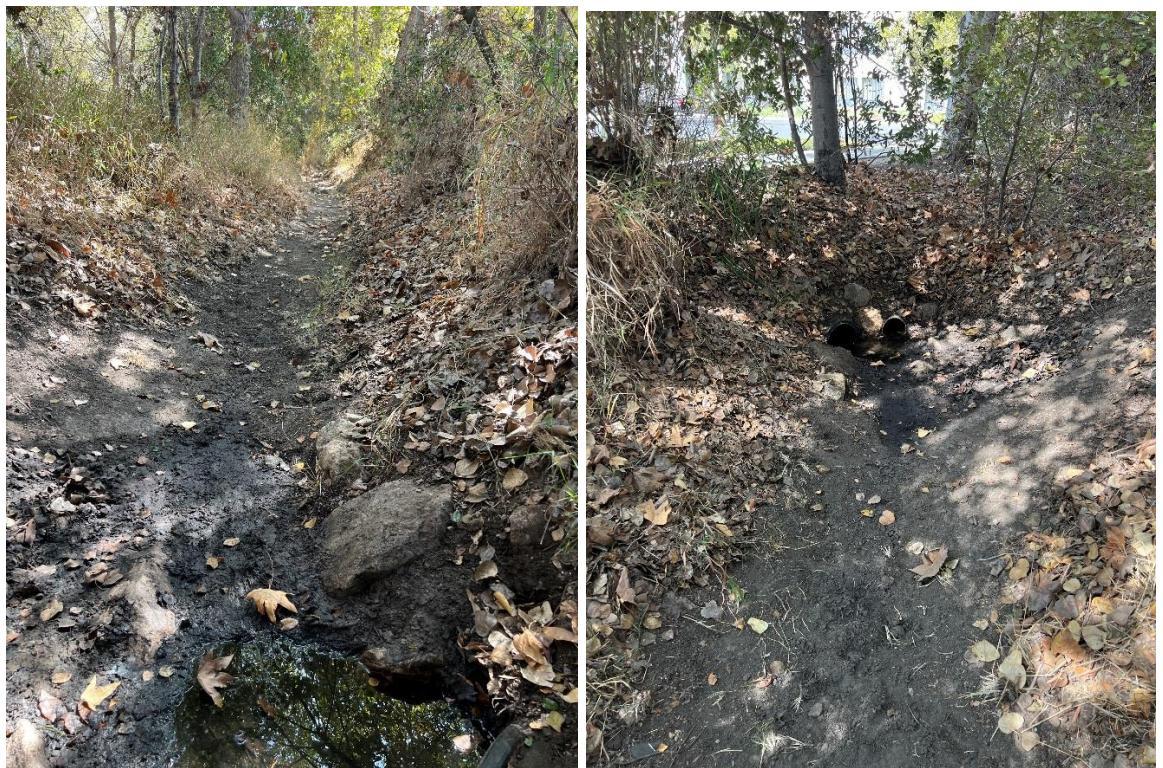
Figures 45 and 46. Bioswales have been denuded and maintained free of vegetation. While this may facilitate drainage it does not mitigate stormwater quality impacts. Bioswales should be planted with native wetland plants such as rushes and horsetails. Elijah Baker. September 30, 2022.

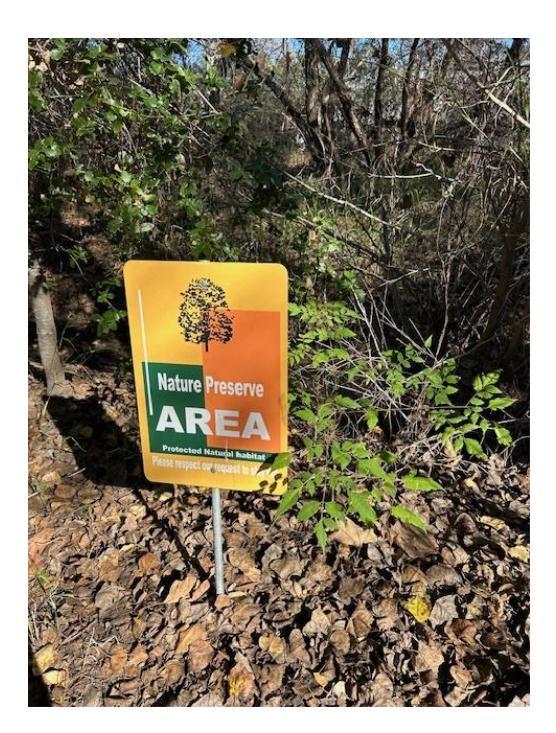
Figure 47. "Nature Preserve" signage helps keep people out of the revegetation area. Note the unidentified nonnative sapling growing to the right of the sign. Brian Trautwein. January 4, 2014.

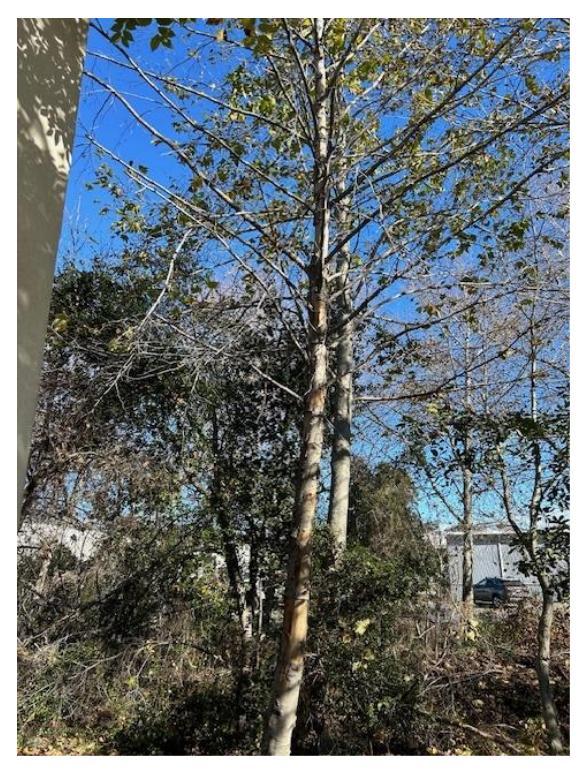
Figure 48. Six deceased while alder trees (e.g., the closest tree in this photo) and no surviving white alder trees were observed in the revegetation area. Brian Trautwein. January 4, 2014.

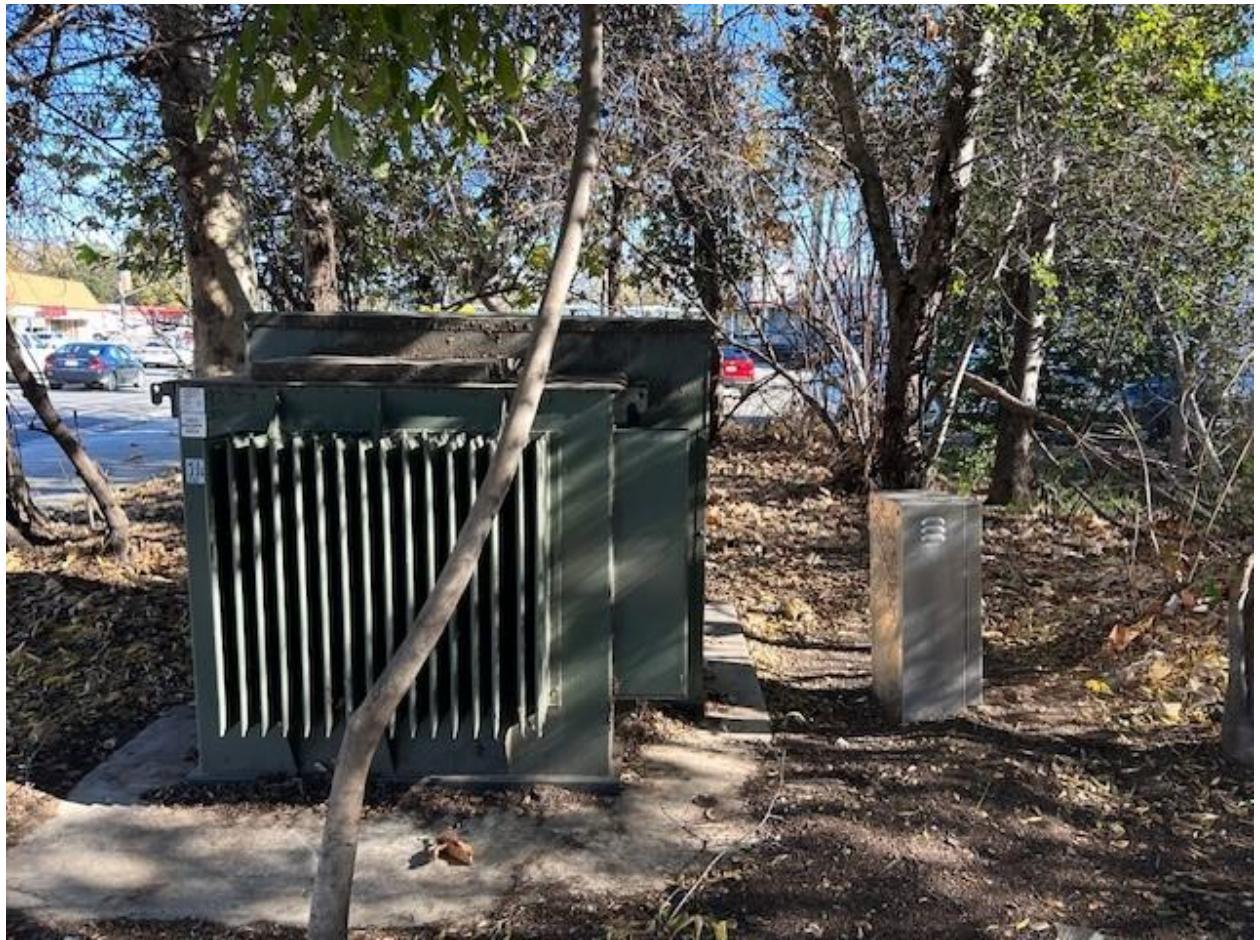
Figure 49. These utility boxes and concrete pad located within the revegetation area near Hollister Avenue indicate that periodic human presence within the riparian woodland is necessary for utility maintenance, degrading the value of the revegetated riparian habitat. Brian Trautwein, January 4, 2024.

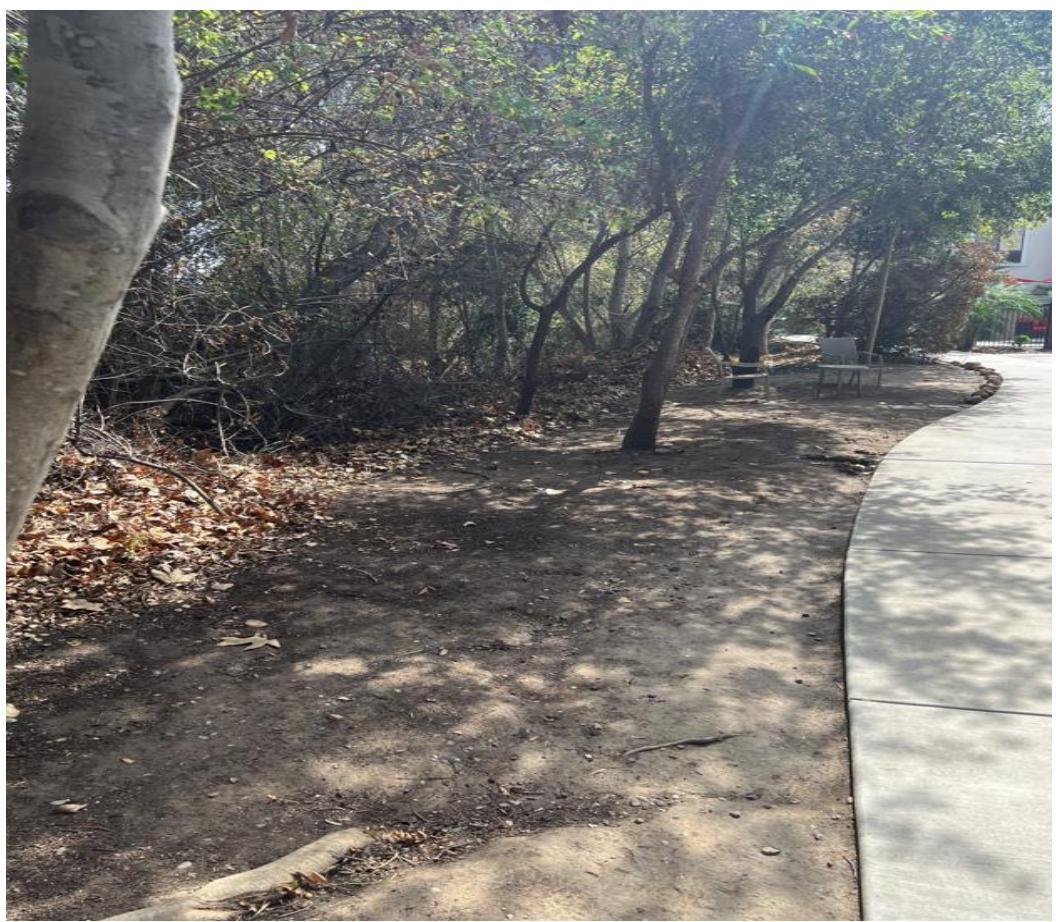
Figure 50. The western edge of the riparian revegetation area is regularly raked, exposing soil to erosion, reducing nutrients, and degrading the riparian habitat. Raking leaf litter should be limited to the bare minimum necessary for fire safety. Brian Trautwein. January 10, 2024.
