GOLETA WATERSHEDS AND WILDLAND-URBAN INTERFACES:
ENHANCING FIRE SAFETY AND RIPARIAN FOREST HEALTH

GOLETA WATERSHED PROTECTION AND EDUCATION PROGRAM

August 2021

ENVIRONMENTAL DEFENSE CENTER

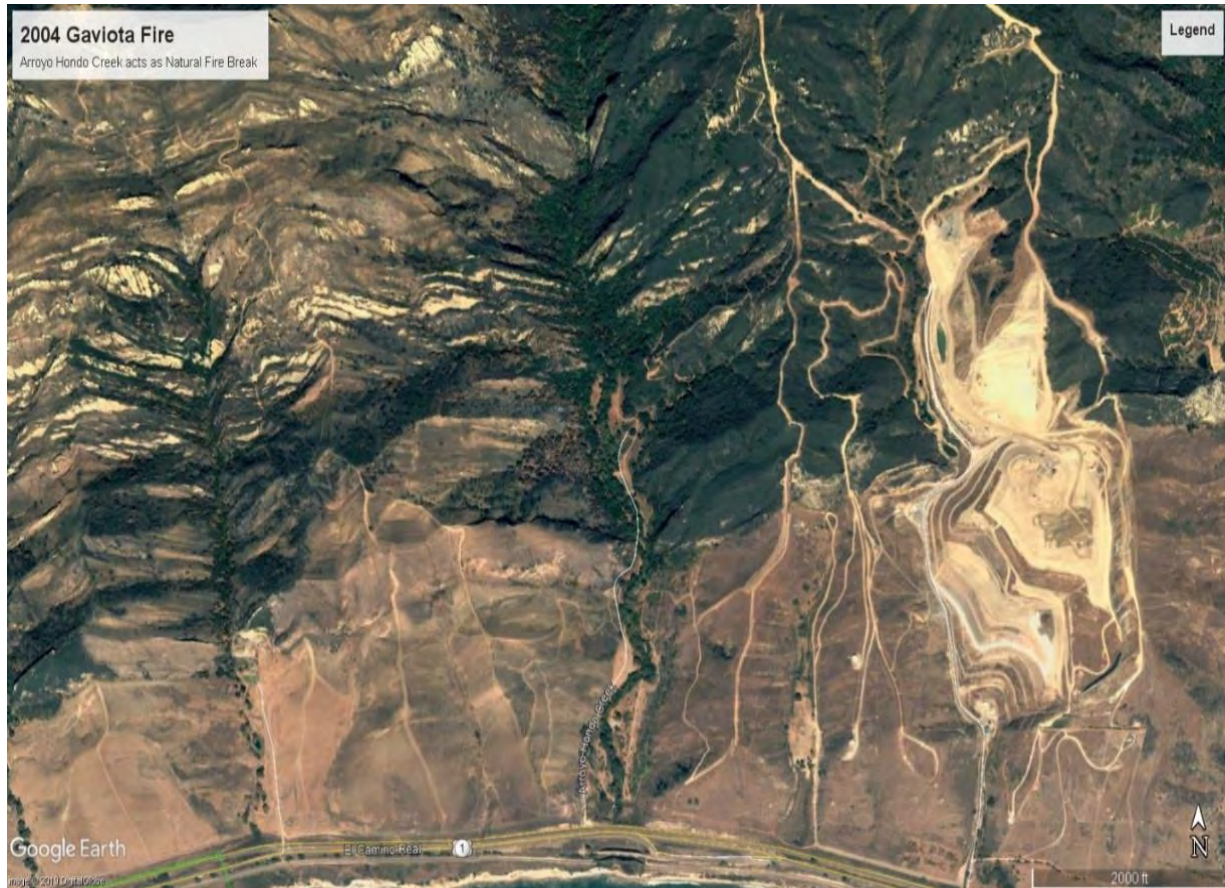
Figure 24. Arroyo Hondo Creek acted as a natural firebreak during the 2004 Gaviota Fire. Note burned landscape to west of creek and green vegetation to east. Google Earth. September 2004.

Goleta's creeks offer countless services to residents and tourists. Riparian corridors that are not over-drafted by wells or stream diversions retain high live fuel moisture levels and can act as create natural fuel breaks. (Figure 24) When protected, creeks, floodplains, and buffers serve as natural flood control channels, safely conveying floodwaters to the ocean. Many trails, bike paths, open spaces, and parks are located along Goleta's creeks, highlighting the importance of Goleta's creeks for public recreation and as biking and pedestrian transportation corridors. Parks and open spaces within the riparian areas along Goleta's creeks provide opportunities for exercise, relaxation, social gathering, walking, hiking, picnics, birdwatching, photography, art, and general nature appreciation. Creeks are also wonderful areas to study the natural world and are used by Goleta-area students from elementary school to college when studying natural sciences, including ecology, botany, environmental studies, zoology, water quality, geology, and hydrology. Creeks allow people to seek solitude and escape from the active happenings in the surrounding urban landscapes and find a quiet spot for contemplation and relaxation.

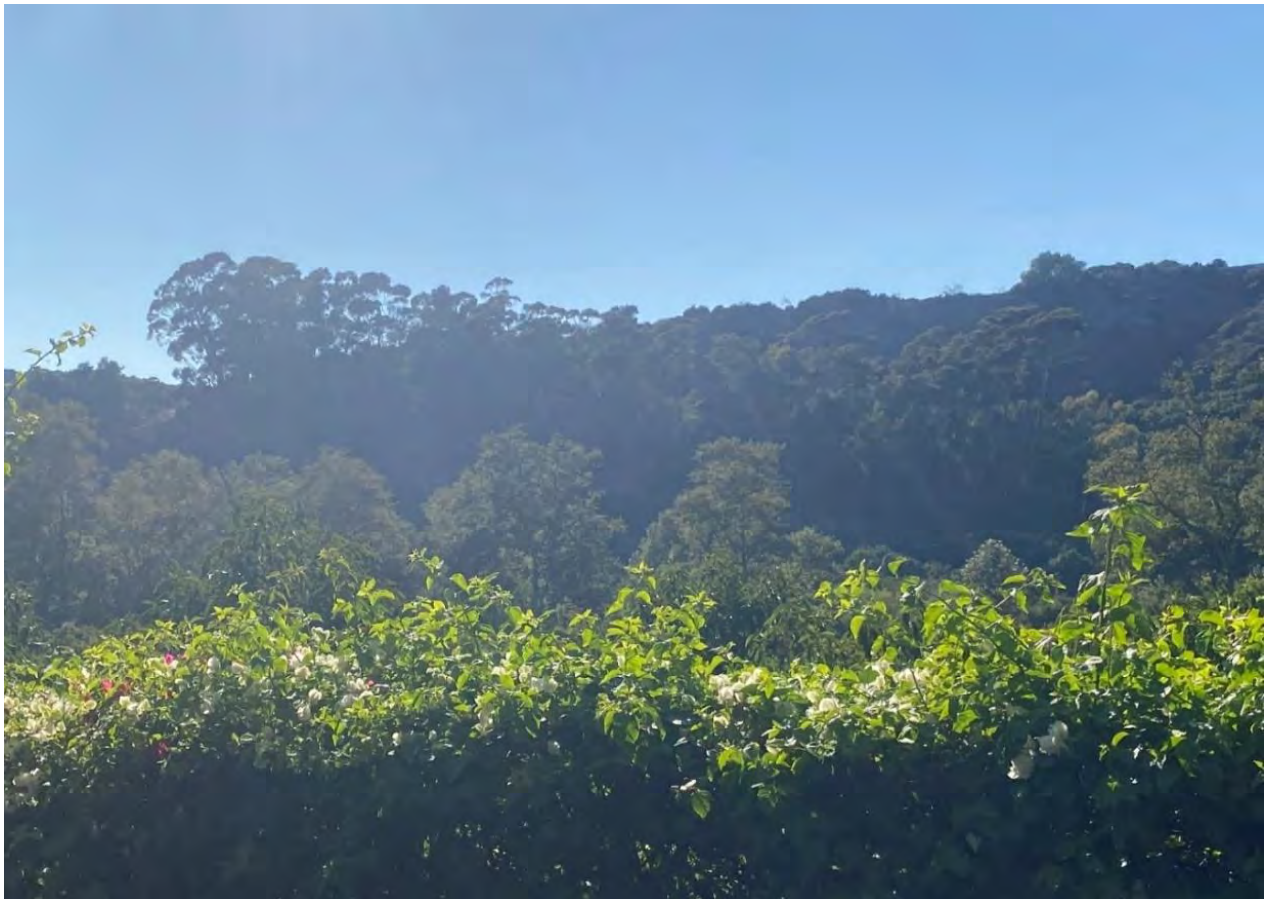
Figure 34. A stand of blue gum eucalyptus trees may increase the fire hazard in Rancho Embarcadero near Tecolote Creek. Max Kalber. September 2020.

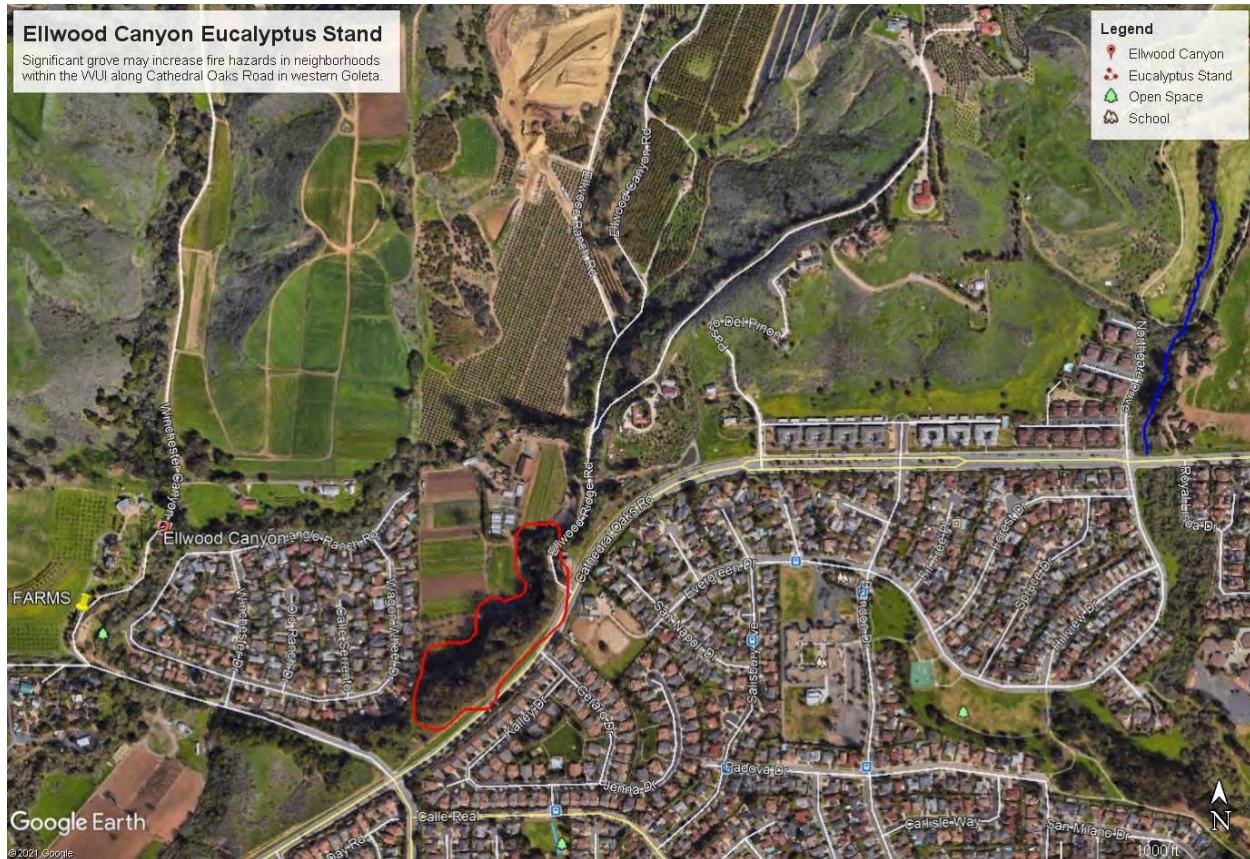
Figure 43. A 350-foot-long eucalyptus stand occurs fifty meters from homes along Kalley Drive. Google Earth, 2019.

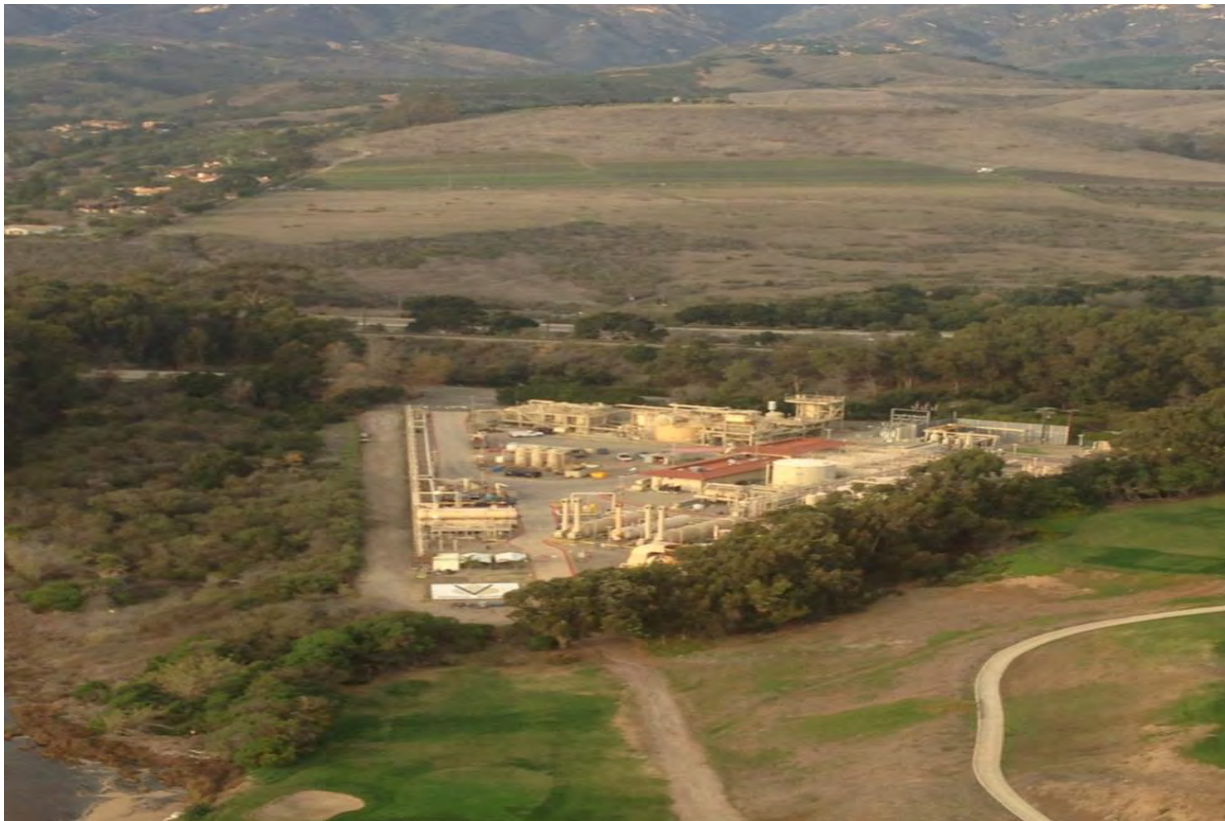
Figure 47. Venoco's abandoned EOF, to be decommissioned, should be removed, and the site converted to a park or open space. Eucalyptus trees west of Bell Canyon Creek and east of the EOF should be replaced with native oak woodland or riparian vegetation. EDC. 2019.

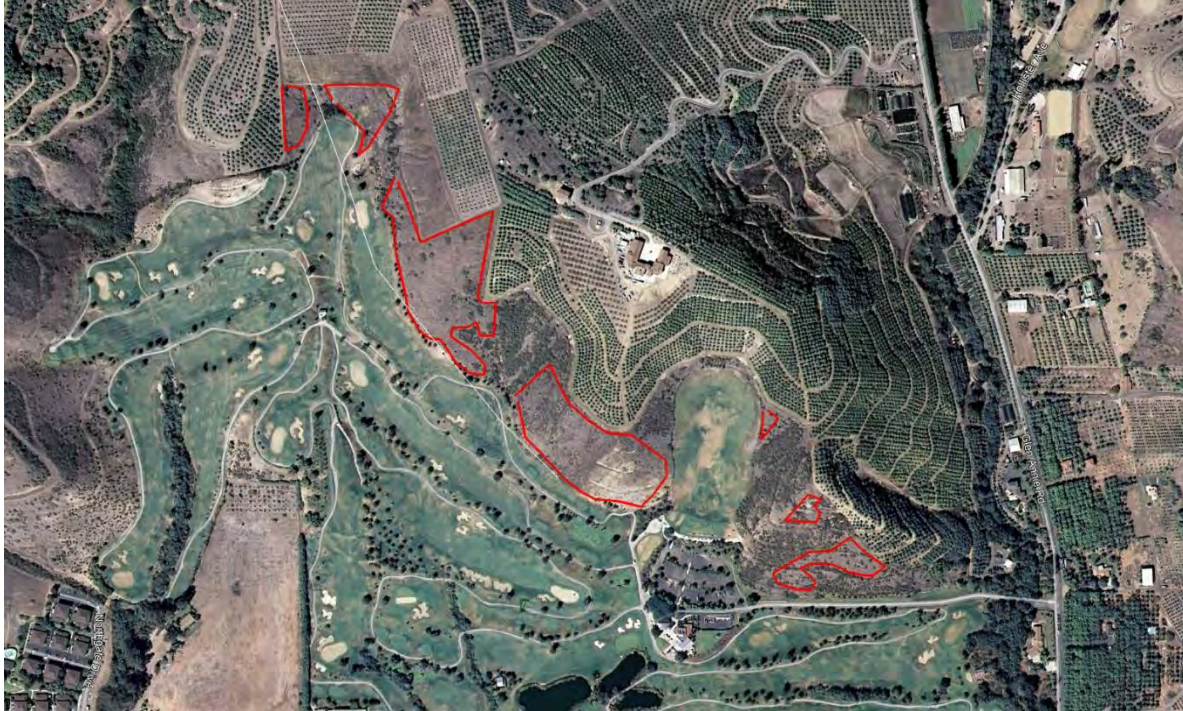
Figure 50. Nonnative annual plants north of Glen Annie Golf Club (red polygons) displace sensitive coastal sage scrub, degrading the El Encanto Creek Watershed and exacerbating fire ignition risks. Google Earth. 2019.

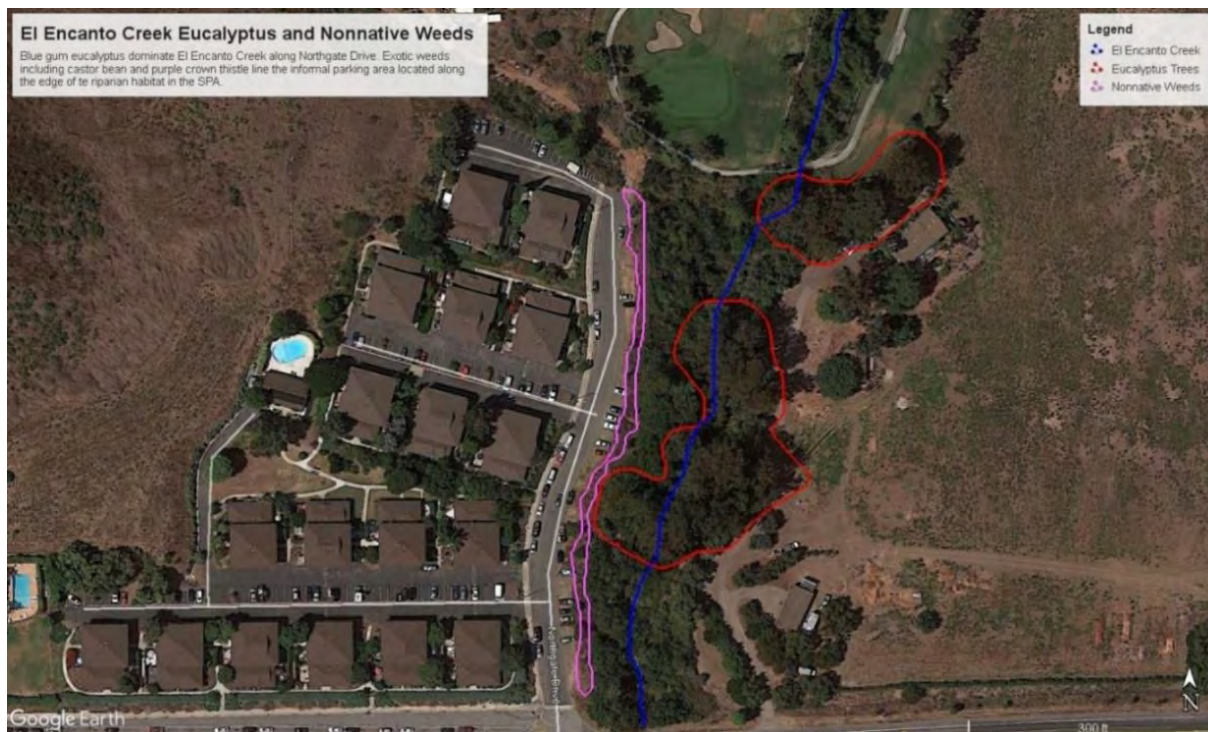
Figure 53. Invasive blue gum eucalyptus (red polygon), and castor bean, mustard, and purple-crown thistle (purple polygon) line Northgate Drive along the western side of the El Encanto Creek (blue line) riparian corridor. Note cars parked in the Creek buffer with headlights pointed directly in riparian habitat. Google Earth. 2020.

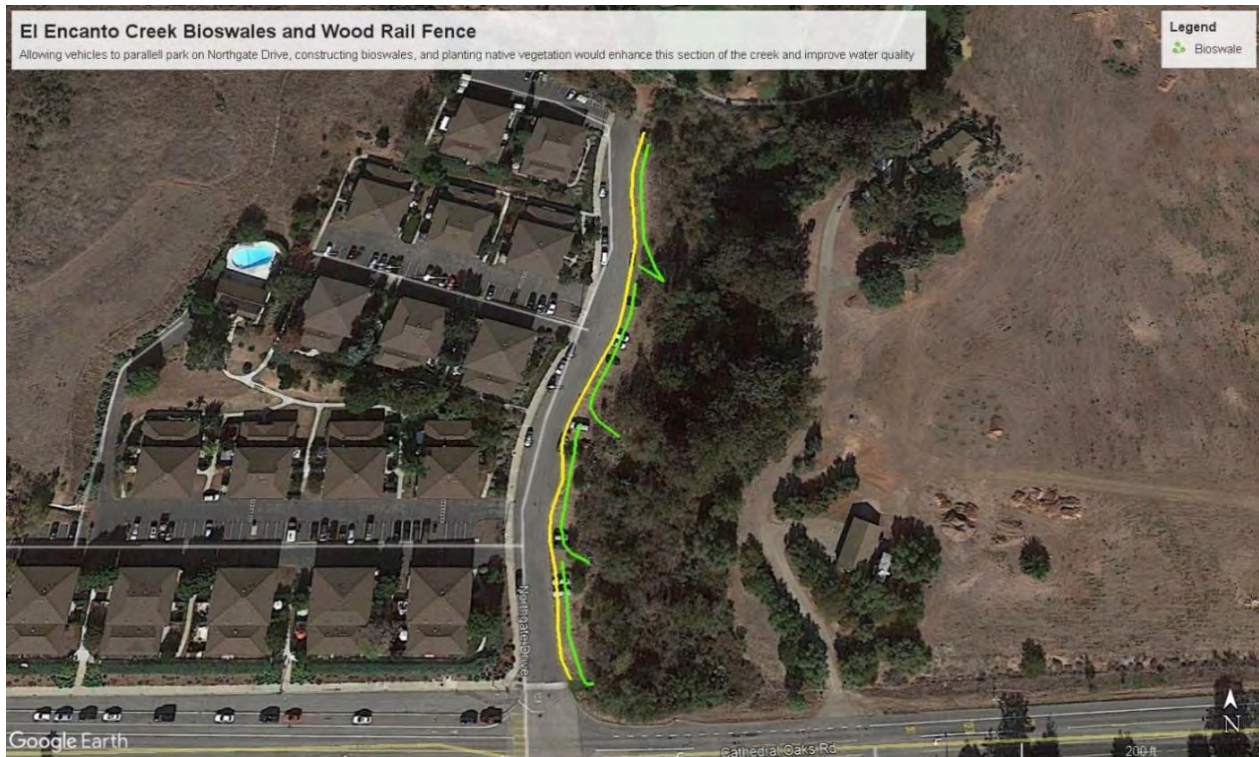
Figure 54. A wood rail fence (yellow line) along the east side of Northgate Drive would prevent vehicles from parking in dry weeds within the El Encanto Creek SPA, reducing fire hazards, improving water quality, improving habitat conditions, and enabling planting of native riparian species. Bioswales (green lines) would convey runoff and filter stormwater pollution from the street runoff before it enters the Creek. Google Earth. 2019.

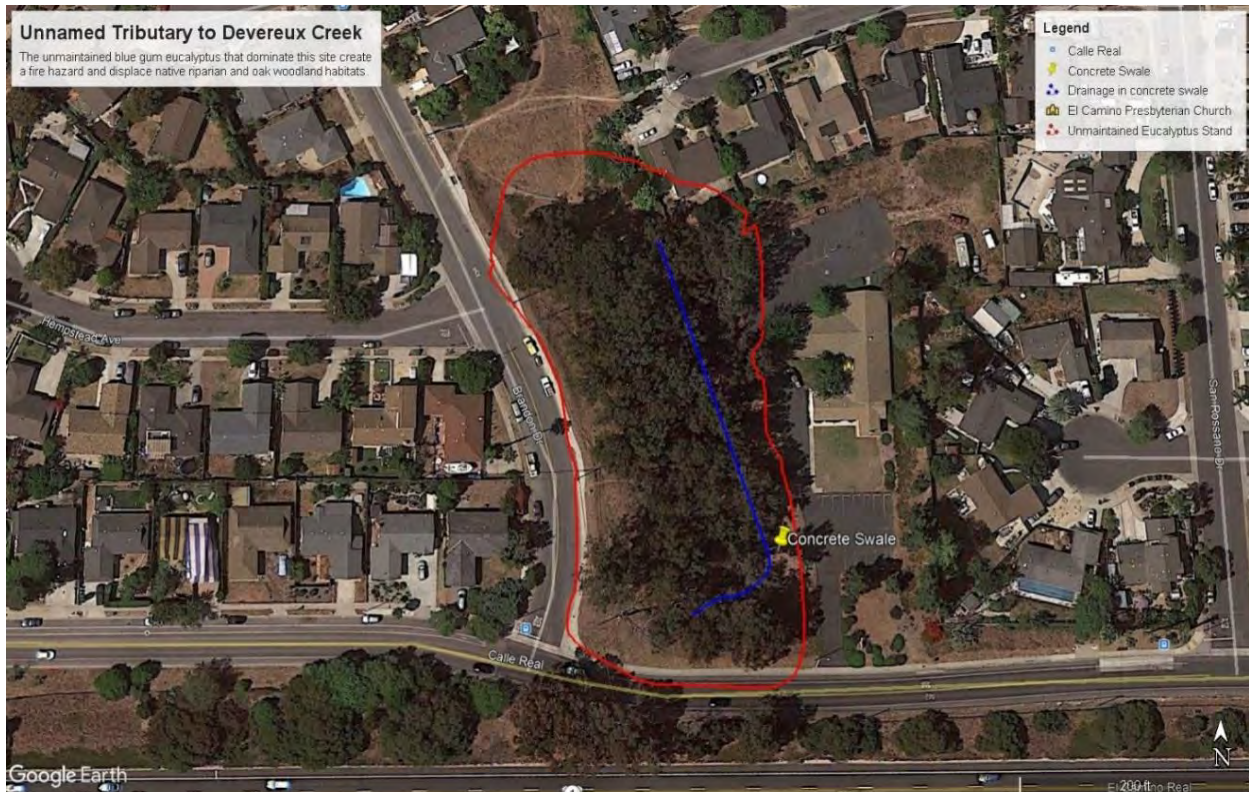
Figure 73. Unnamed tributary to Devereux Creek in open space with invasive flammable eucalyptus trees and a concrete-lined channel. Calle Real and Brandon Drive. Google Earth. 2019.

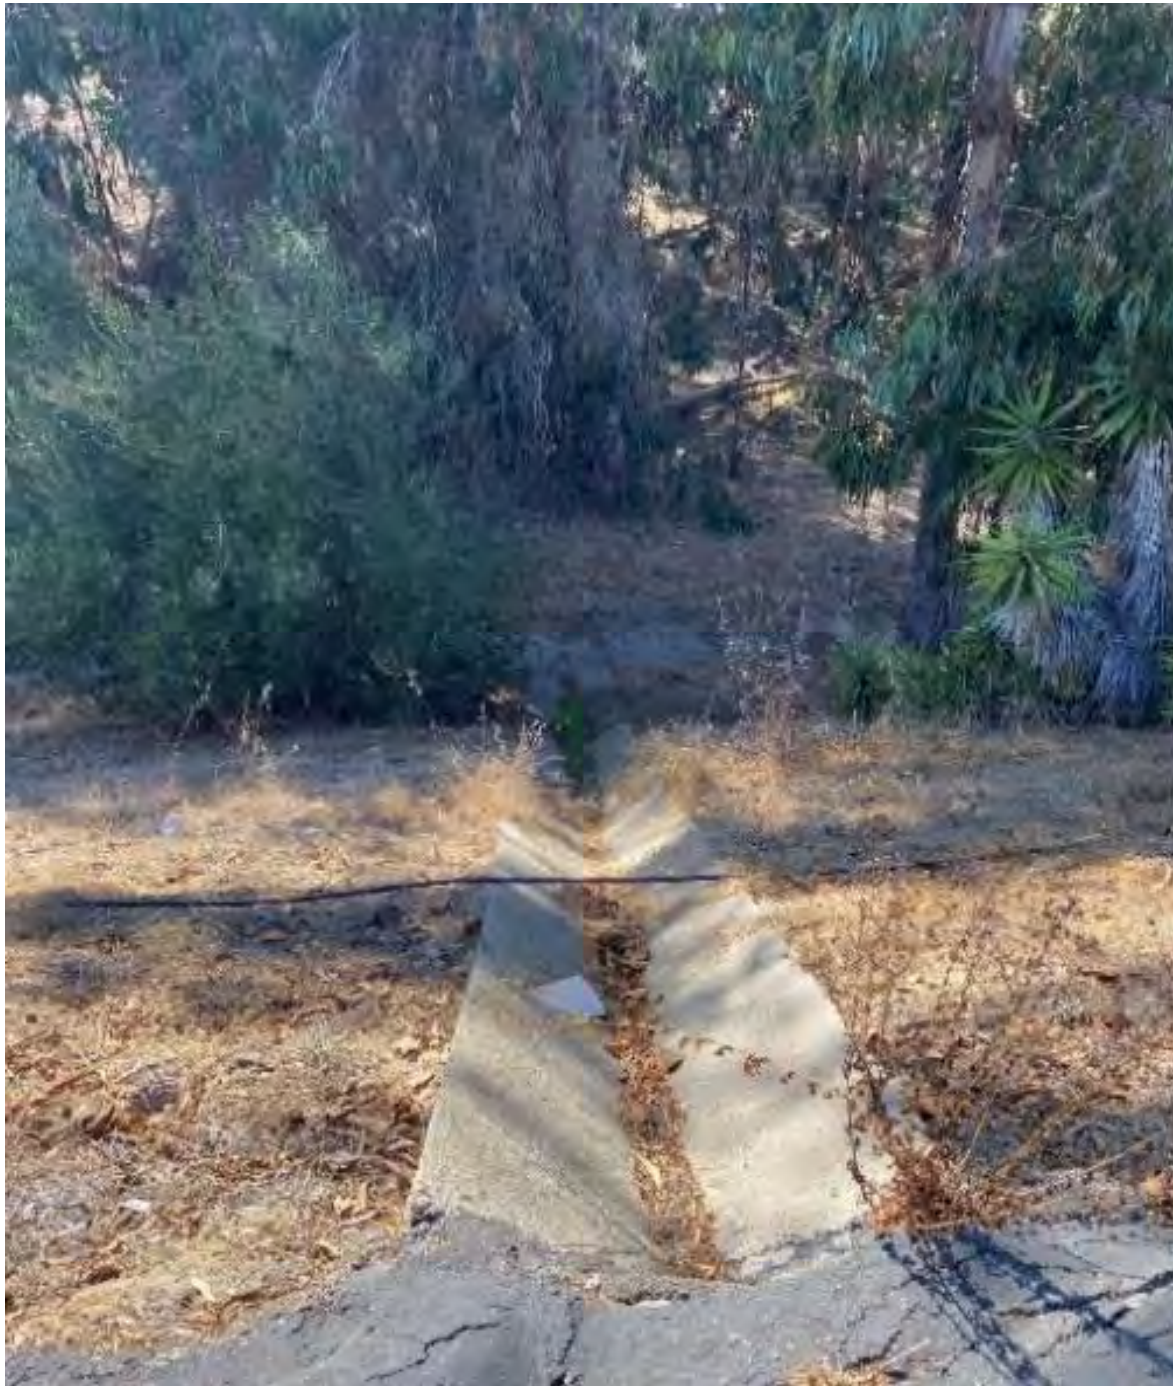
Figure 74. A concrete-lined storm drain directs parking lot runoff into the tributary without any opportunity for infiltration. Brian Trautwein. October 2020.

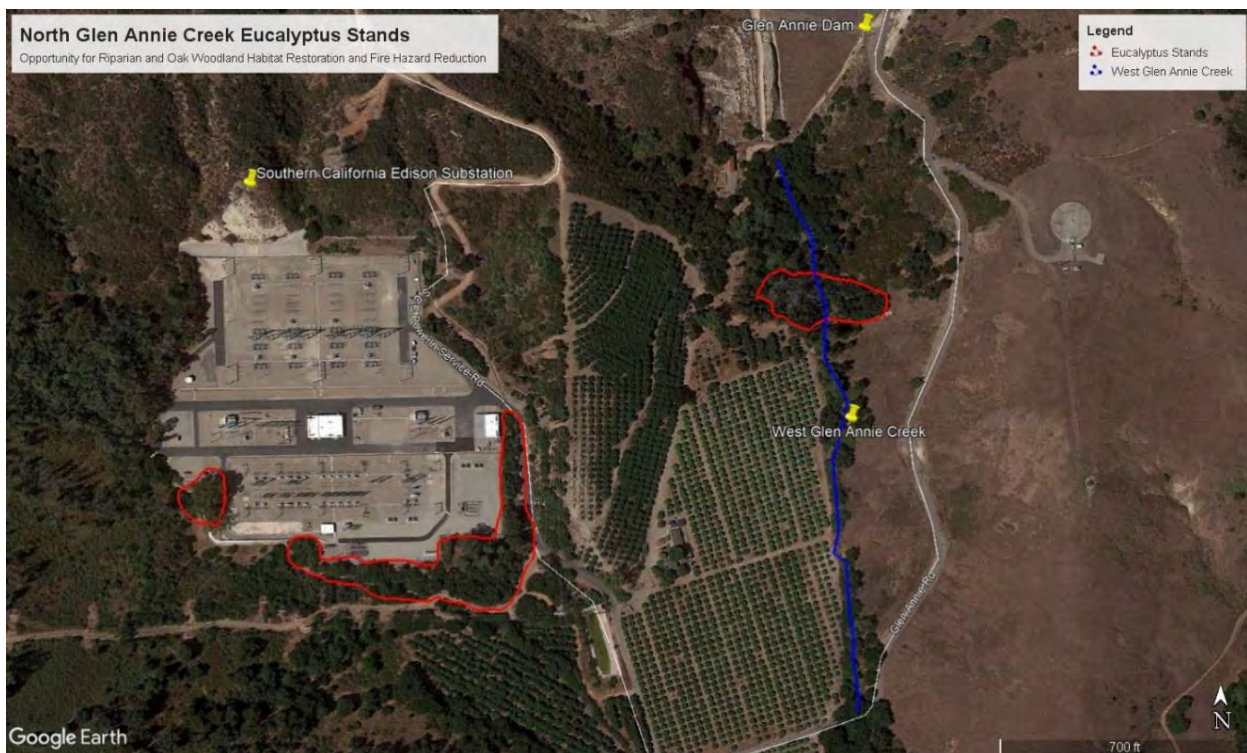
Figure 89. Highly flammable, invasive eucalyptus trees in the WUI directly below Glen Annie Dam and south of the Edison electrical substation may have been planted to visually screen the facilities. Google Earth. 2019.

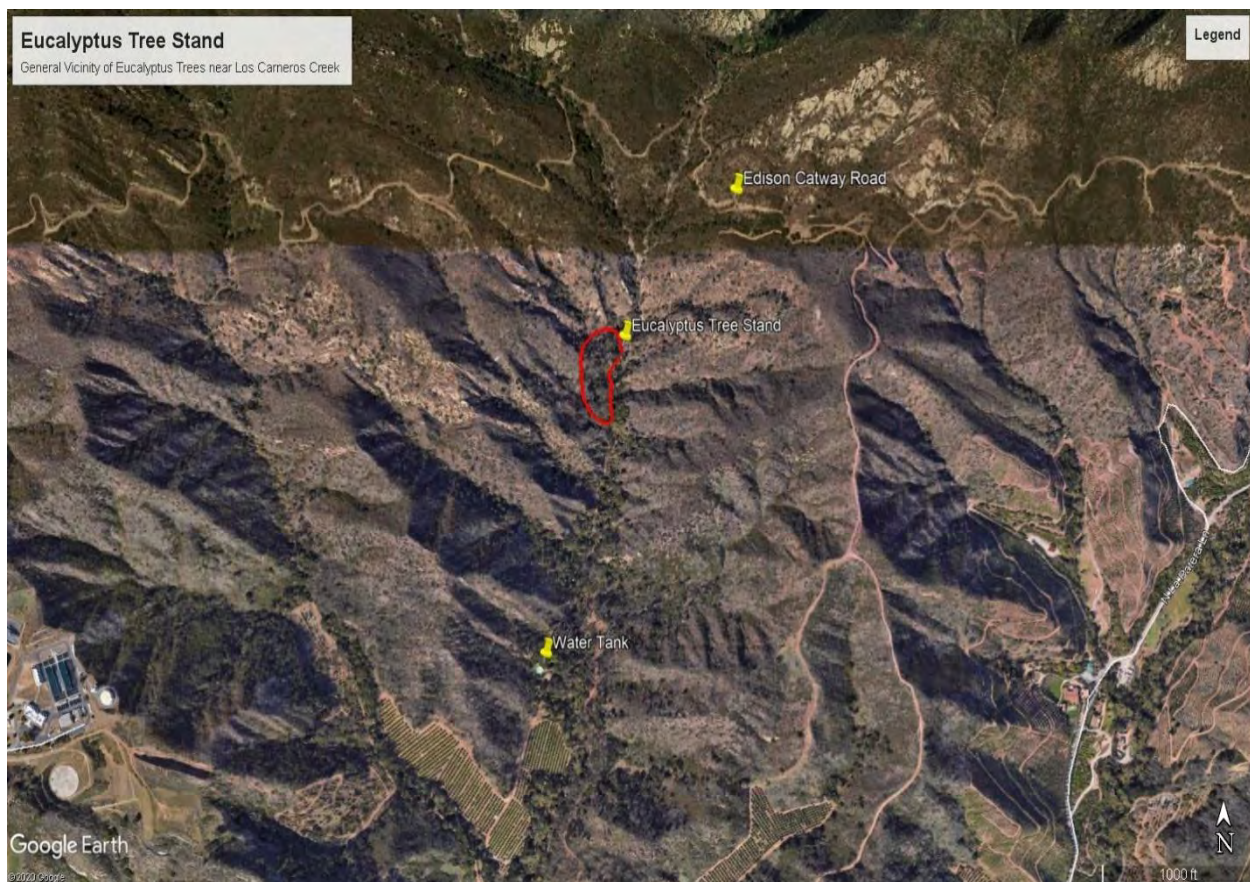
Figure 109. A stand of eucalyptus trees (red polygon) is present near Los Carneros Creek. An apparent water tank is located up-gradient from irrigated orchards near Los Carneros Creek indicating the potential presence of a stream diversion(s) and/or water wells near the Creek.

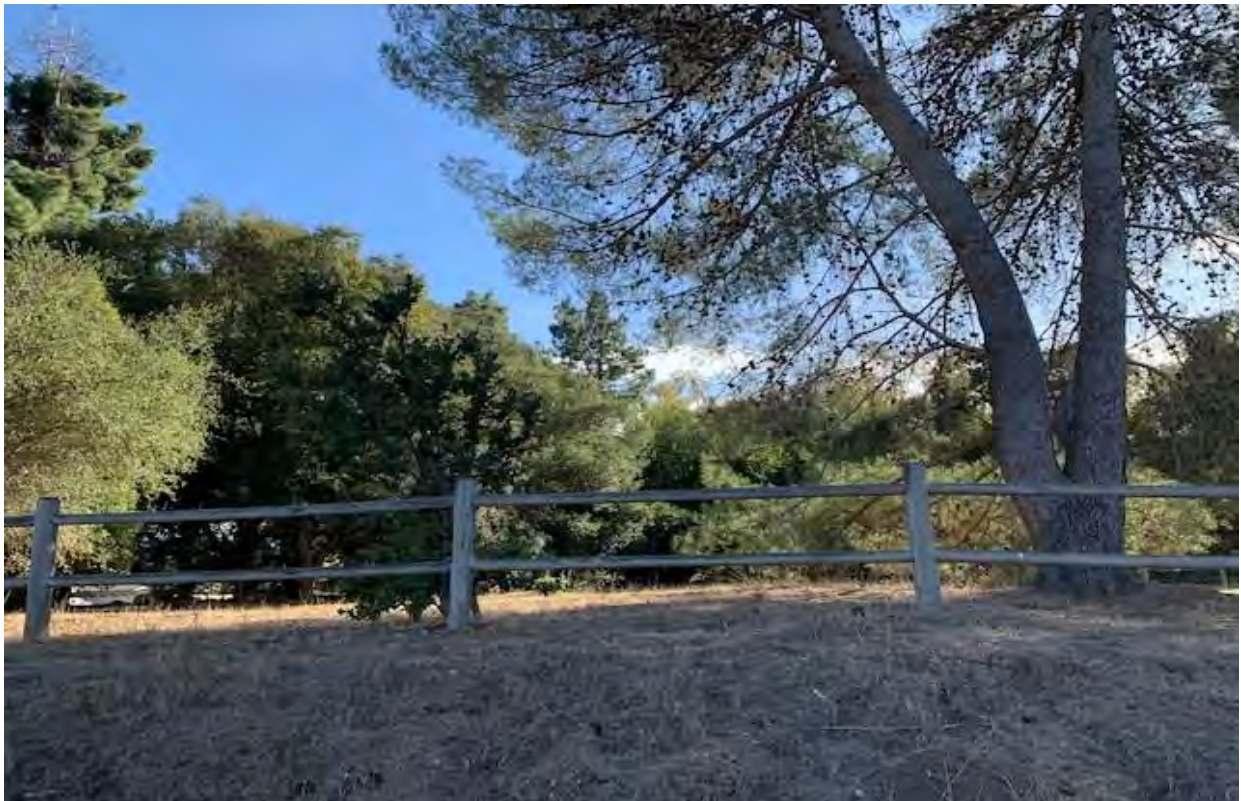
Figure 126. Twenty nonnative pine trees including Italian stone pines, occur along San Pedro Creek in City of Goleta’s Stonebridge Open Space south of Cathedral Oaks Road. Brian Trautwein. December 2020.

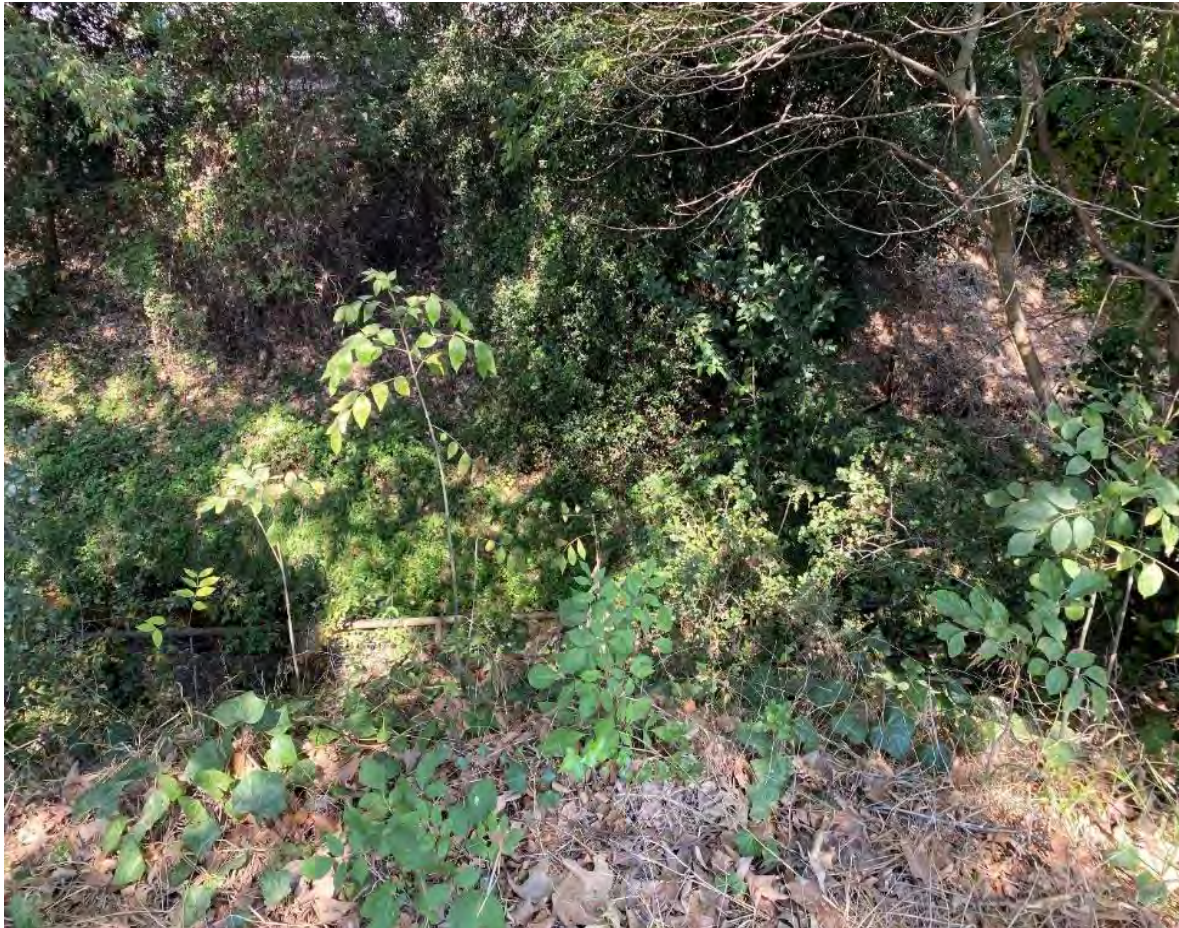
Figure 127. Invasive nonnative plants, including Algerian ivy (*Hedera canariensis*) and Shamel ash (*Fraxinus uhdei*) should be removed from the riparian portion of the Stonebridge Open Space. Max Kalber. October 6, 2020.

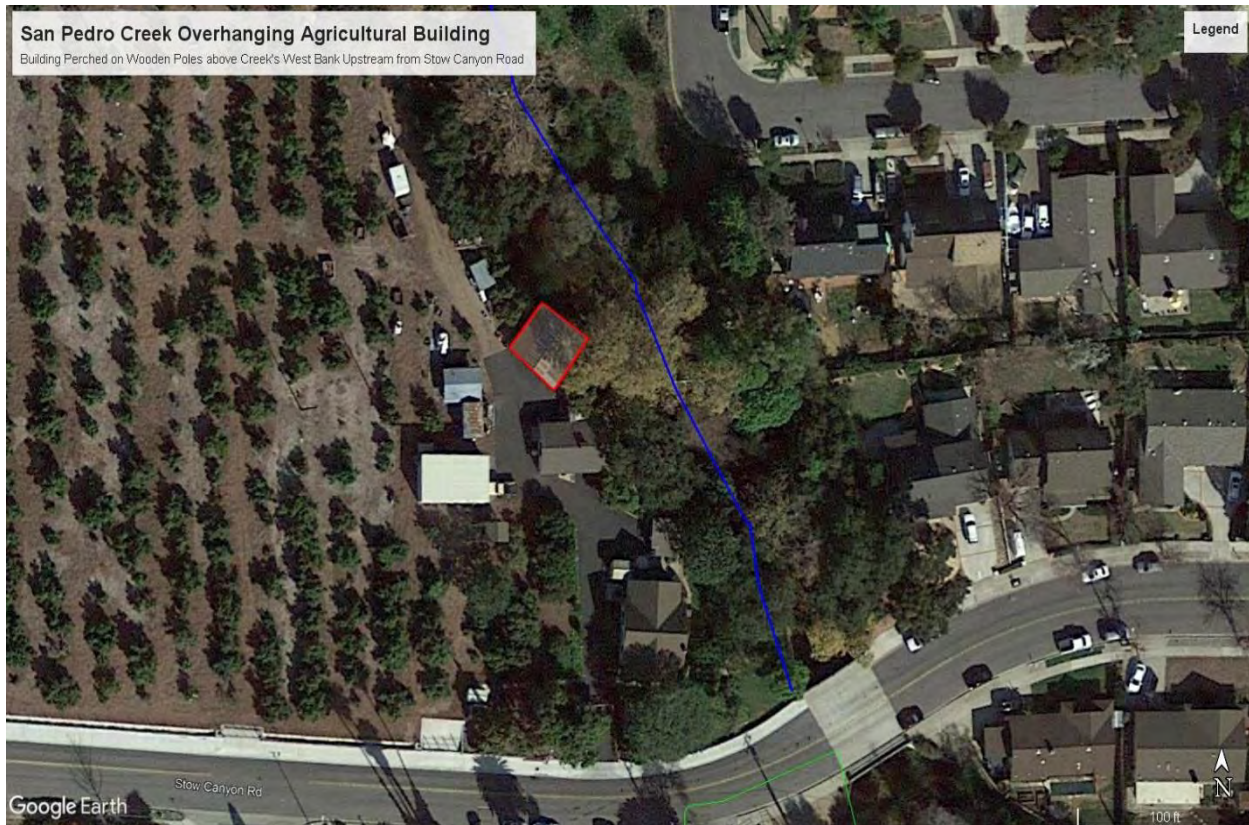
Figure 129. An agricultural storage building (outlined in red) is perched over the west bank of San Pedro Creek (blue line). Google Earth 2019.

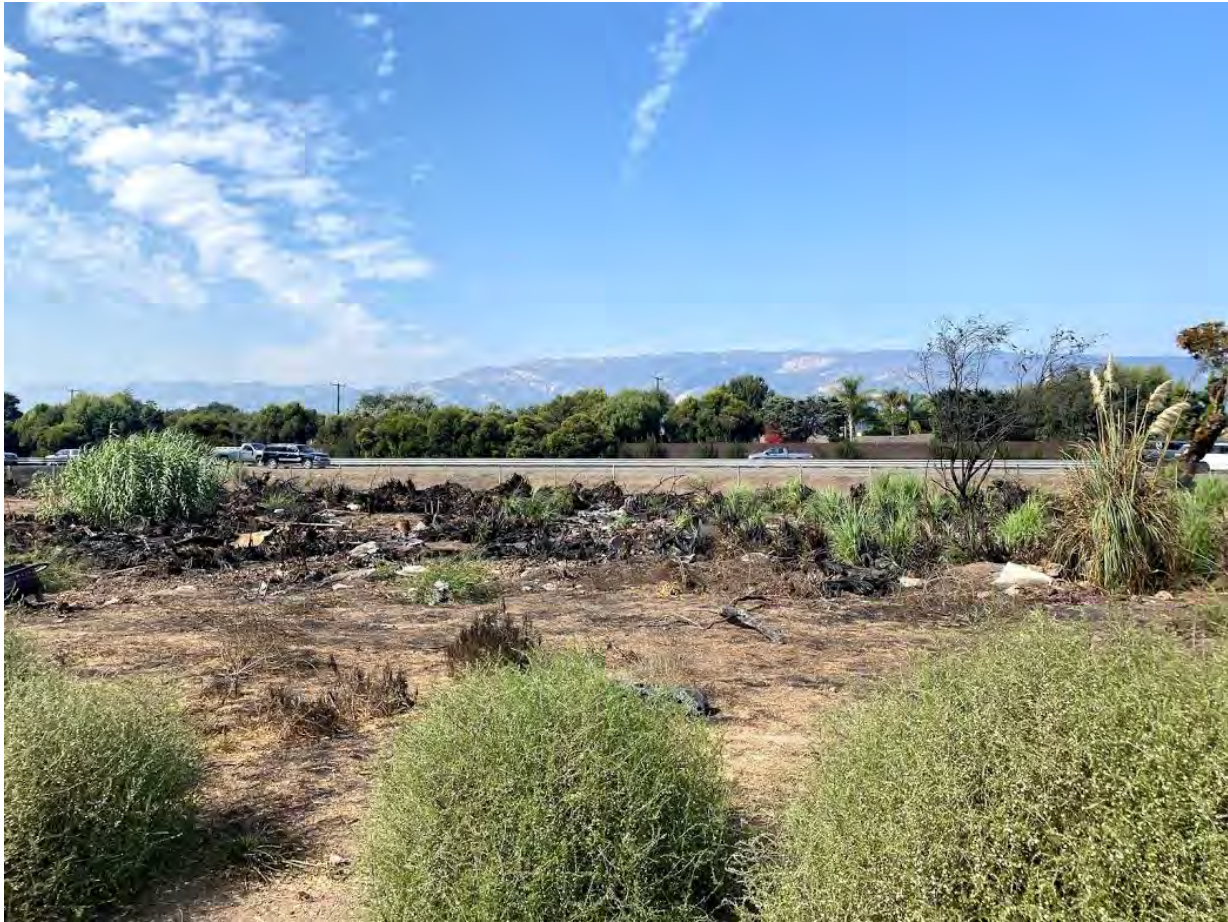
Figure 150. A recent fire occurred west of the San Pedro Creek homeless community member encampment. Note the burnt vegetation, single willow sapling, resprouting Arundo and pampas grass, and metal debris. This area should be cleaned up and restored as riparian habitat. Brian Trautwein. October 6, 2020.

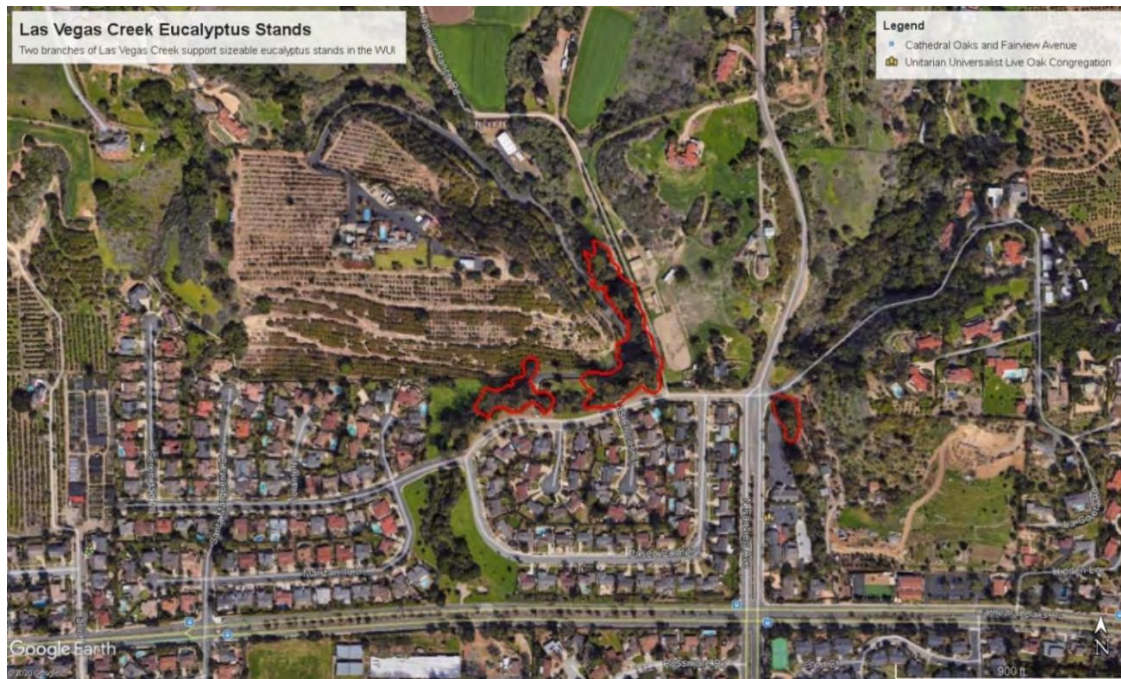
Figure 165. Three significant stands of eucalyptus trees along Las Vegas Creek increase fire hazards and degrade the riparian woodland in the WUI near Fairview Avenue and La Goleta Road. Google Earth. 2019.

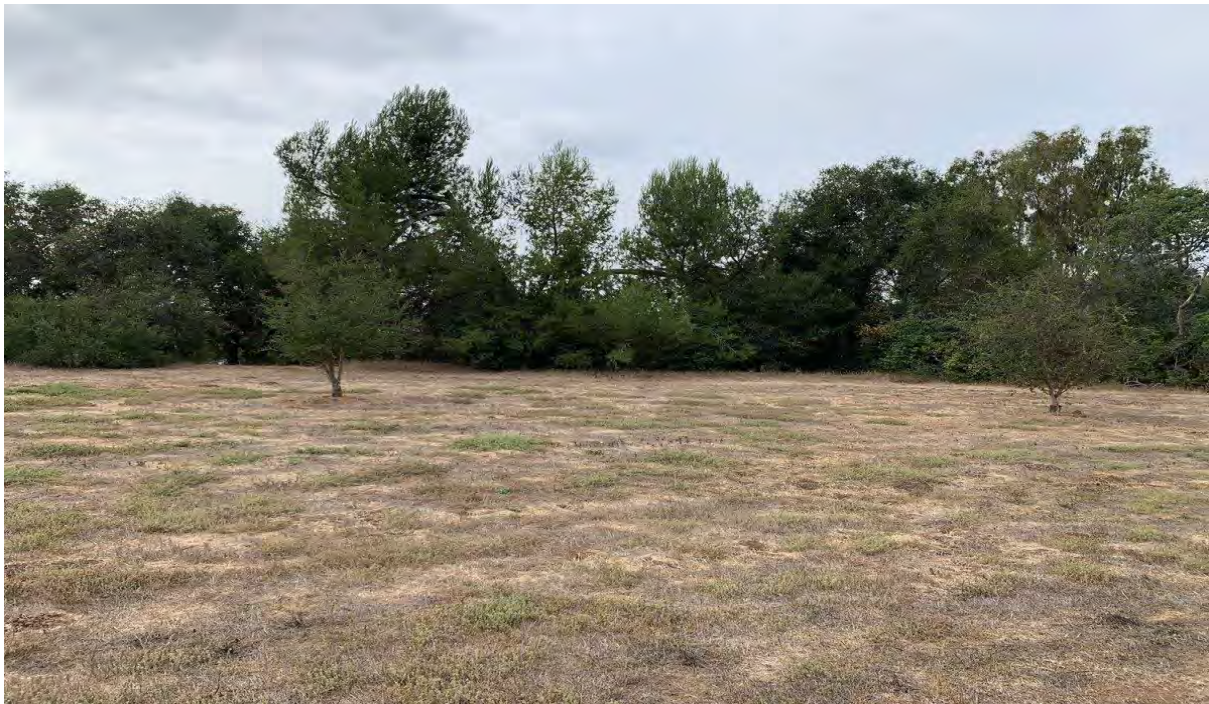
Figure 170. Las Vegas Creek at the La Goleta Open Space lacks sufficient native vegetation in the SPA and offers opportunities for riparian and oak savannah restoration. Flammable pine trees in riparian corridor and flammable mowed weeds could be replaced with less flammable native species. Brian Trautwein. October 1, 2020.

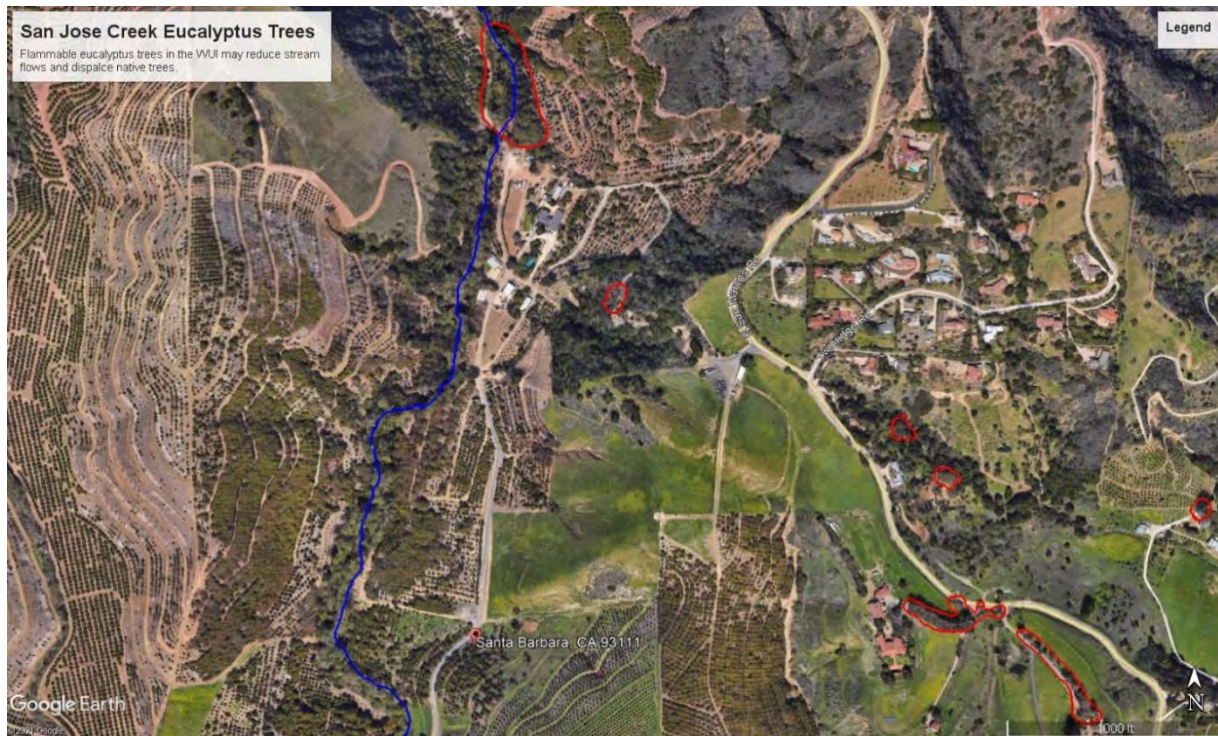
Figure 187. Eucalyptus trees growing within native oak woodland, chaparral, and riparian plant communities increase fire hazards. Google Earth, 2020.

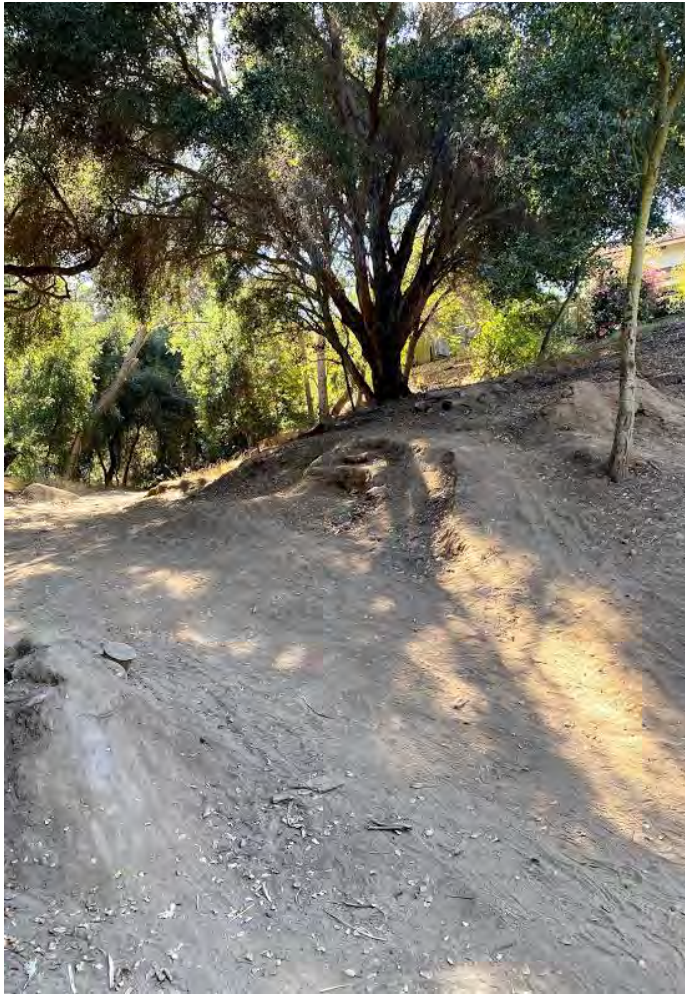
Figure 196. BMX jumps are built adjacent to San Jose Creek in the riparian corridor and buffer zone. Max Kalber. November 2020.

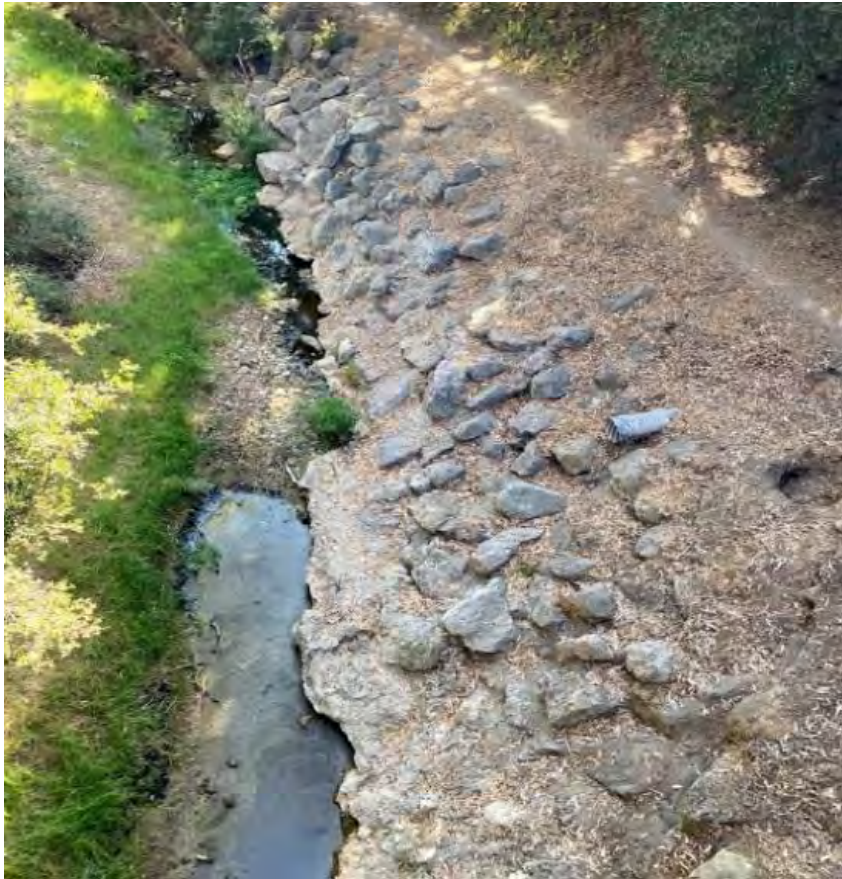
Figure 197. A grouted rock embankment lines the west bank of San Jose Creek at North Patterson Avenue. Note the overhanging bank below the structure provides fish habitat. Max Kalber. November 2020.

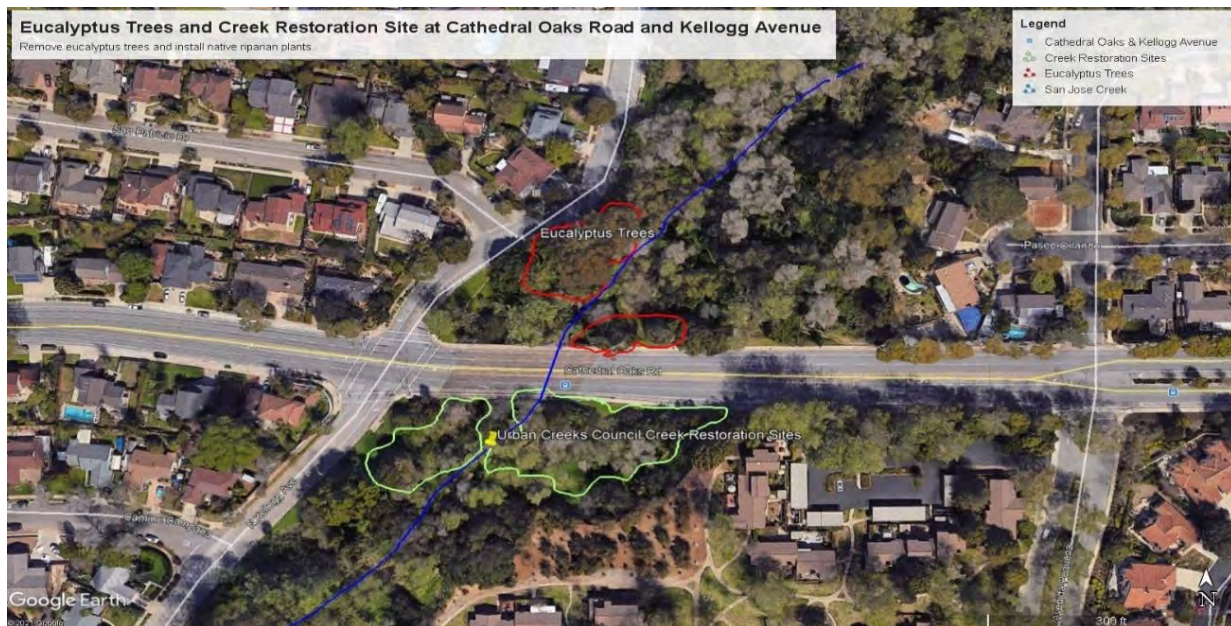
Figure 199. Eucalyptus trees (red polygon) increase the fire hazard in this area. Restoration sites should be planted with native perennial understory vegetation such as wild blackberry and maintained to reduce flammable nonnative weeds in understory. Google Earth. 2019.

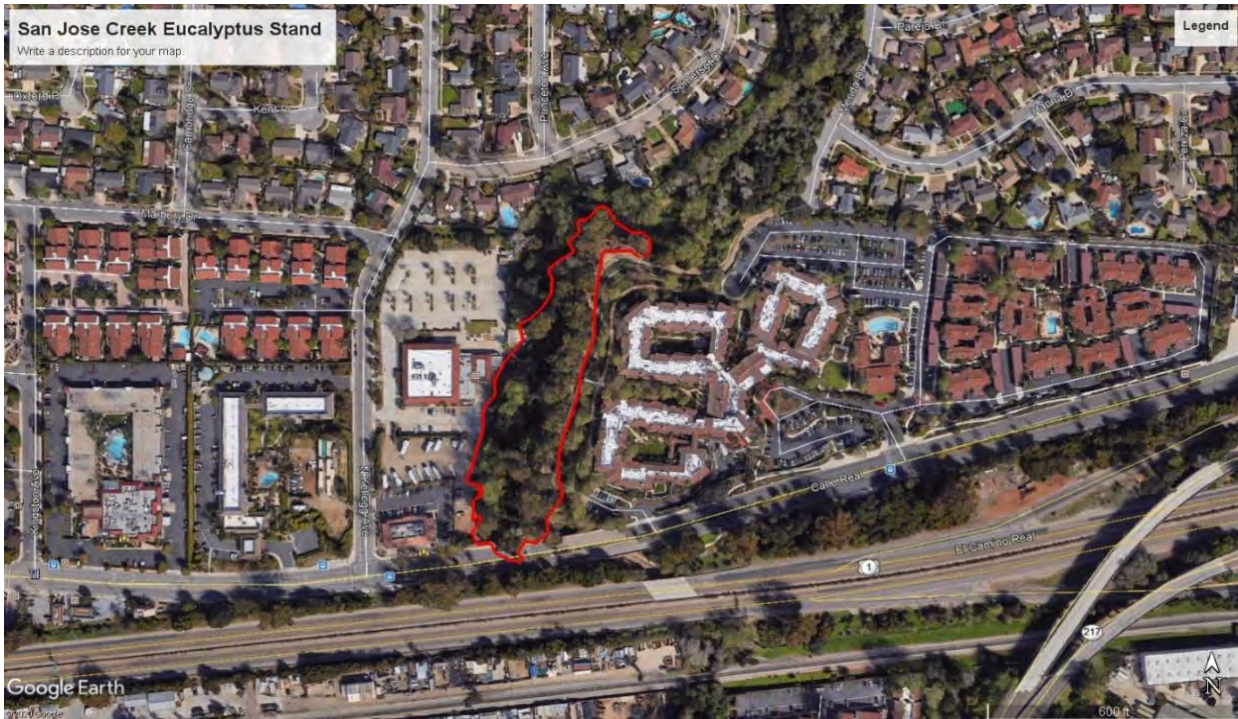
Figure 219. This substantial eucalyptus grove once served as a monarch butterfly overwintering site and turkey vulture roost. It creates a fire hazard near the Maravilla Assisted Living Community. Google Earth. 2019.
