GOLETA WATERSHEDS AND WILDLAND-URBAN INTERFACES:
ENHANCING FIRE SAFETY AND RIPARIAN FOREST HEALTH

GOLETA WATERSHED PROTECTION AND EDUCATION PROGRAM

August 2021

ENVIRONMENTAL DEFENSE CENTER

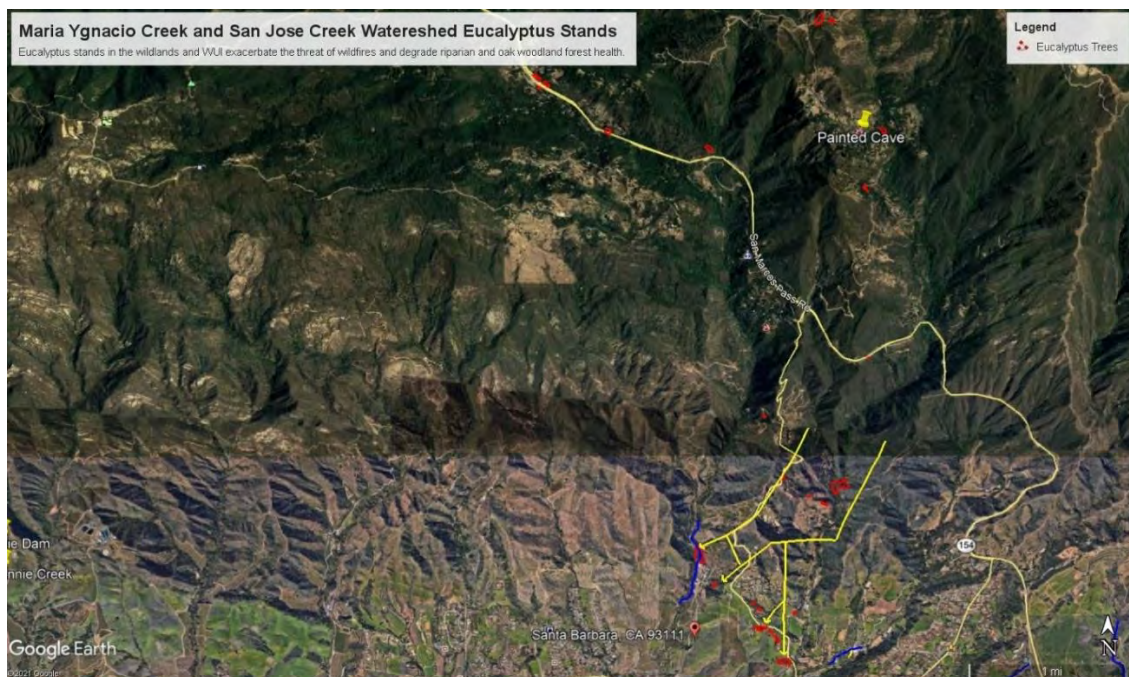
Figure 232. Several stands of eucalyptus in the Painted Cave, San Marcos Pass, San Jose Creek, and Maria Ygnacio Creek areas increase fire hazards and decrease native forest quality. Google Earth. 2019.

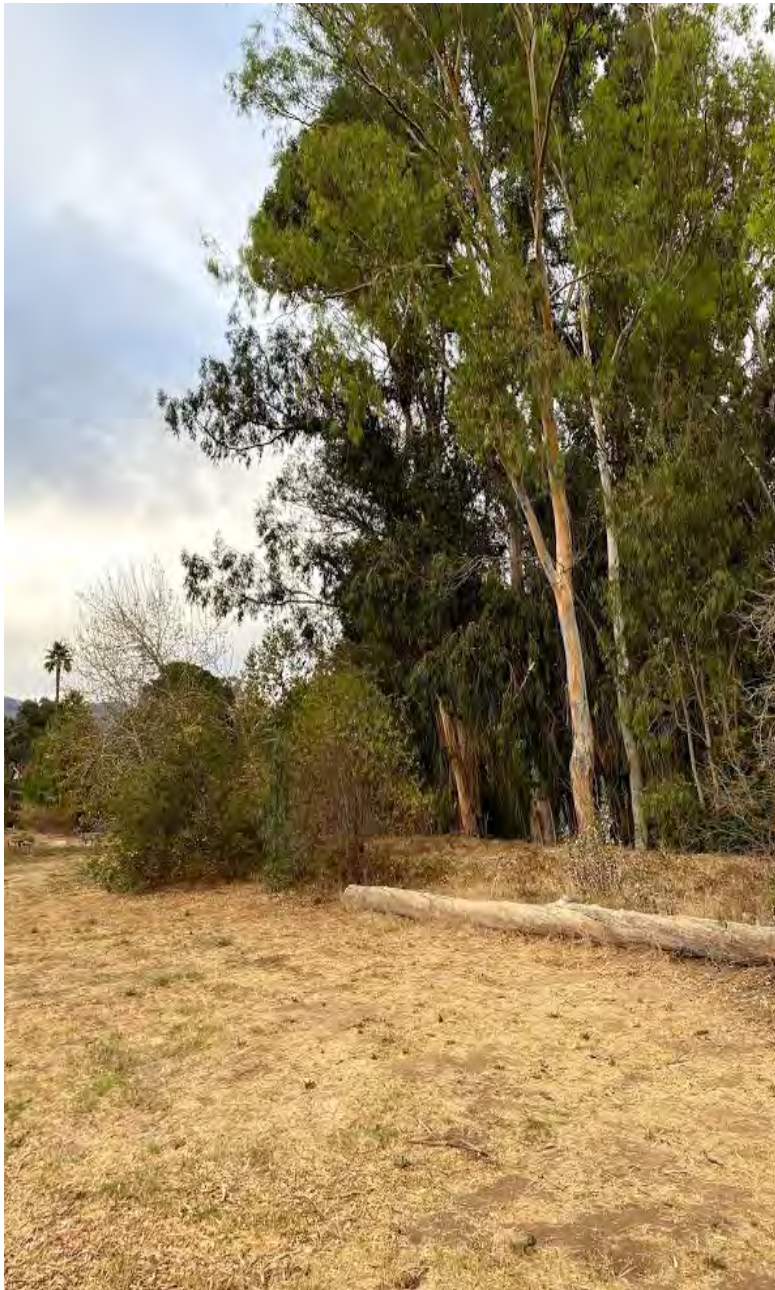
Figure 258. Eucalyptus trees in Monarch Butterfly Overwintering Sites 2788 and 3216 on the west bank of Maria Ygnacio Creek in the Calle Barquero Open Space should be managed pursuant to the City of Goleta Community Wildfire Protection Plan to reduce fire hazards and maintain monarch butterfly habitat. Continue to plant native riparian and oak woodland plant species (left side of photo) in areas outside of the monarch overwintering site, and where eucalyptus trees die or fall within the grove. Prevent the spread of eucalyptus trees within Maria Ygnacio and San Antonio Creek. Note nonnative weeds mowed in foreground. Max Kalber. November 5, 2020.

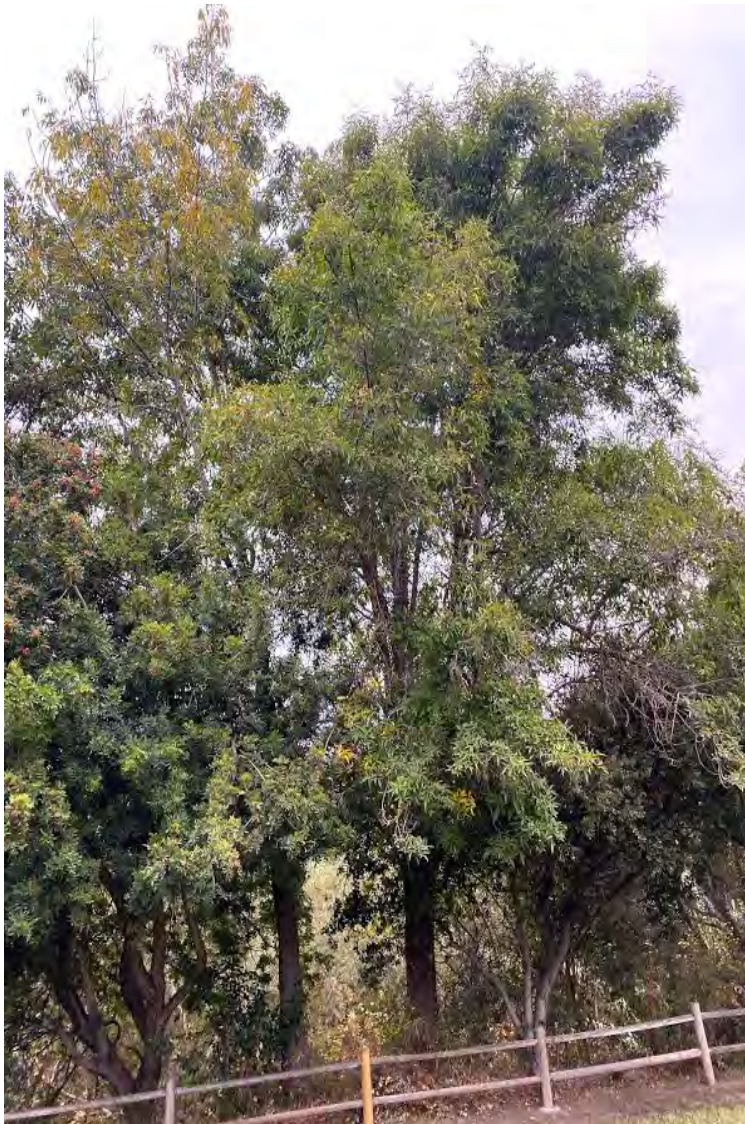
Figure 267. Shamel ash trees atop the east bank of Maria Ygnacio Creek at Lassen Open Space. Note the wood-rail fence at the top of bank and lack of a buffer vegetated with riparian plants. Max Kalber. November 5, 2020.

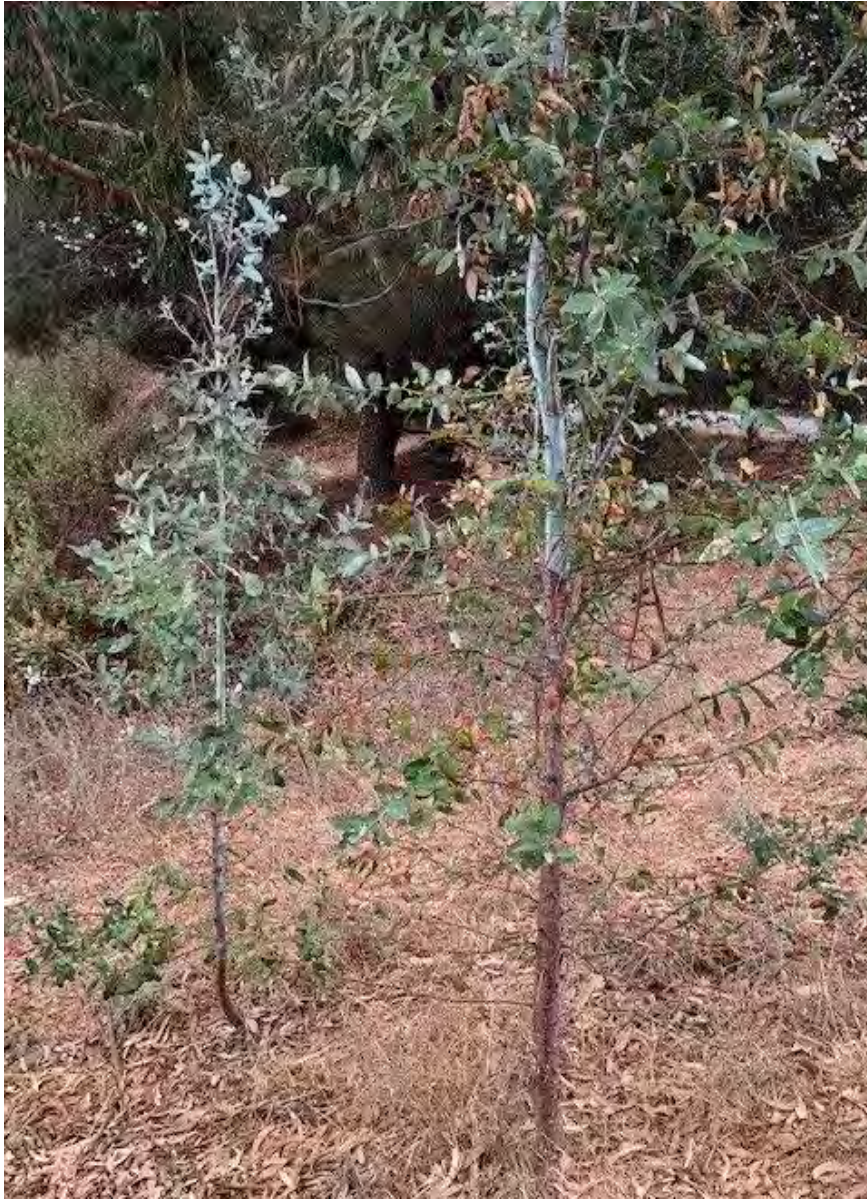
Figure 268. Eucalyptus saplings indicate the eucalyptus trees are spreading in the Maria Ygnacio Creek riparian corridor. Removing them will halt the spread, reduce fire hazards, create an opportunity to restore oak woodland and riparian forest habitat, and provide public education. Brian Trautwein. November 5, 2020.

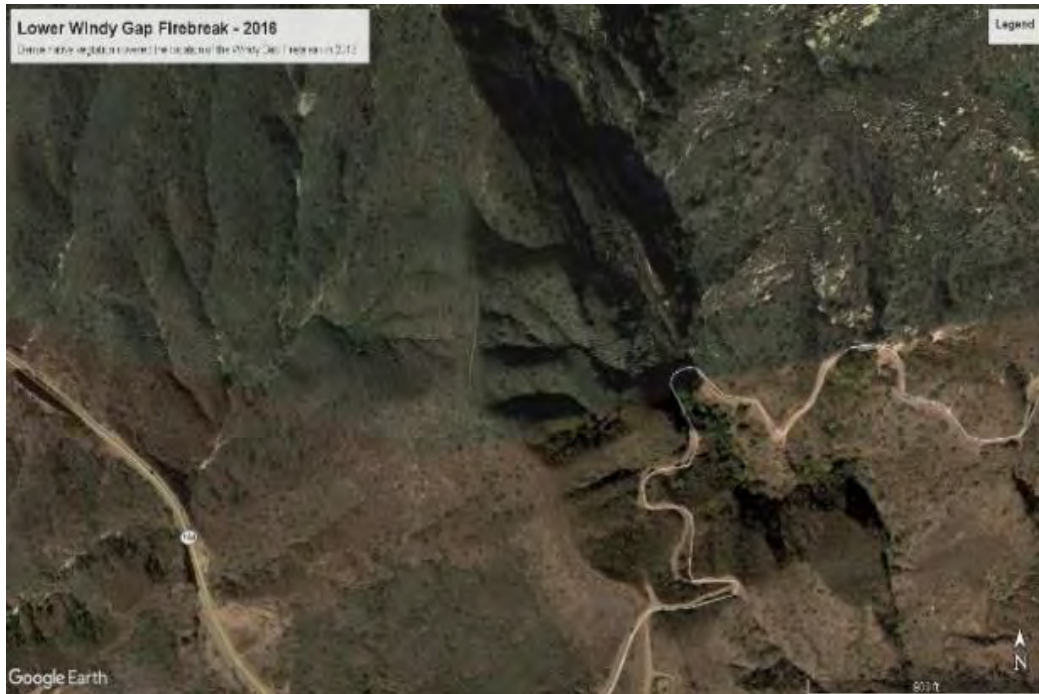
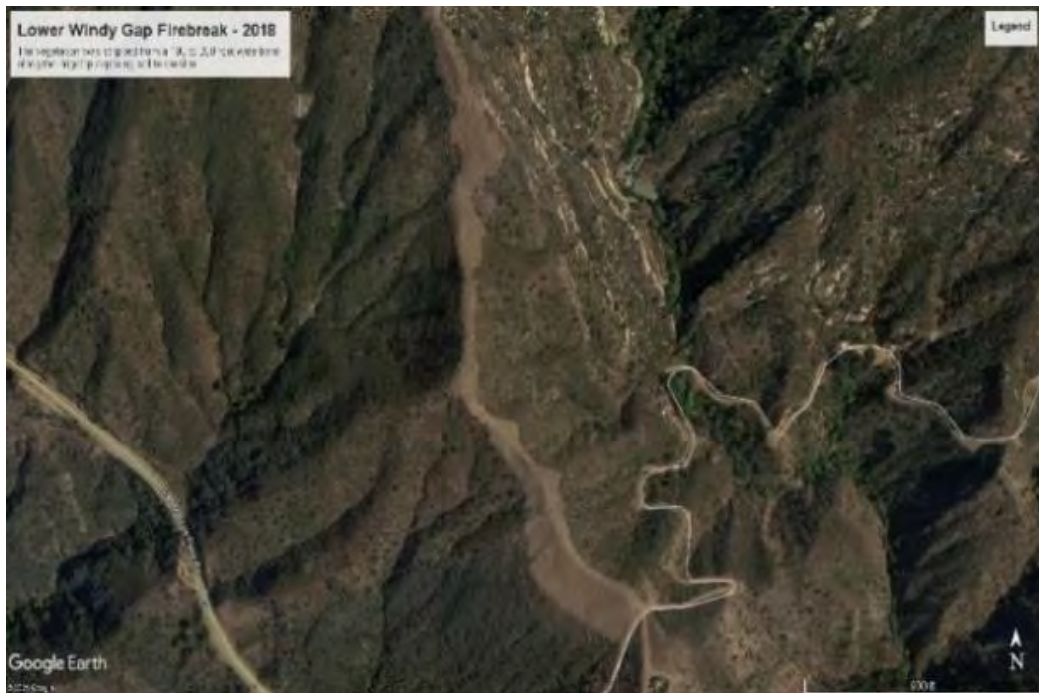
Figure 284. The Windy Gap Firebreak before it was cleared (2016) and Figure 285 after it was cleared (2018), exposing the soil to erosion. Google Earth, 2016 and 2018.

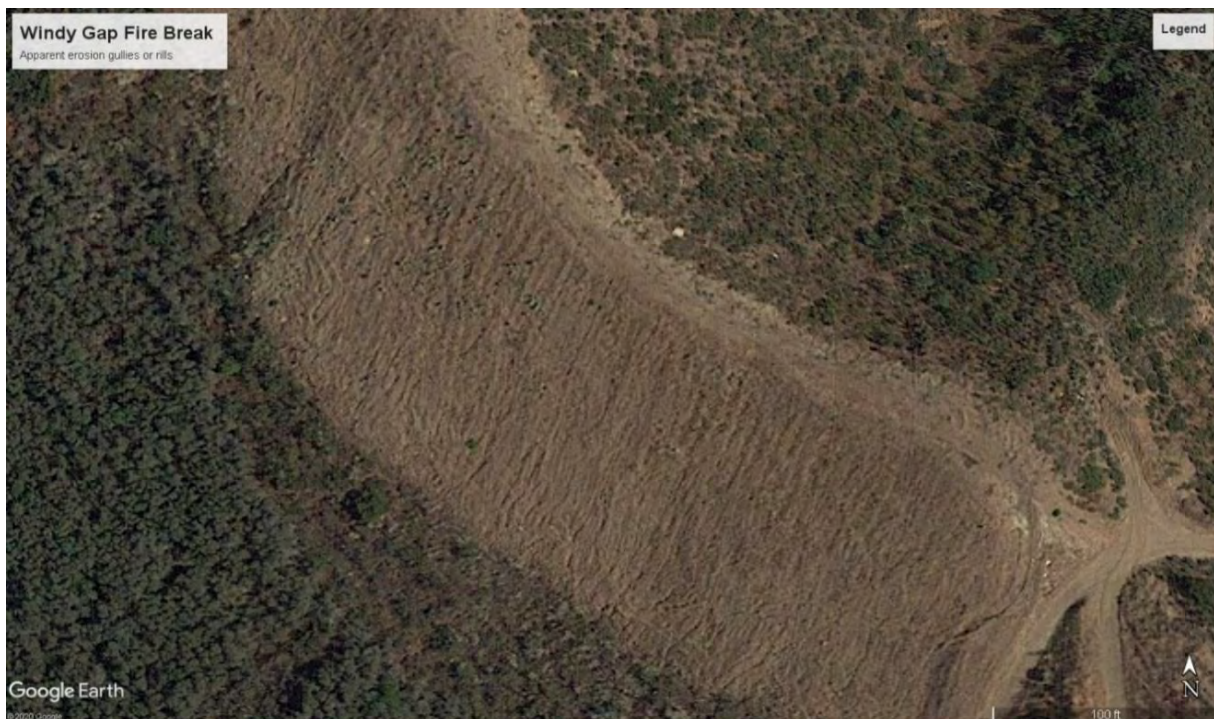
Figure 288. Erosion gullies or rills were present on the Windy Gap Firebreak in 2019 despite the installation of erosion control water bars. Google Earth. 2019.

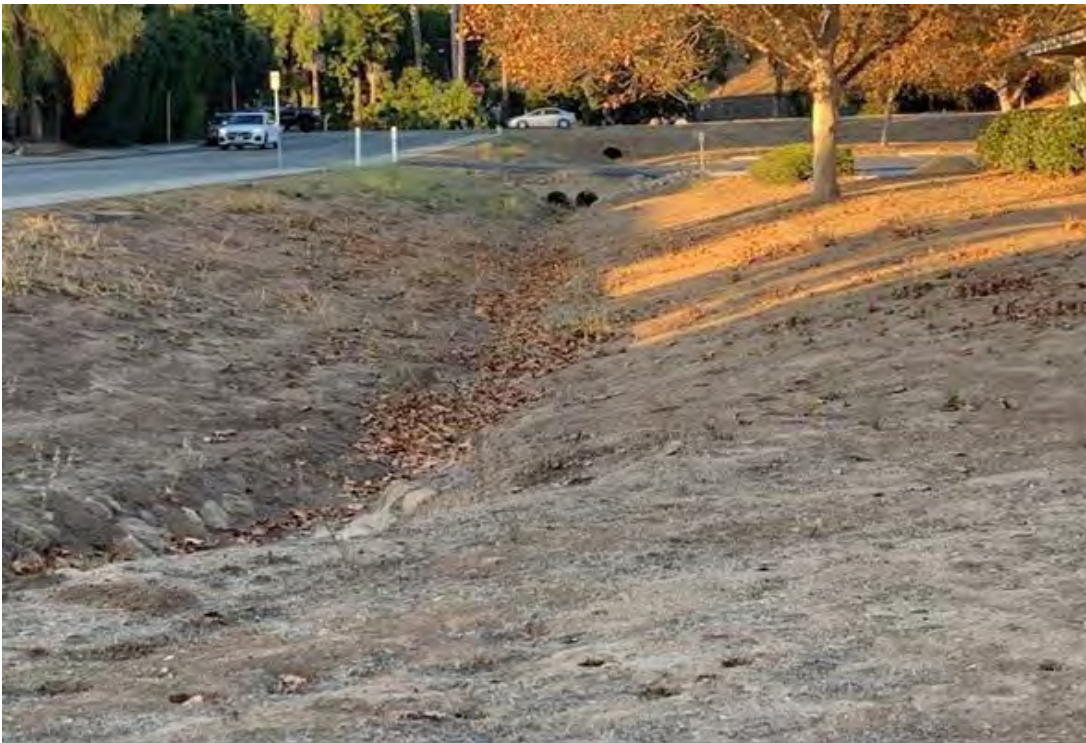
Figure 302. The bioswale would be constructed where the existing swale and culverts are located along Vala Drive and would extend southward, then eastwards until it reaches the west bank of San Antonio Creek. Brian Trautwein. November 24, 2020.

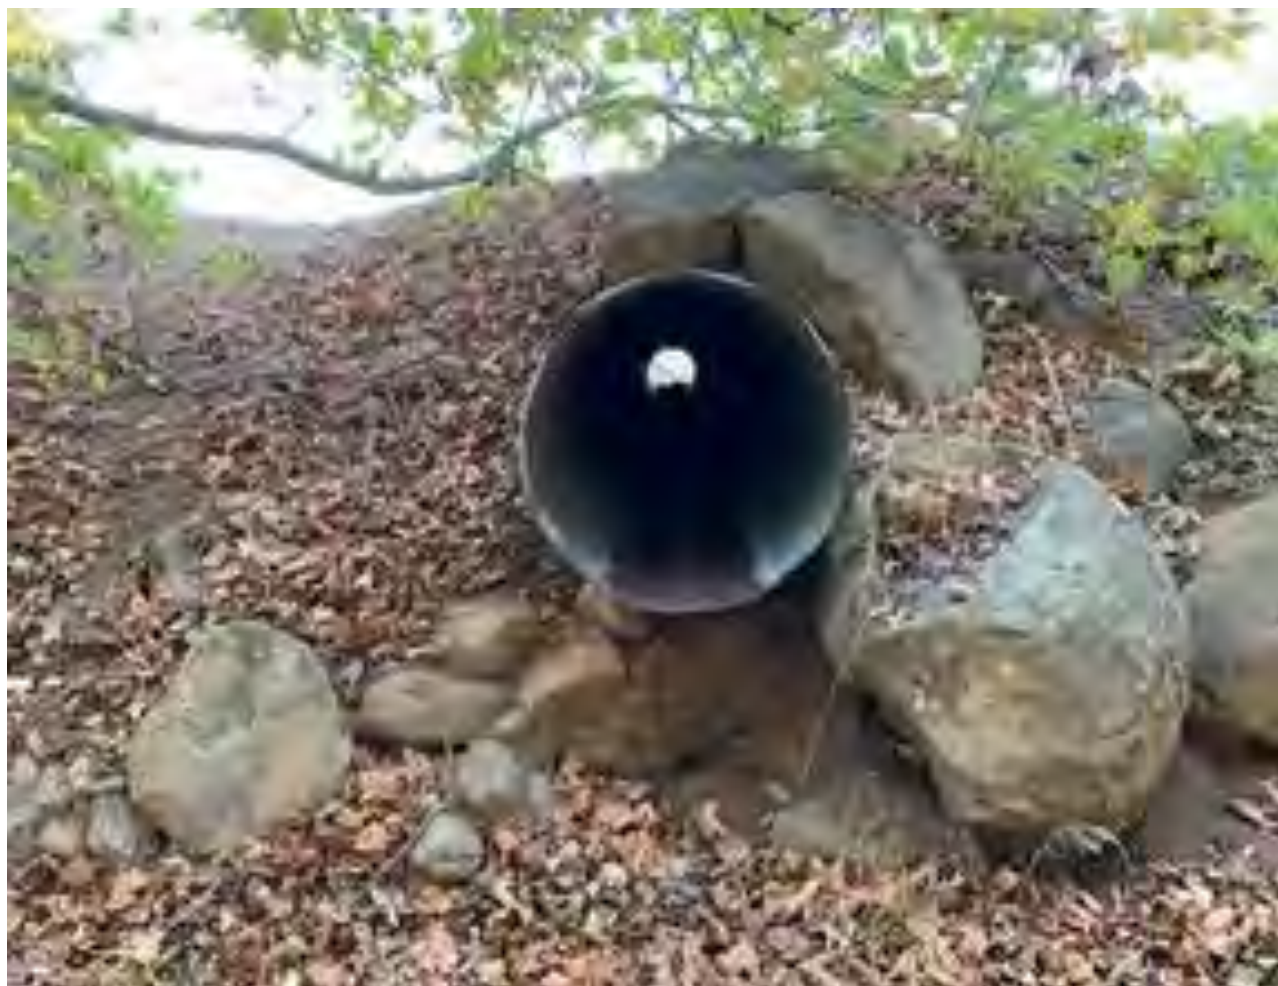
Figure 305. This storm drain has no mechanism for filtering pollutants that eventually discharge into San Antonio Creek. We recommend removal of the pipe and installation of a bioswale. Brian Trautwein. November 24, 2020.

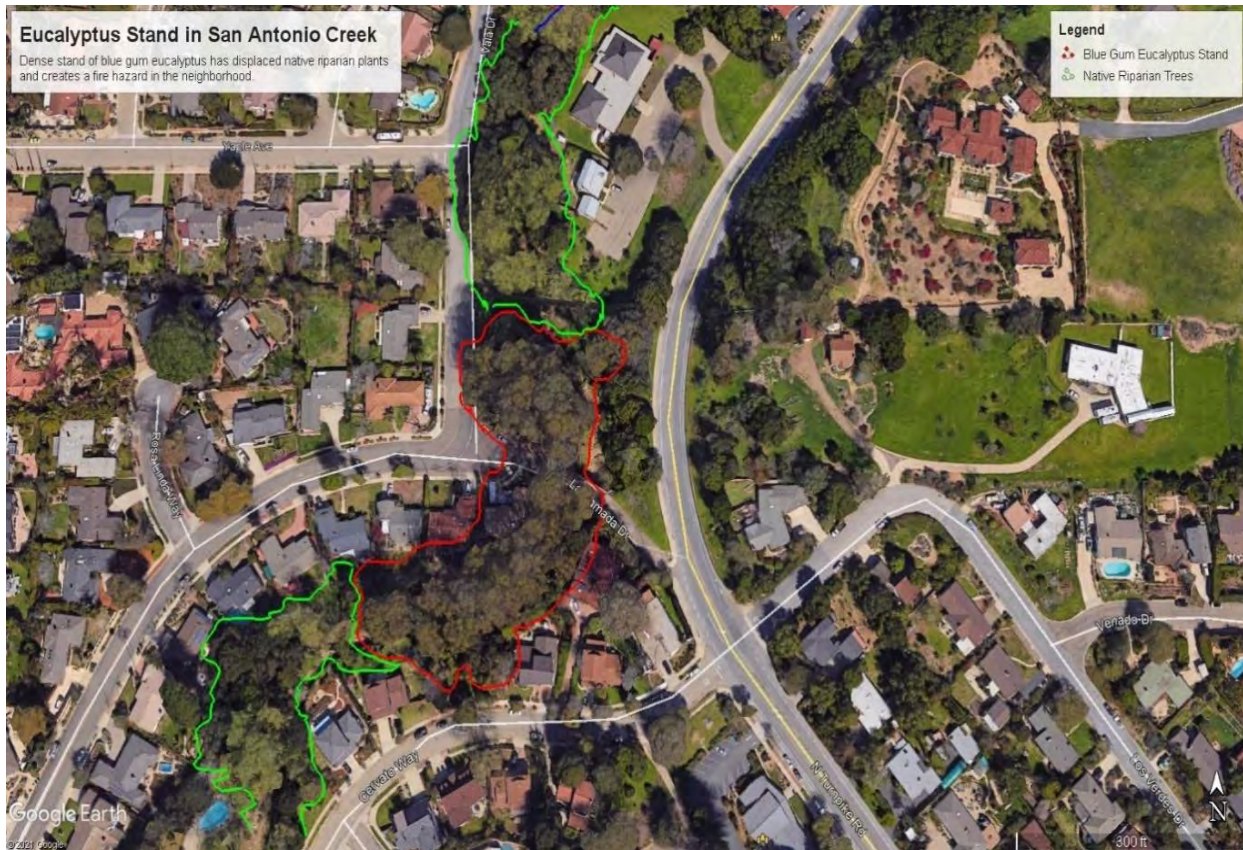
Figure 308. The red outline depicts a large stand of eucalyptus trees at La Ramada Drive and North Turnpike Ave. The green polygons depict native riparian forest along San Antonio Creek. Google Earth. 2019.

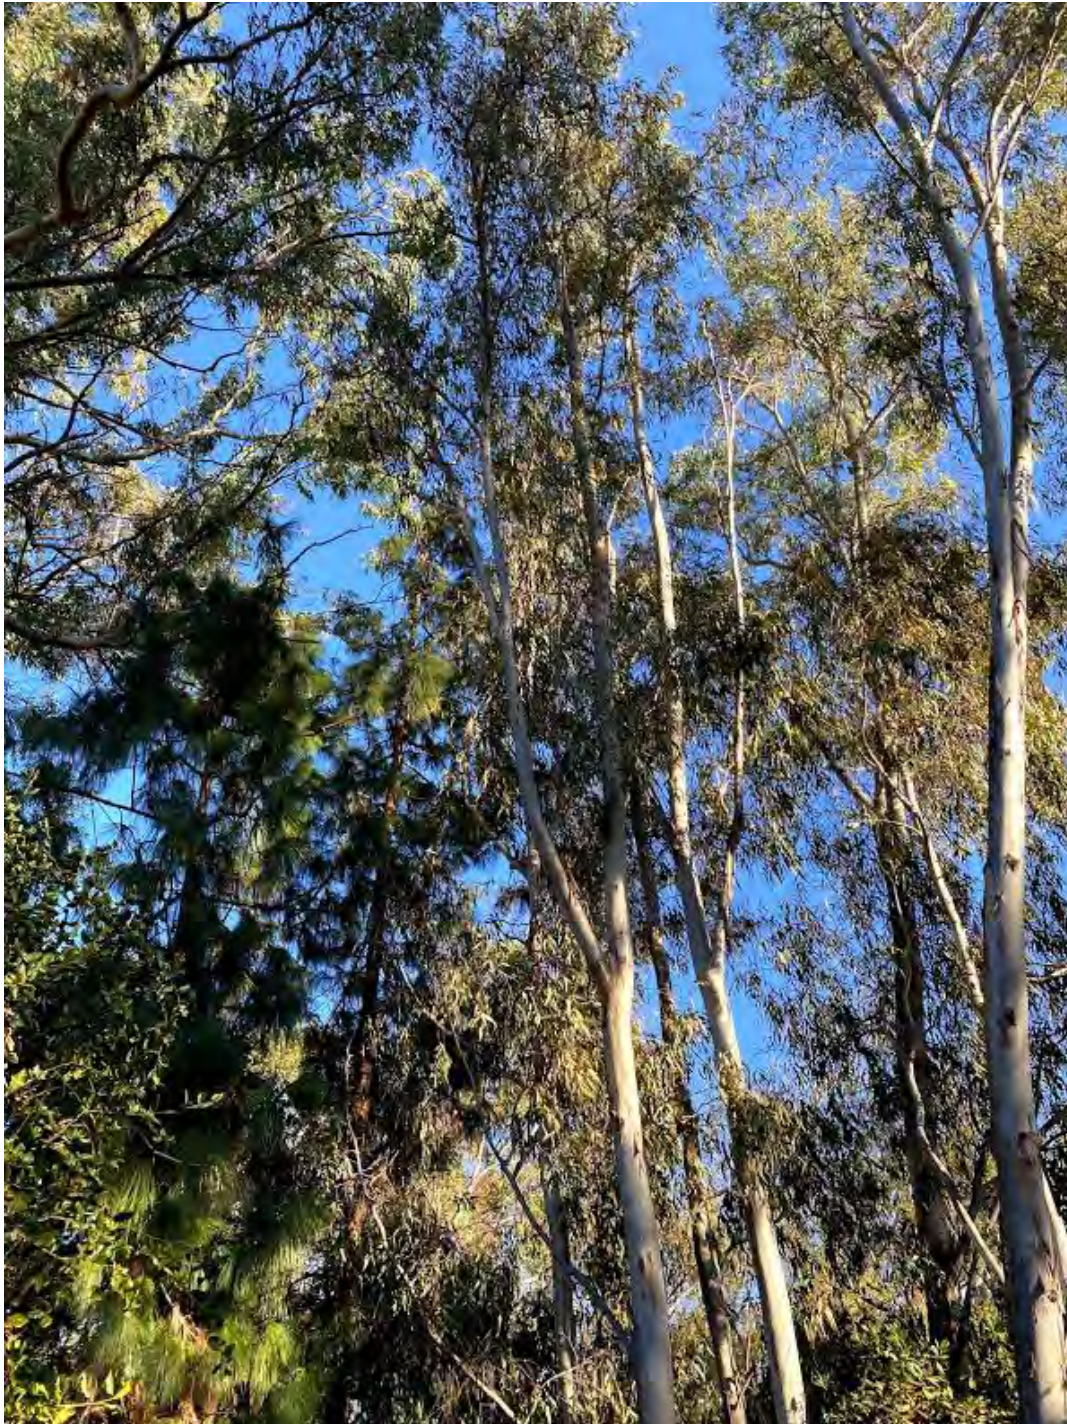
Figure 361. Eucalyptus trees invading the oak riparian woodland, and pine trees increase neighborhood fire hazards in the WUI. Max Kalber. December 17, 2020.
